POWGEN T0 Baseplate Upgrade A Lesson In Configuration Management

September 19, 2018

DENIM VII 2018

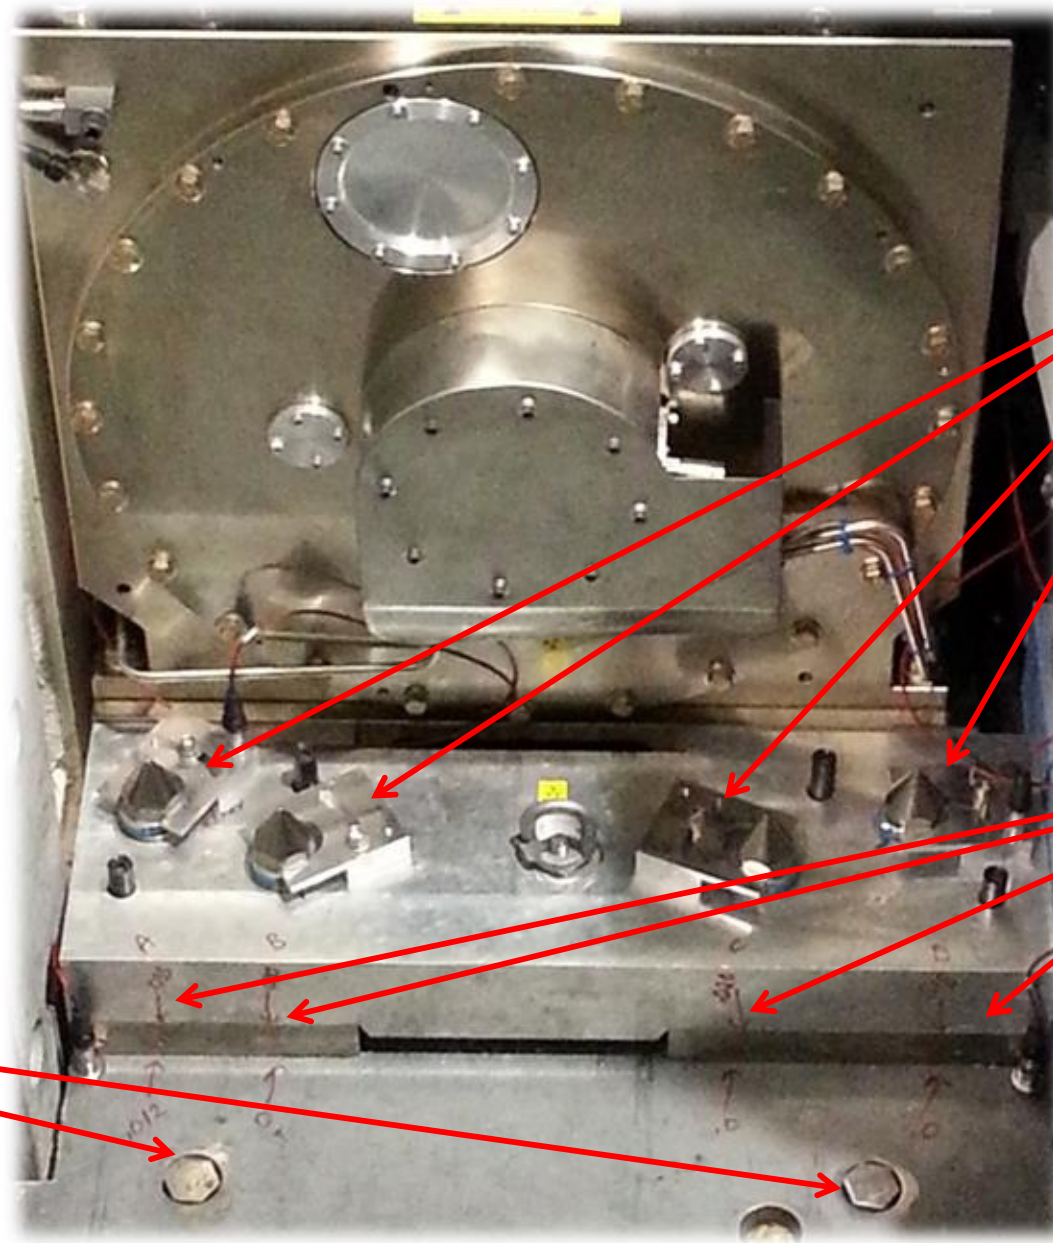
Chopper, as repaired, 2015

Keepers (to prevent captured bolts from backing out)

These nuts, which attach the baseplate to anchor studs, were ground away during 2007 installation

These markings show measurement locations – problem investigation included measuring these gaps

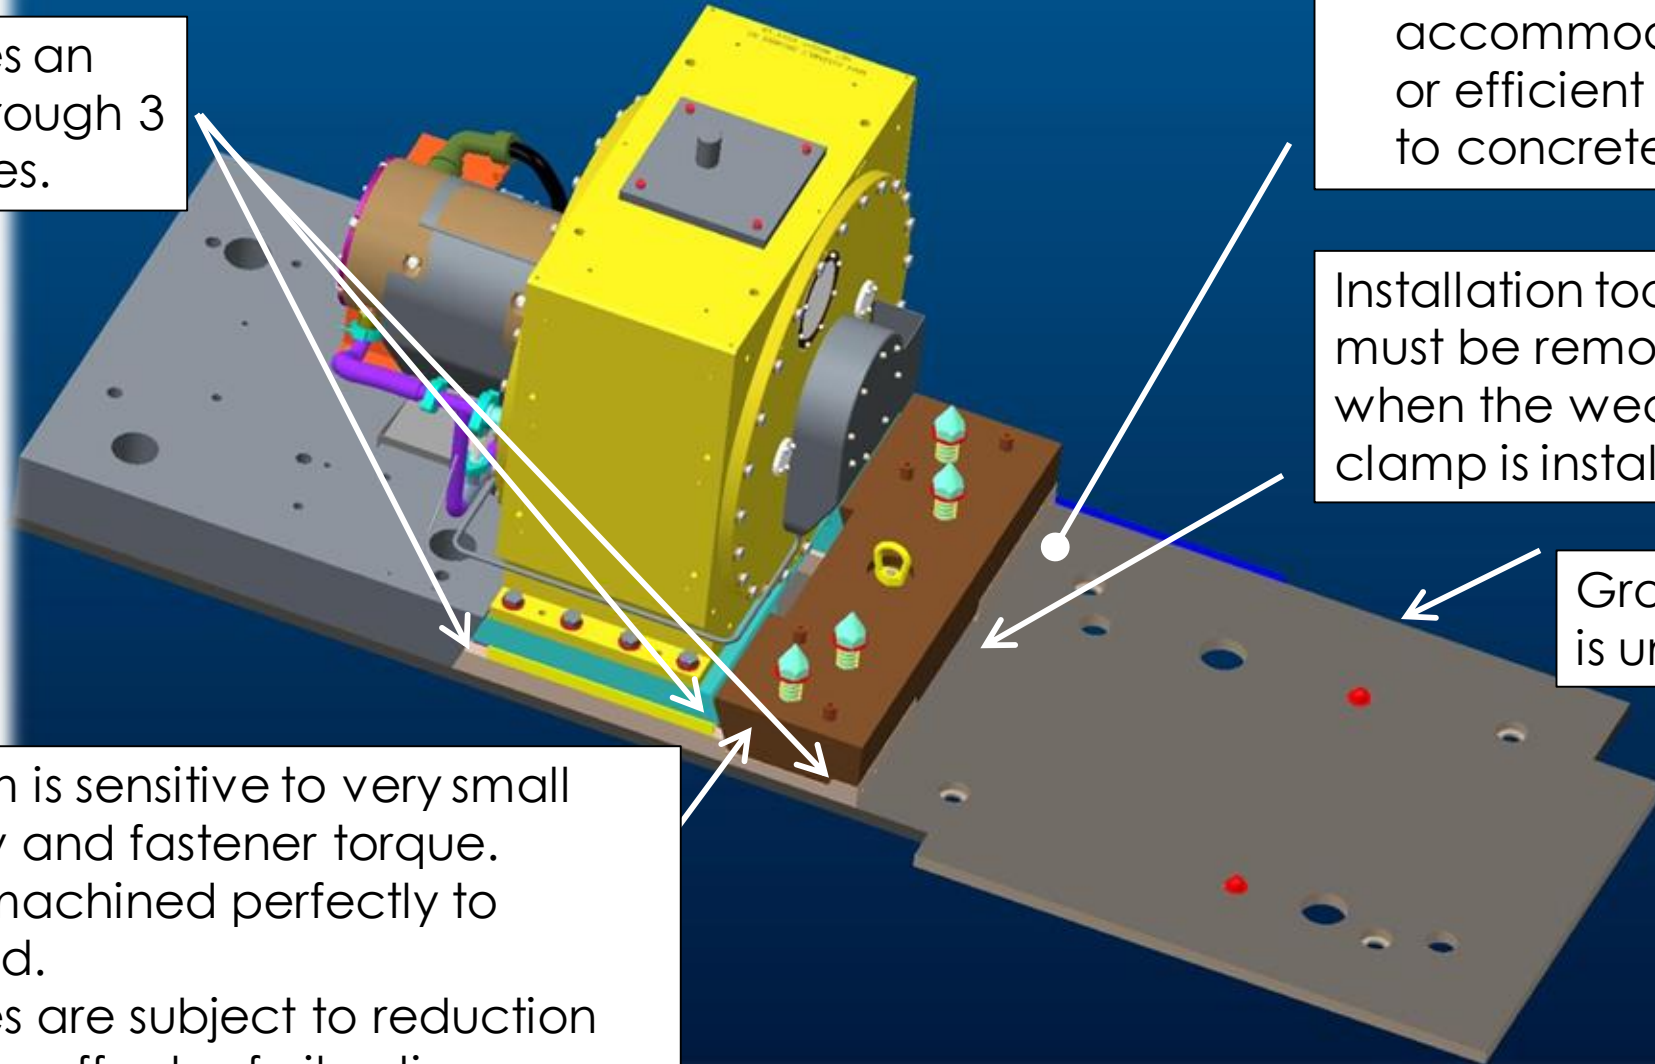
POWGEN T0 Chopper, original design

Clamp system applies an indirect load path through 3 rigid surface interfaces.

Embed plate is thin.

- Does not accommodate anchors or efficient load transfer to concrete foundation.

Installation tool must be removed when the wedge clamp is installed.

Grout condition is unknown.

The rigid clamp system is sensitive to very small variations in geometry and fastener torque.

- The parts must be machined perfectly to perform as designed.
- The fastener torques are subject to reduction over time due to the effects of vibration.

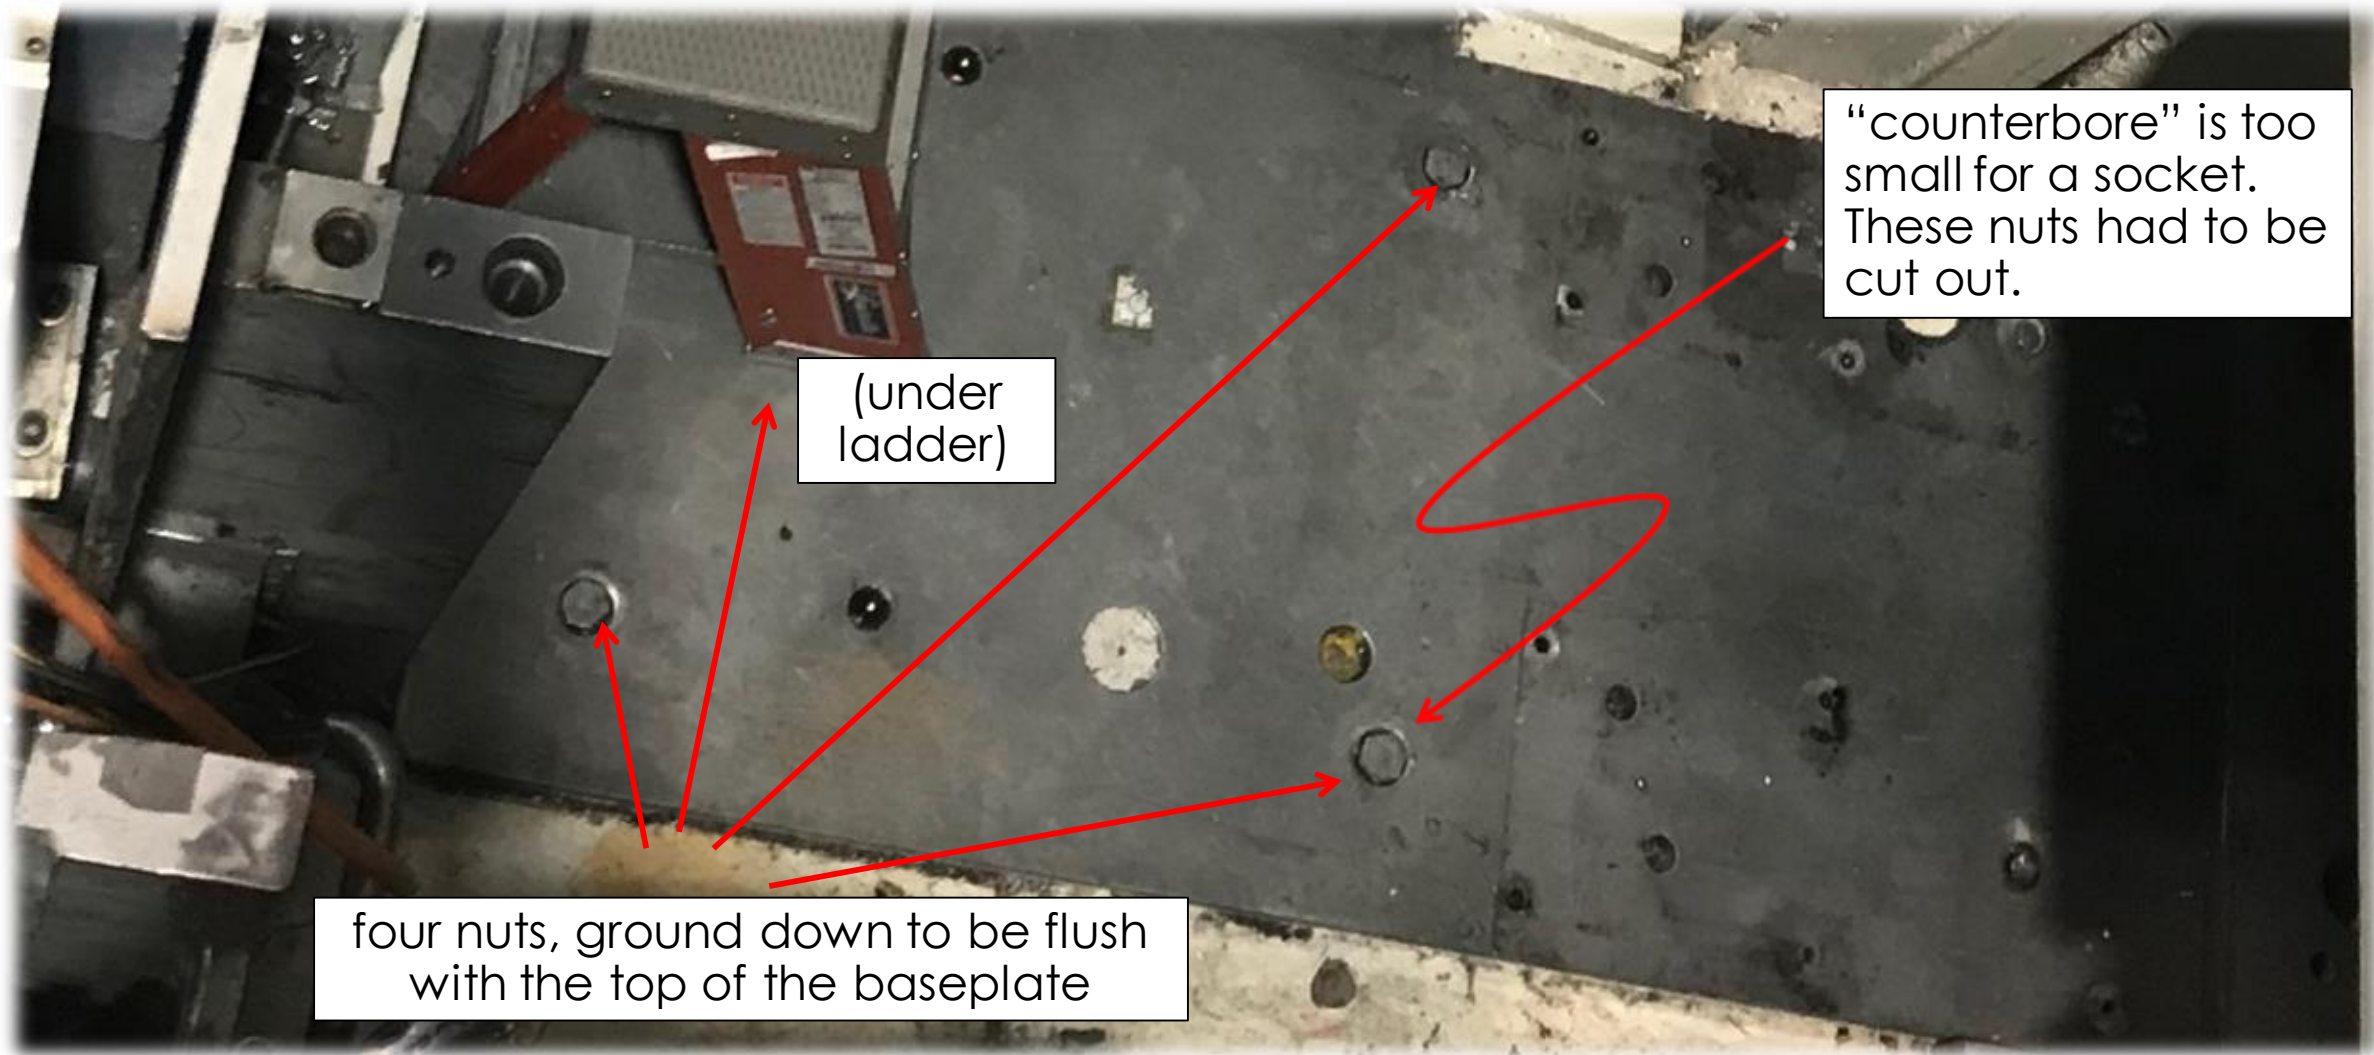
Surprise Number 1 – Holes Not Large Enough For Nuts

The ...a001 assembly is included in its parent assembly as a shrinkwrap (a simplified geometric representation of the full CAD model, used to save memory / load faster), with no holes shown

No fasteners are included in this model

No drawing exists for this assembly

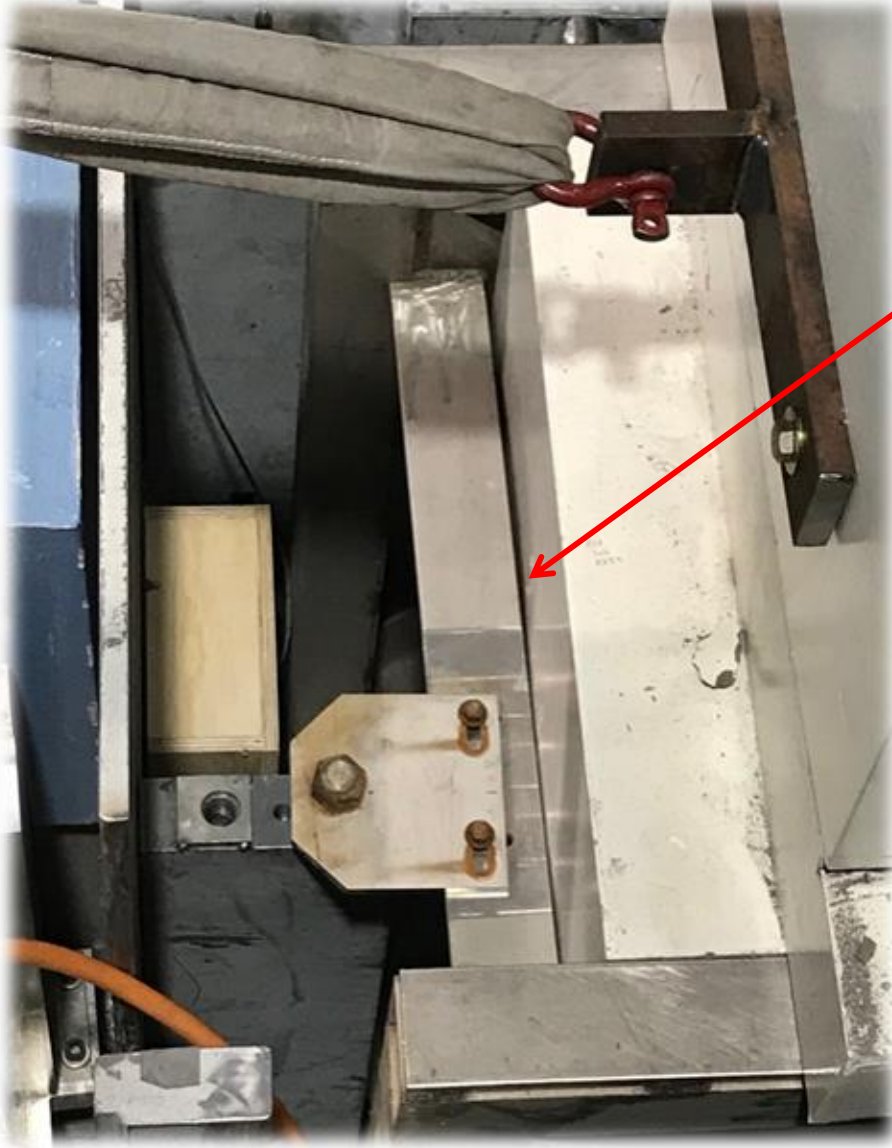
Surprise Number 2 – Shield Blocks Won't Come Out

When the downstream ends of the three stacked blocks are pulled all of the way against the installation fixture ...

the upstream end is still under the lintel...

there is no way to get them out!

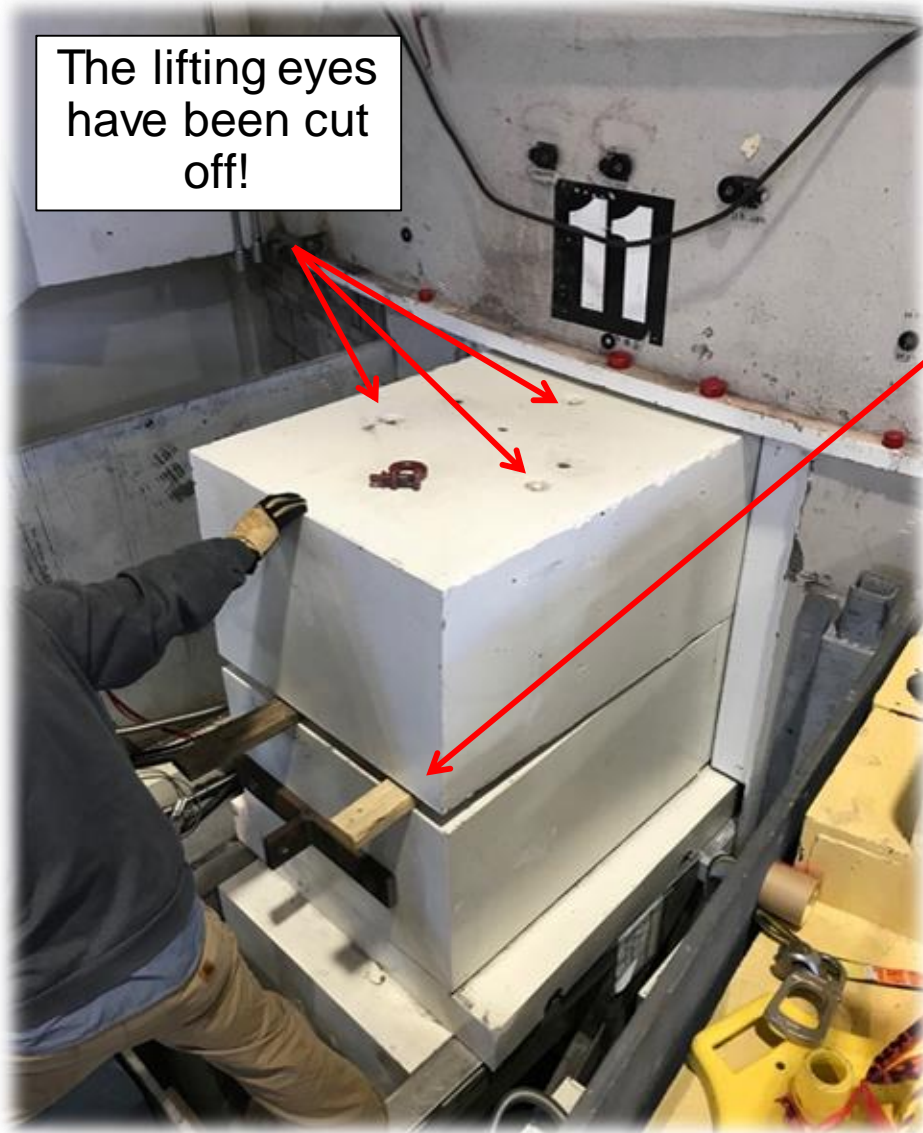
Surprise Number 3 – Lifting Features? What Lifting Features?

...so, the riggers wedge up the downstream end of the top block ...

and put a strap under it

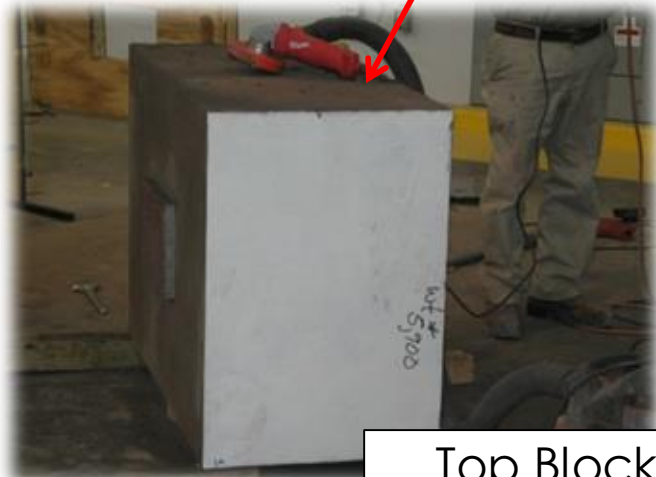
Top Block

Cuts #3 & 4 – both sides of the top block are cut

Counterbore is completely removed, preventing installation of tie-down rod

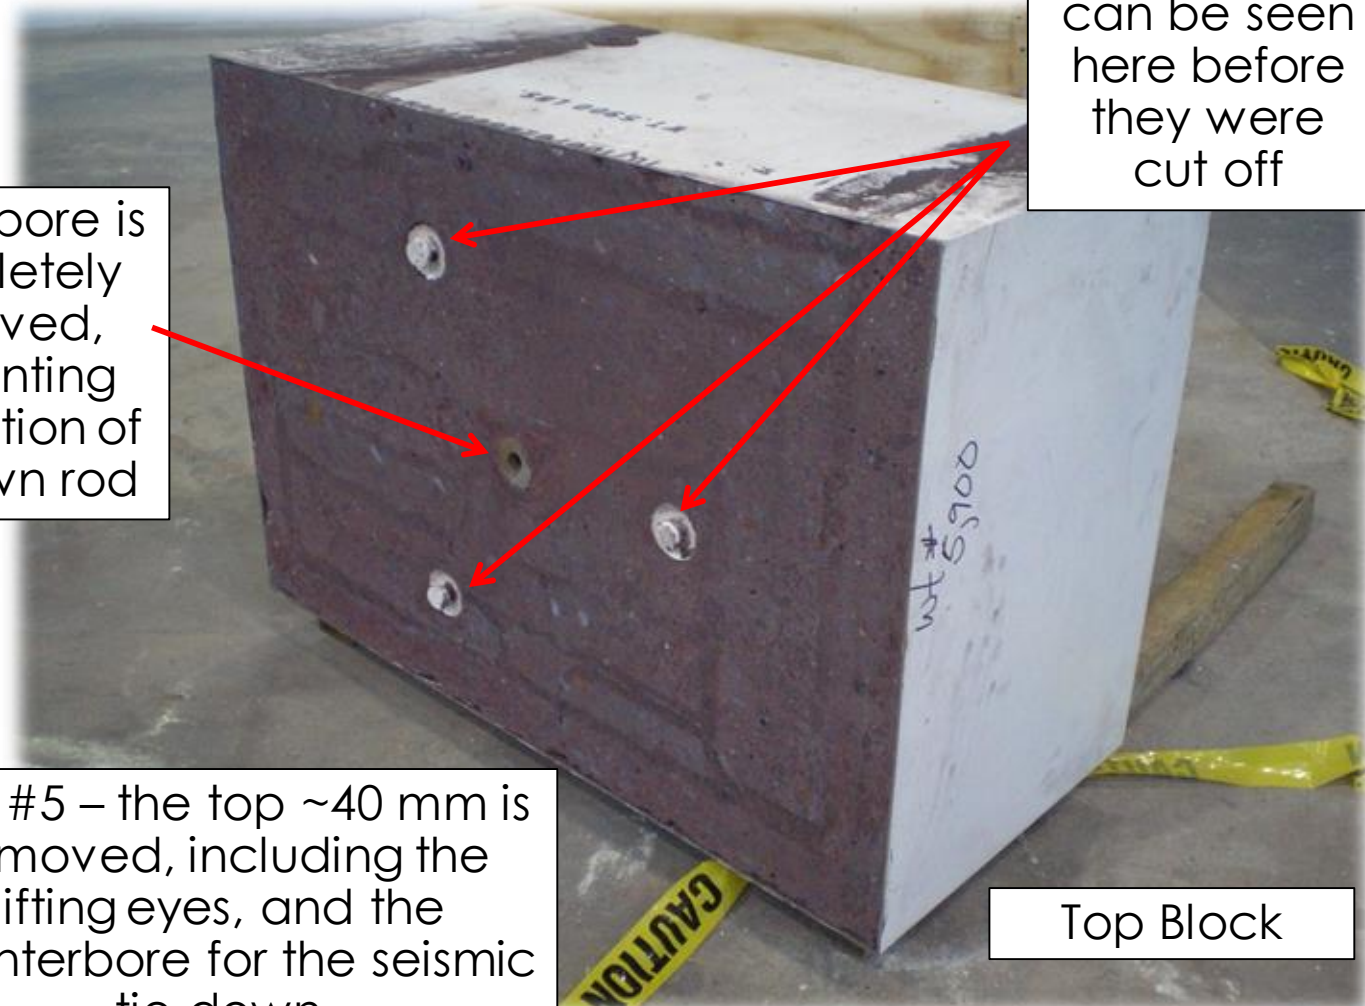
Top Block

Lifting eyes can be seen here before they were cut off

Cut #5 – the top ~40 mm is removed, including the lifting eyes, and the counterbore for the seismic tie-down

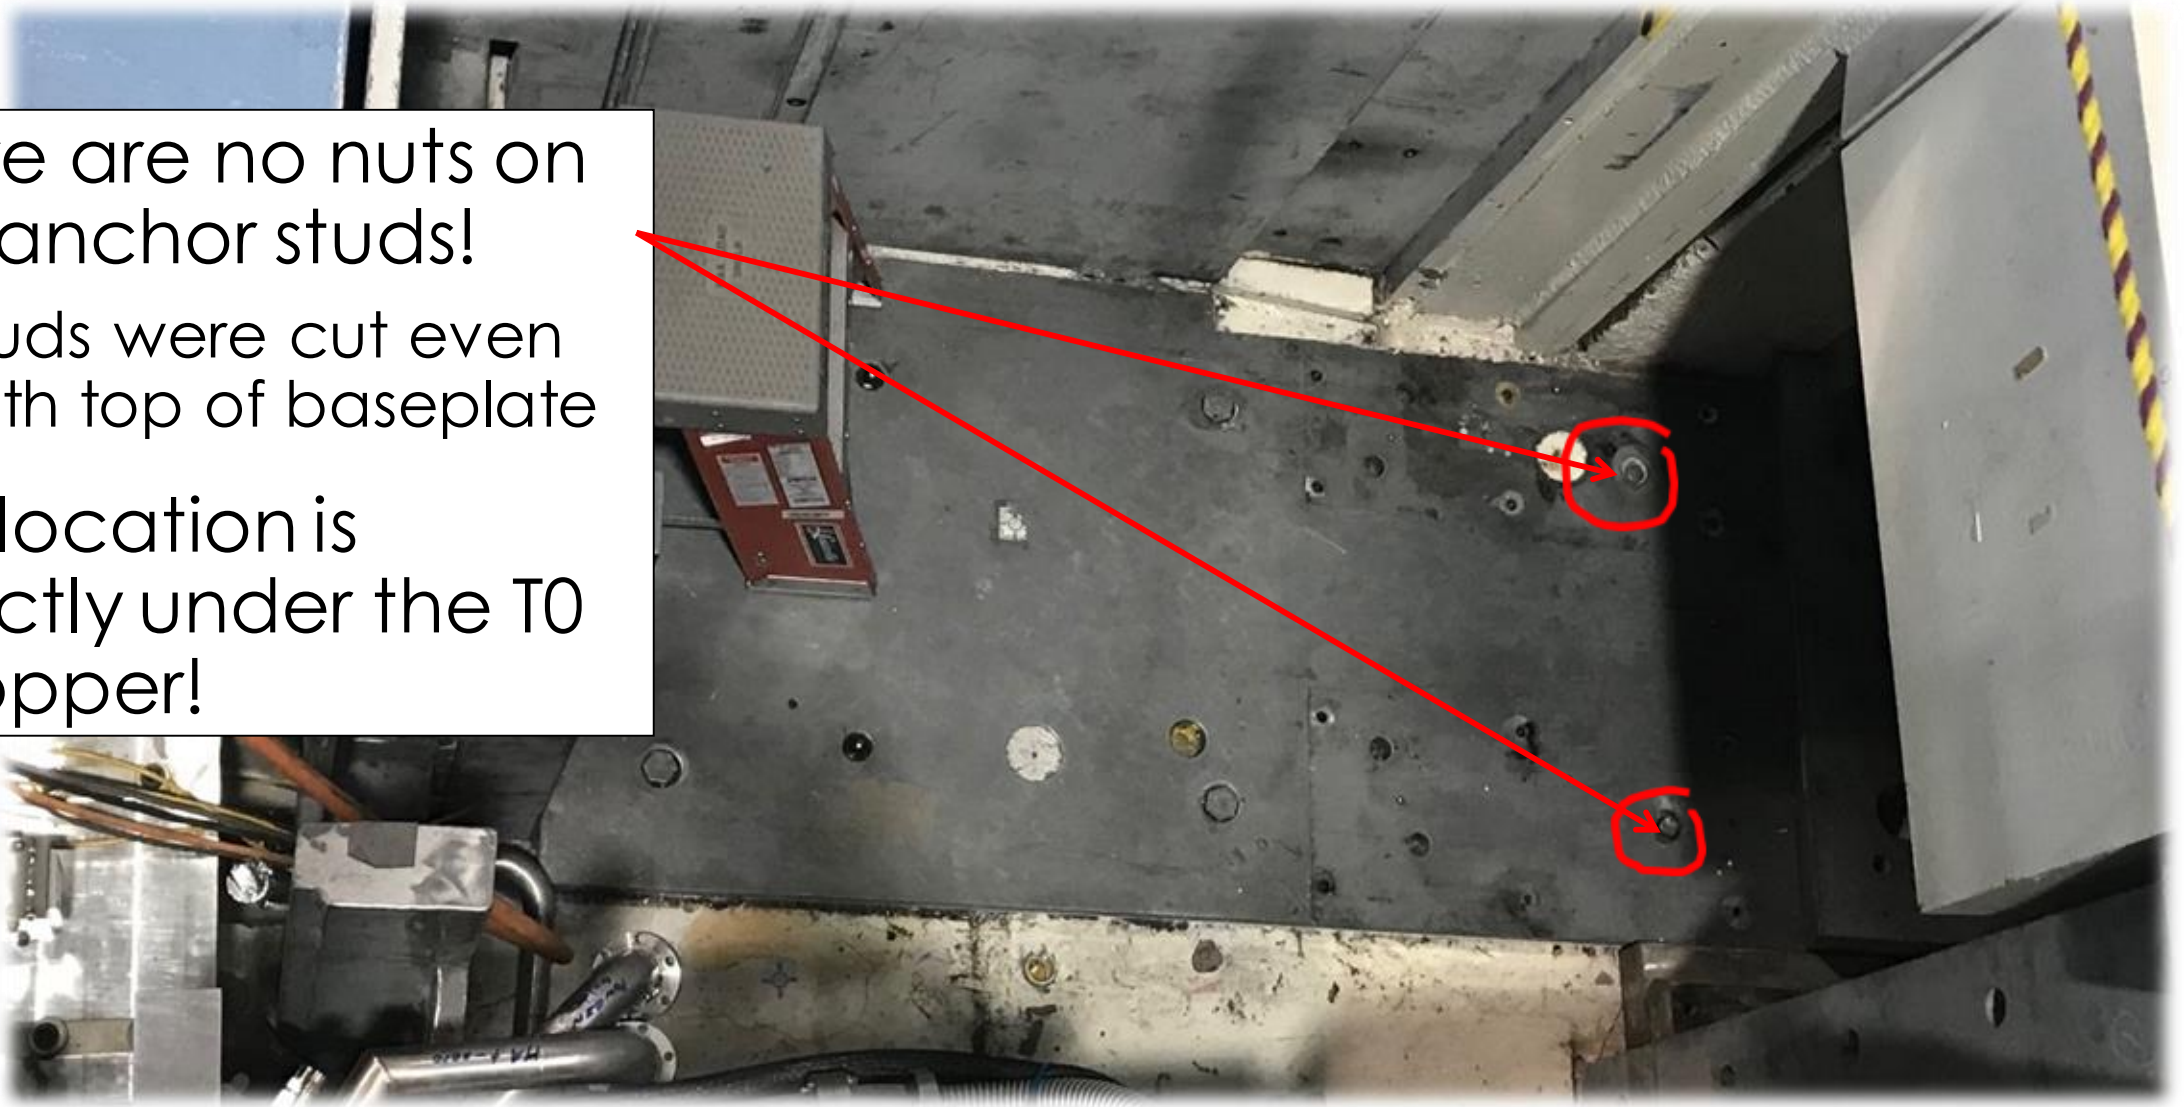
Surprise Number 4 – The Biggie!

- There are no nuts on the anchor studs!
 - Studs were cut even with top of baseplate
- This location is directly under the T0 Chopper!

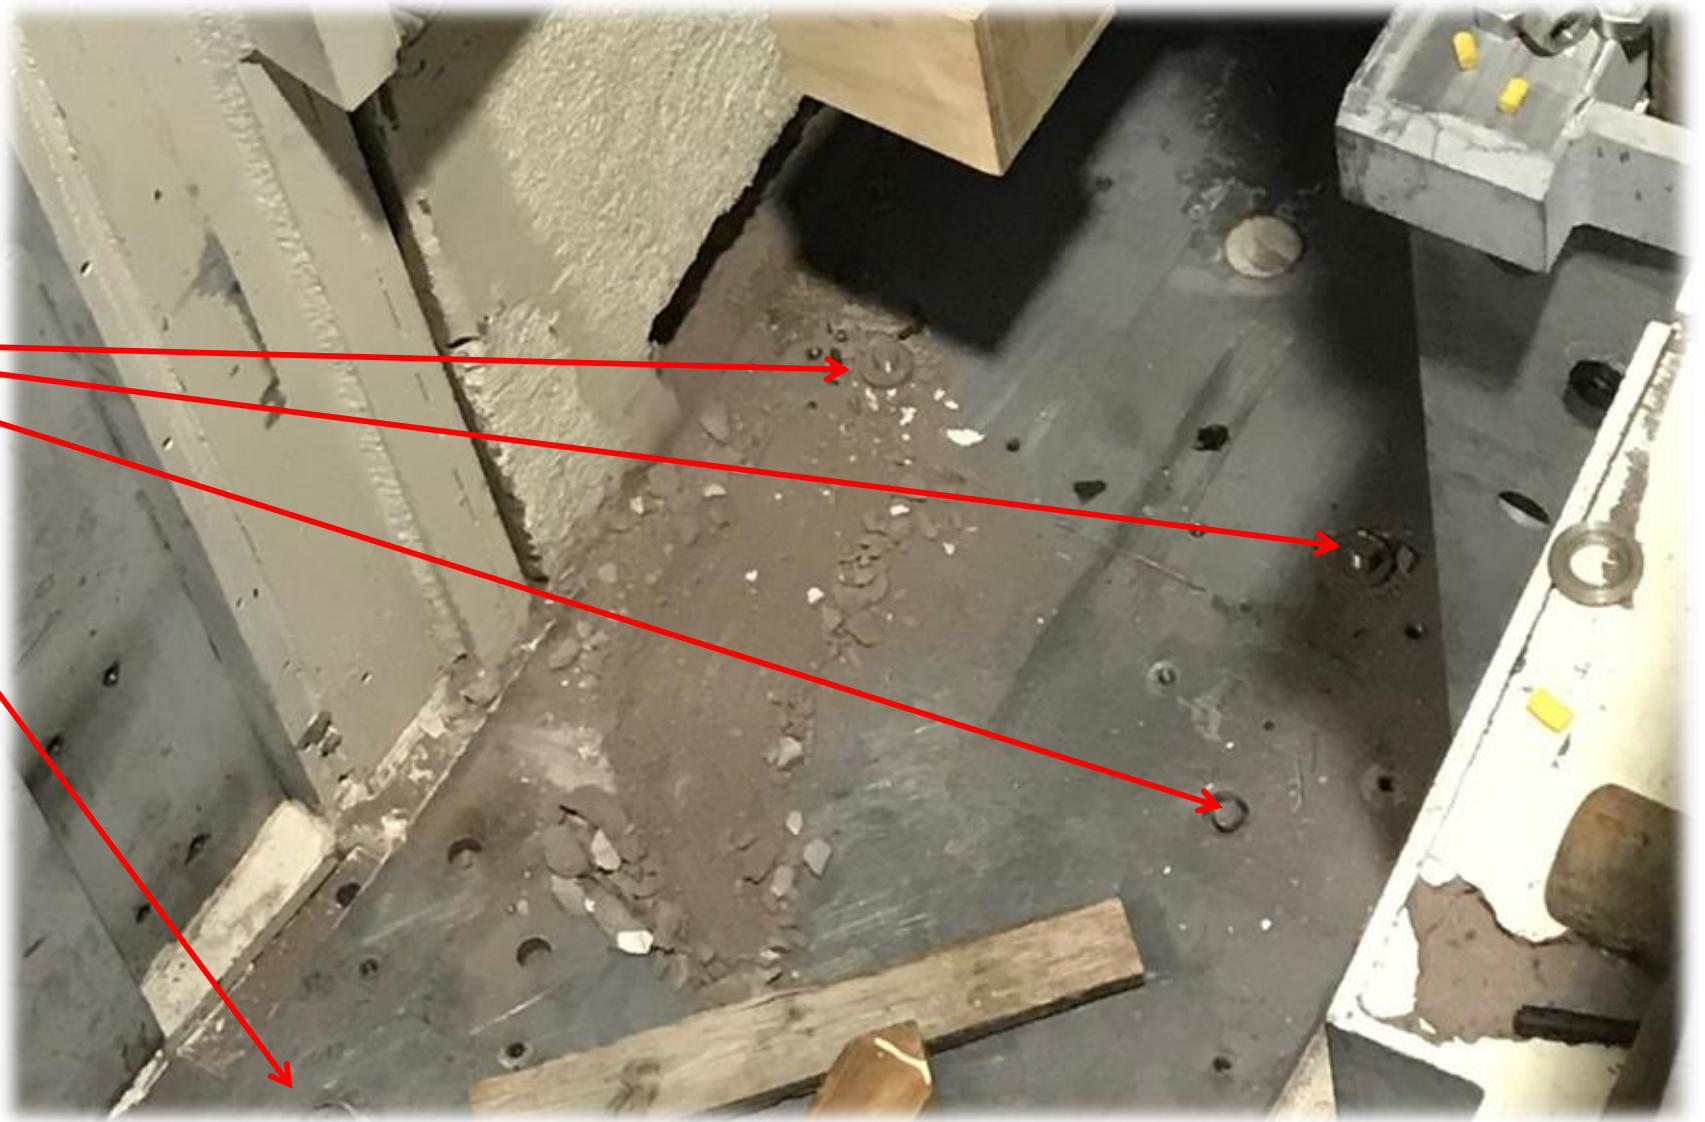
Embed Plate Removed

All anchor studs appear to be the same size, although holes in plate are 2 different sizes
