LCLS-II RF System Checkout Lessons Learned

Andrew Benwell, Jing Chen, Jorge Diaz-Cruz, Sonya Hoobler, Rick Kelly, Andre McCollough, Mark Petree, Alex Ratti, SLAC, Menlo Park, CA 94025, USA
 Brian Chase, Josh Einstein, Ed Cullerton, Fermi, Batavia, IL, 60510 | Ramakrishna Bachimanchi, Curt Hovater, JLAB, Newport News, VA 23696, USA
 Larry Doolittle, Gang Huang, Shree Murthy, Carlos Serrano, LBNL, Berkeley, CA 94720, USA

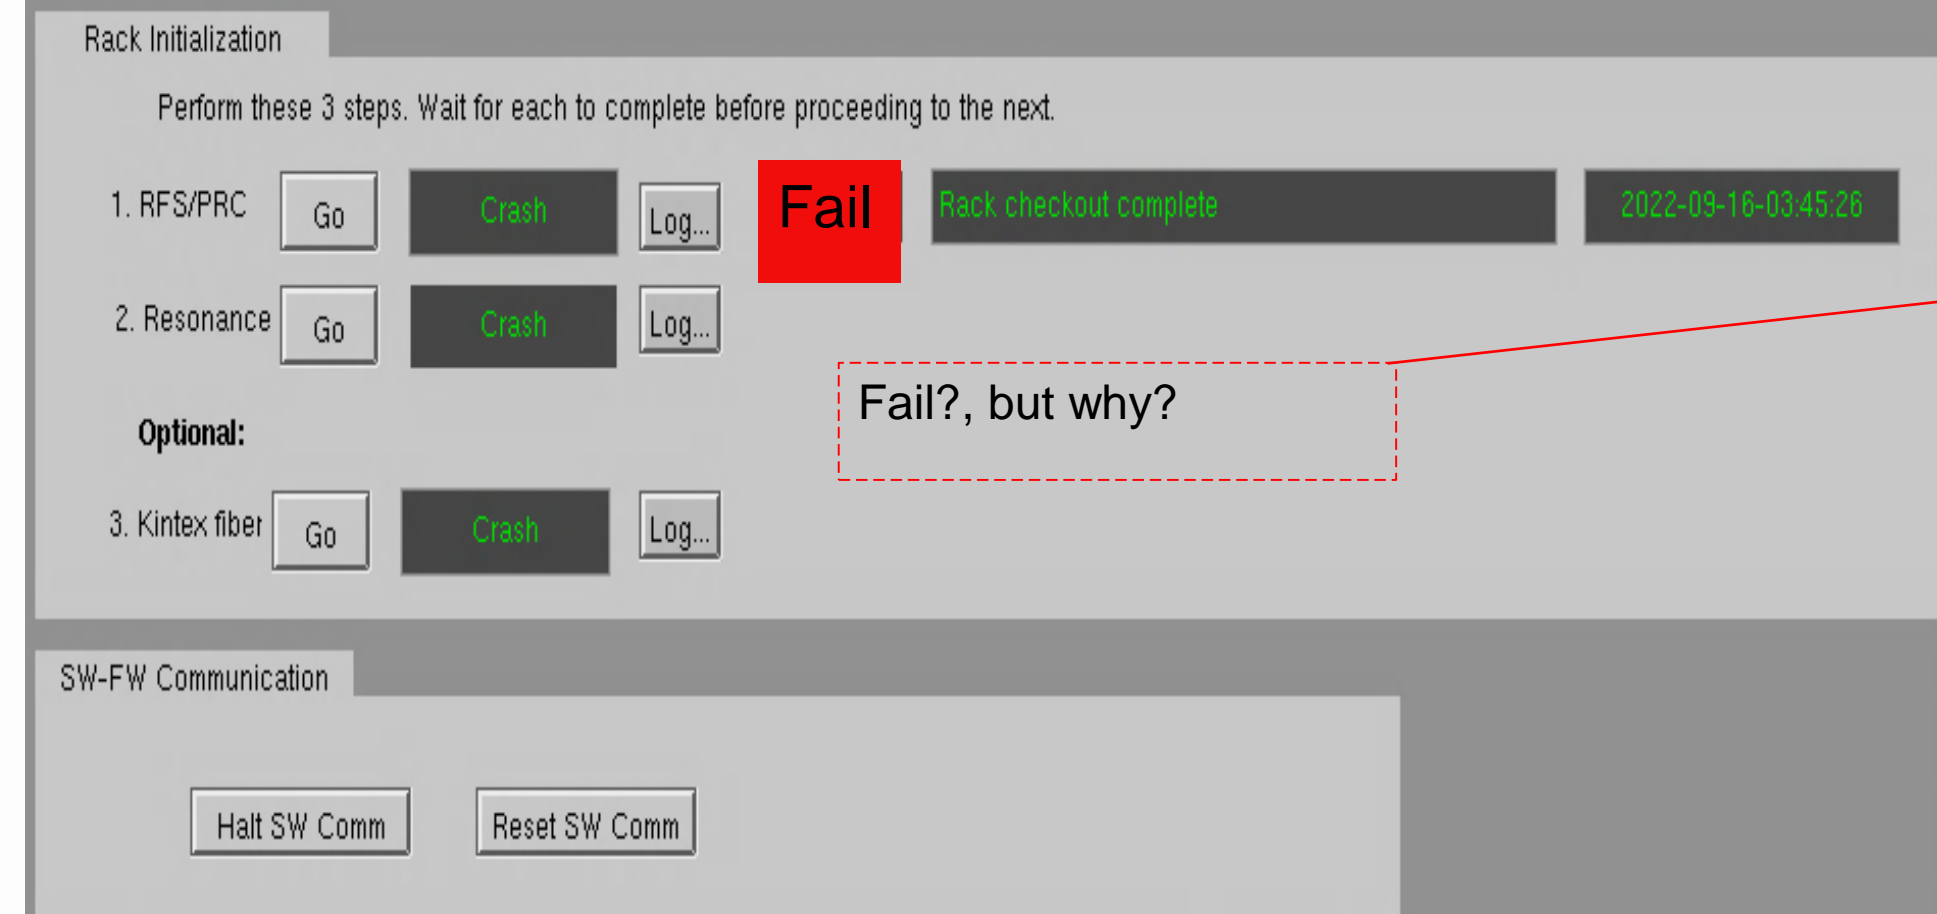
Hardware initialization control screen

Rack Checkout Result	# of times
PASS	168441
FAIL	90750
Total	259191

Failure mode	Error count	Issue
SEL_ENABLE	48084	firmware development issue
SEL_WAVE_TEST	14859	firmware development issue
timeout	6189	Networking problem
STATION_CHECK	4141	firmware development issue
CRC_CHECKN	2657	Inter-chassis fiber network problem
Setup	2621	network timeout during setup
frequency	2385	wrong timing frequency
LINK_MAP	2016	Inter-chassis fiber network problem
information	1939	internal PCB problem
oscillators	634	problem setting board oscillator
BUFR	502	problem reading buffer
Kintex	420	Problem with Kintex configuration
mmcm	281	firmware clocking issue
LO_LEVEL	138	clock too low
QSFP	49	cannot read values from transceiver
GET_RAW_ADCS	32	problem reading ADC buffer

- From August 2021 to October 2022, rack checkout was run ~ 260 thousand times over 74 LLRF racks
- 8 times per night for every available LLRF rack
- Failure modes were counted and analyzed for improvements
- As new features were developed, rack checkout was updated
- Automated rack checkout extremely valuable to determine failure modes

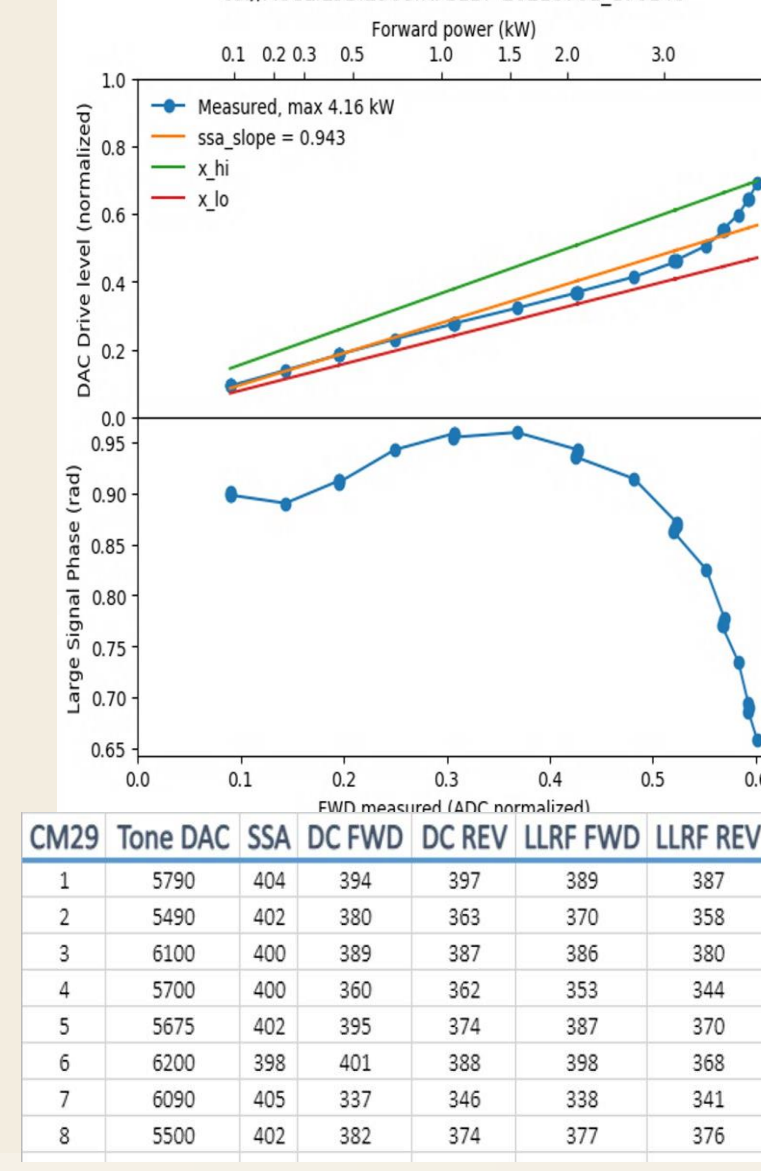
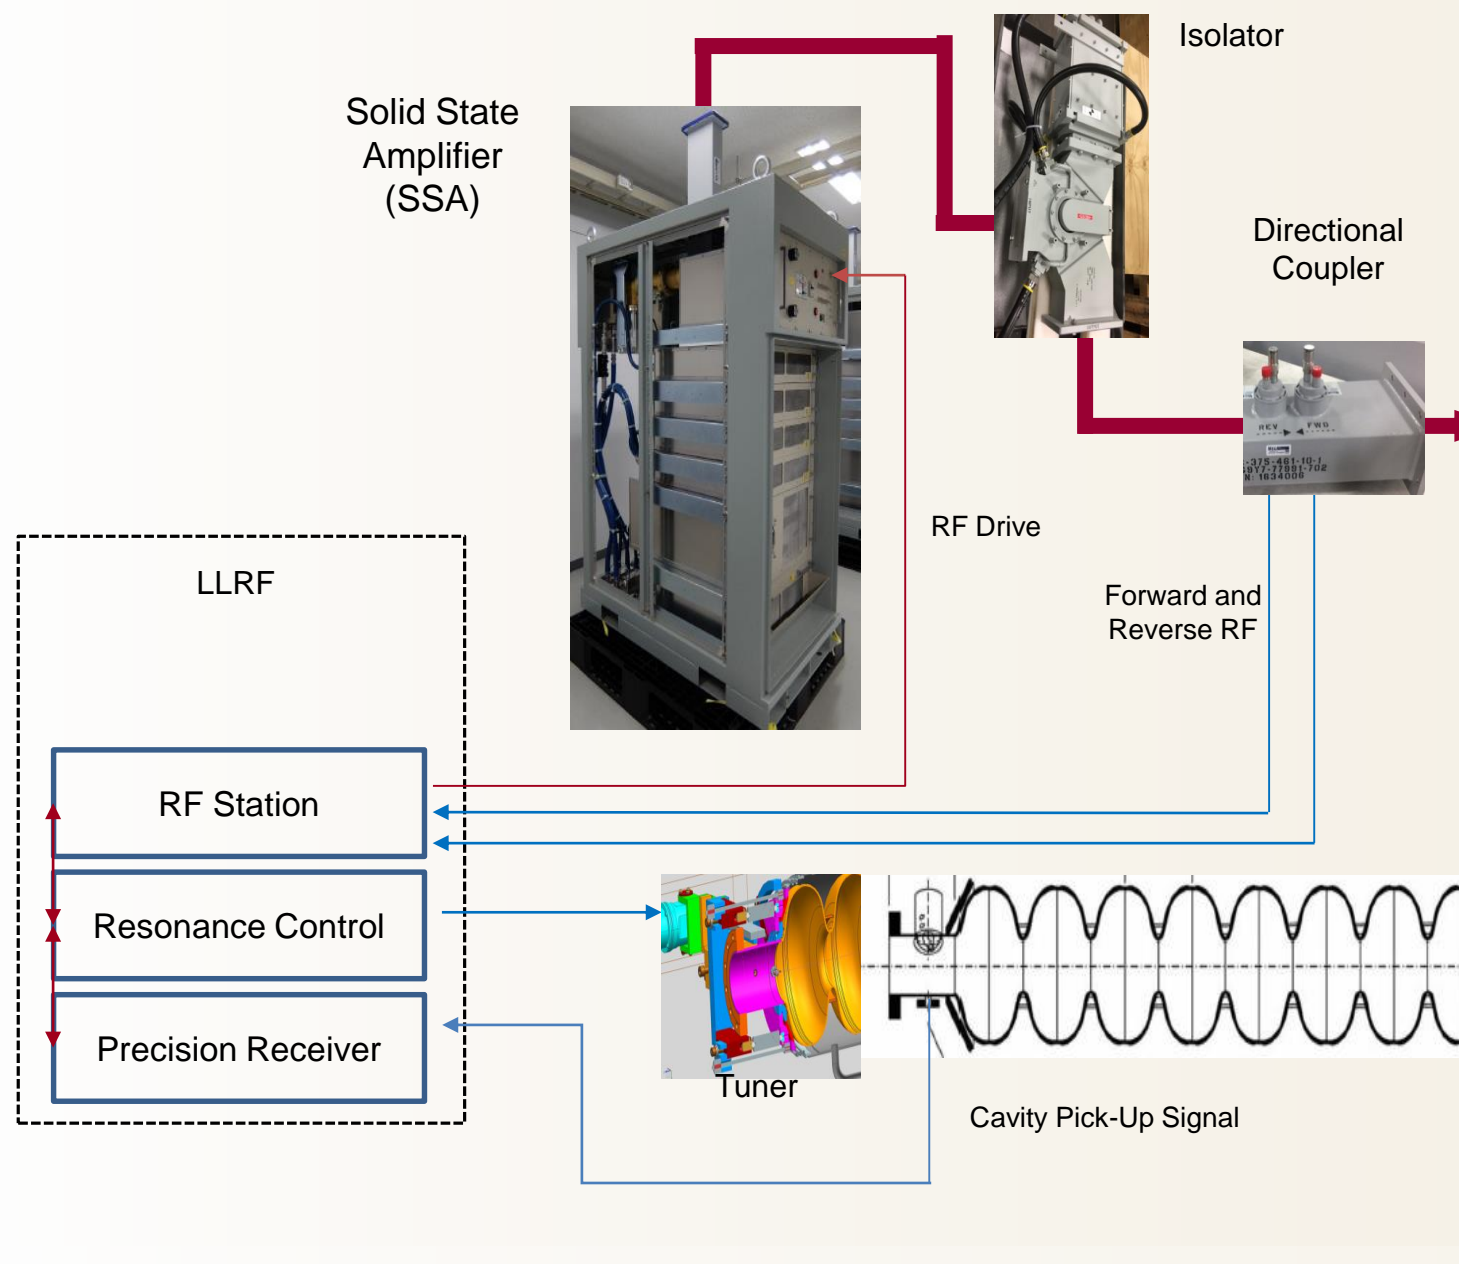
- HPRF test
- LLRF drives SSAs at 400 W to warm CM cavities
- Waveguide non-ionizing radiation (NIR) surveys
- Power measurements are made at the directional couplers
- SSAs are briefly (<200 μs) chirped to 4 kV and the SSA health is characterized

Failure type	Number found
Swapped SSA permit Cables	78 cases
Swapped RF heliax	Many (fixed immediately)
Low RF drive	28 chassis
Failed SSA electronics	18 failed interlock PCB 1 failed Control Unit 2 Failed Amplifier modules
Calibration error > 5%	>50 cases
Poor water flow	often
