Non-destructive investigation of „The violinist” a lead sculpture by the Spanish artist Pablo Gargallo, using the neutron imaging facilities of the Paul Scherrer Institute

Author: Alex Masalles, Conservator-restorer at MNAC, Museu Nacional d'Art de Catalunya, Barcelona (Spain)

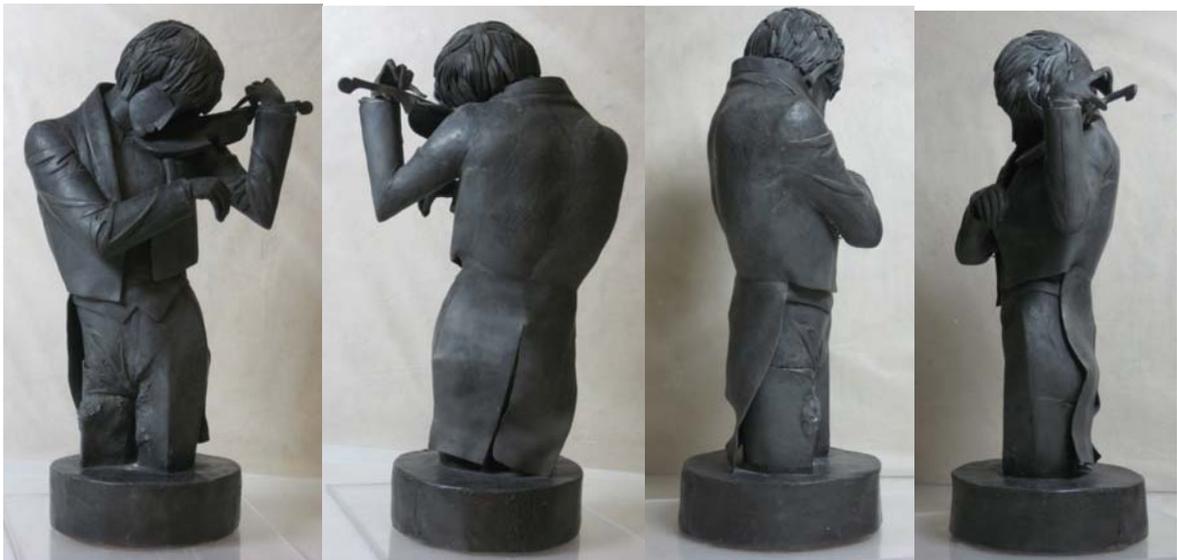
Fig. 1. Four main views of The violinist (MNAC 010972-000), by Pablo GARGALLO. 1920.

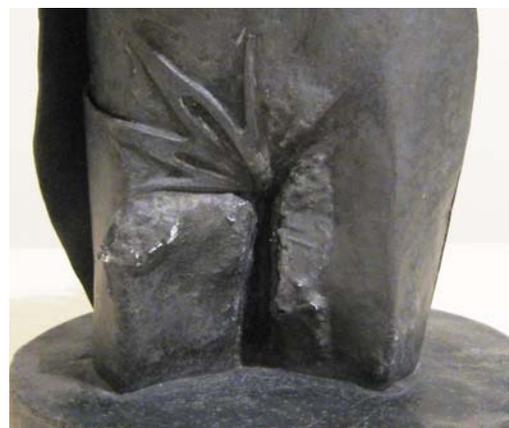
Some years ago we saw for the first time some bumping areas on both legs of the violinist. With time these areas grew larger and higher, and began to open up while a white substance began to show through. A sample taken from the right leg was analysed, the result was lead carbonate. The fine parallel lines that can be seen when looking at a sample of lead carbonate through the binocular microscope shows the way this type of corrosion builds up with every new layer of lead

Fig. 2 Plastic deformation on both legs due to advanced lead carbonate corrosion .

carbonate formed most probably by an increase in relative humidity.

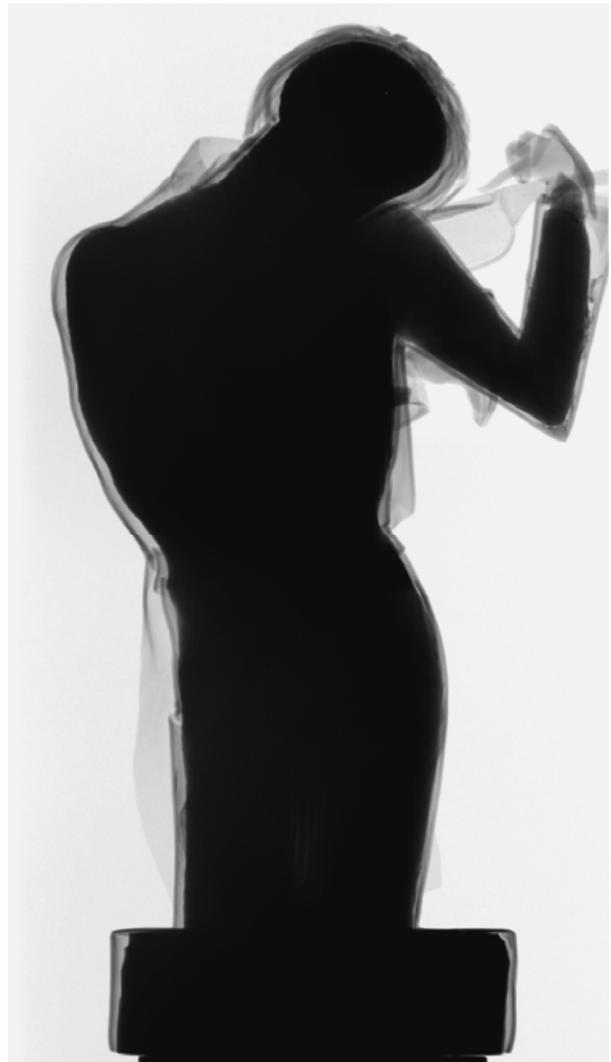
Fig.3. Frontal view of The violinist seen in a neutron radiography. The inner wood structure is very close in shape to the lead sculpture.

The shape of the inner wood structure looks very much like the lead sculpture except in the hands which are made out of lead only.

The wood kernel is thinner but not perforated in between the legs (here there is only about 10% transmission of the neutrons).

Where wood is thinner the wood grain can be seen in the images. Thanks to this fact we can now state that the left arm is carved in the same block of wood as the torso.

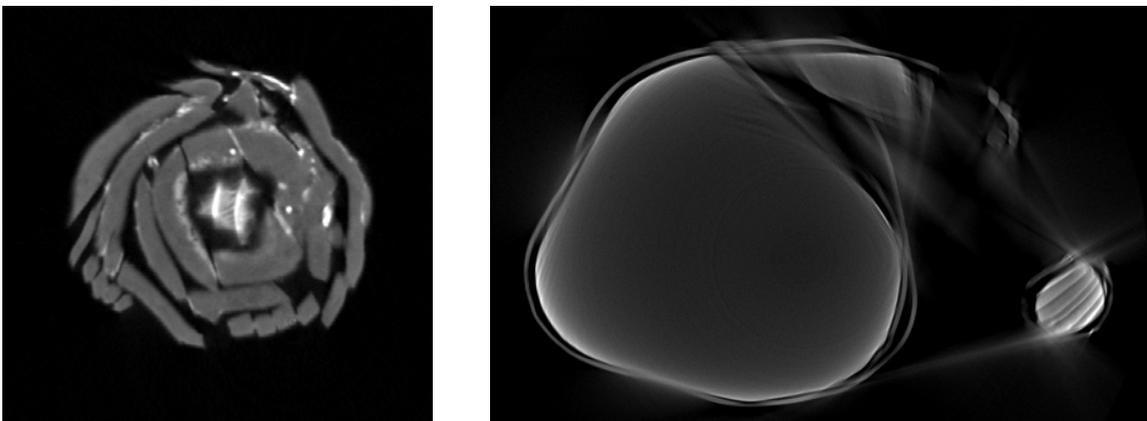
Fig.4. Left: Tomography cross section of the top of the head where soldering, lead corrosion and some grain of the inner wood structure can be seen. Right: Tomography cross section at the level of both arms showing blurred areas where the information was not properly captured.

Despite the blurred areas lacking information, tomography has been very useful to locate the carbonate layers and the fixing nails and solder. It can also be used to find the limits of the different pieces of lead in the sculpture.

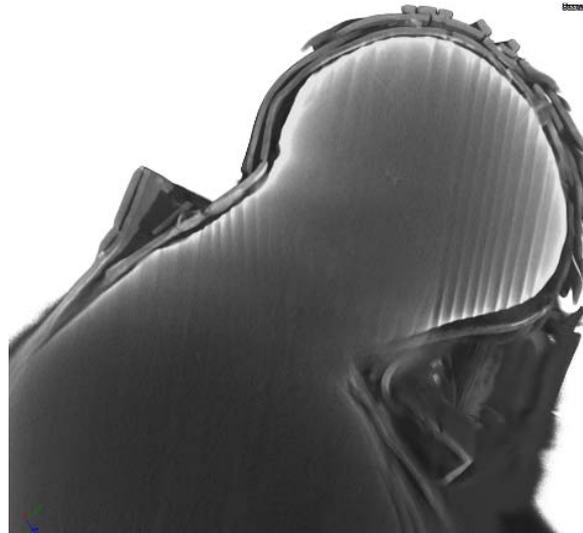
Fig. 5. Detail of the head and upper part of body cross sectioned in the 3D reconstruction. The different lead plates, nails and some wood grain can be perfectly identified.

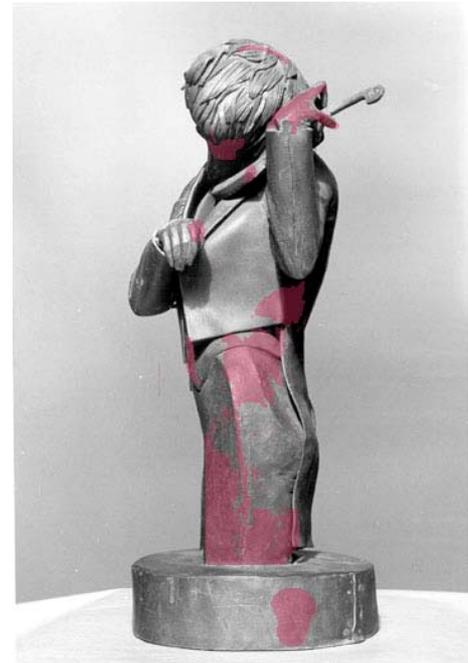
In tomography the lead carbonate layers appear as a fine white band attached to the inside of the lead plates. They can sometimes be confused by the remains of flux in the soldering. The accurate and thorough analysis of the tomographic images can help us obtain quite an accurate mapping of the areas affected by carbonation and thus estimate the percentage of the total internal lead surface affected which is of about 10 to 15%.

Fig. 6. Mapping of corroded areas on the inside of the lead plates, according to the information given by the tomography cross sections.
