MUSE: EQUIPMENT STATUS

PAUL E REIMER

Villigen, Switzerland
5 February 2024

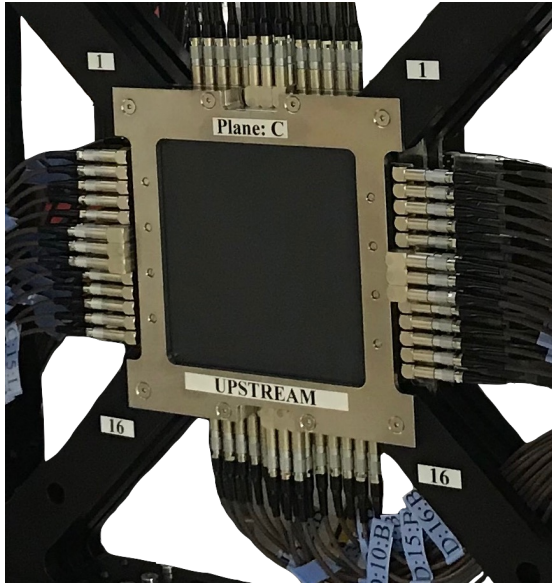
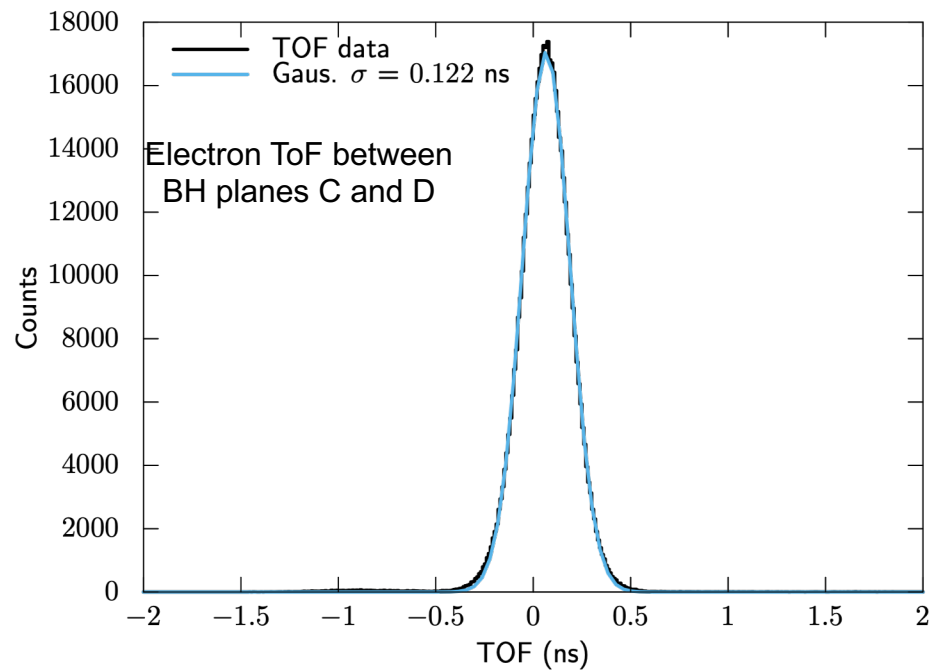
BEAM HODOSCOPES—BH

- Excellent ToF resolution $\sigma_{\Delta T} = \sqrt{\sigma_A^2 + \sigma_B^2} = 122$ ps
 - $\sigma_T = \frac{1}{\sqrt{2}} 122 \approx 86$ ps
- Larger currents in some BH SiPMs
 - Likely due to radiation damage
 - Discussion of replacement of SiPMs

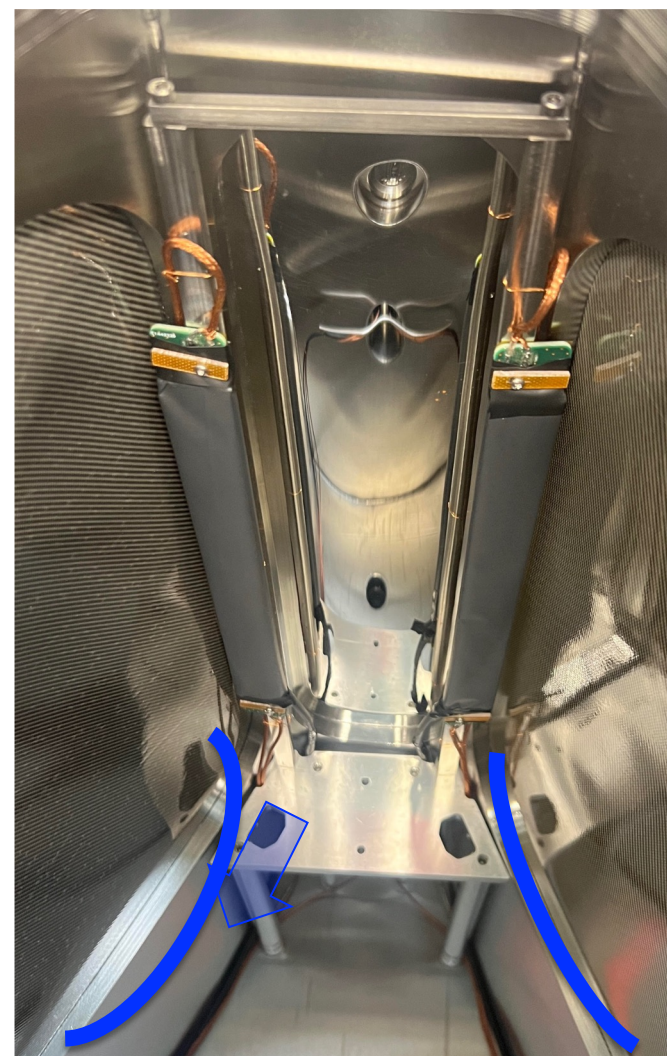
TARGET CHAMBER POST VETO—TCPV

Initial installation stability

- Vacuum chamber pump down caused slight flex in target posts.
- “Chair” slid slightly upstream and rotated
- TCPV damaged
- Received immediate attention from *PSI Detectors, Irradiation and Applied Particle Physics Group* to aid in repair.
- Designed fixed table and better mounting not susceptible to this flex.

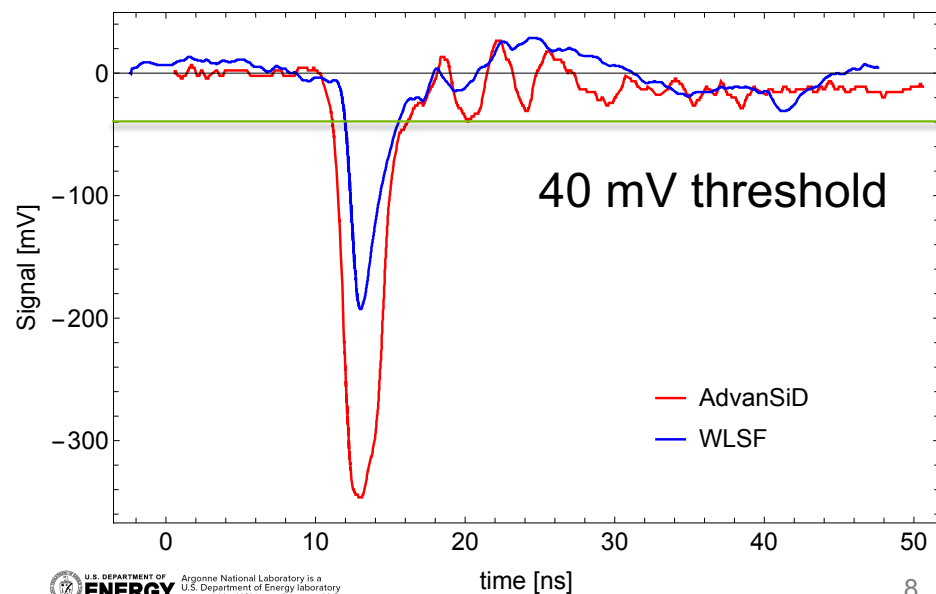
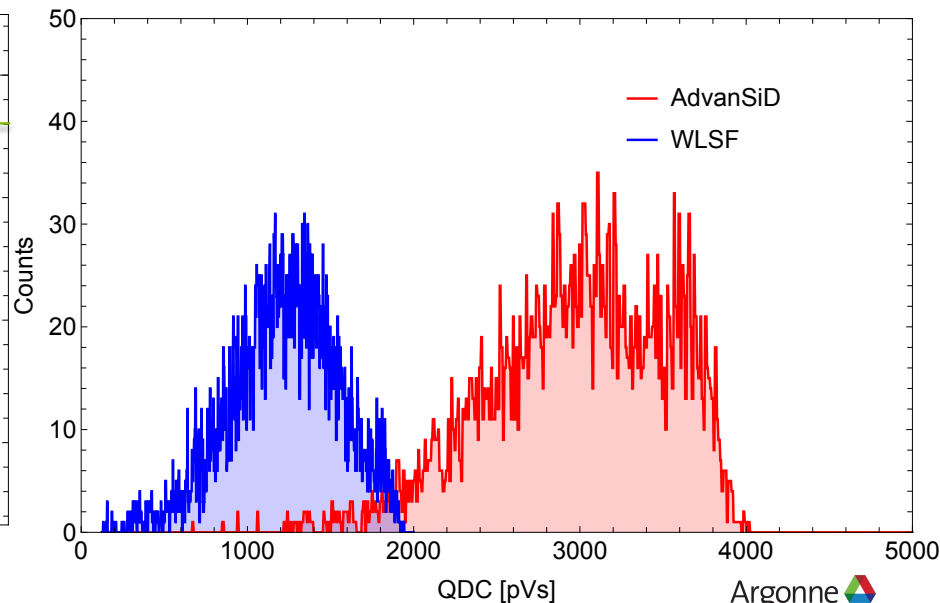
WLS vs internal SiPM

- Internal SiPM clearly has more easily discriminated (larger) signal.
- MUSE is evaluating the **relative veto performance of the two readout methods and the safety of in-chamber SiPM readout.**

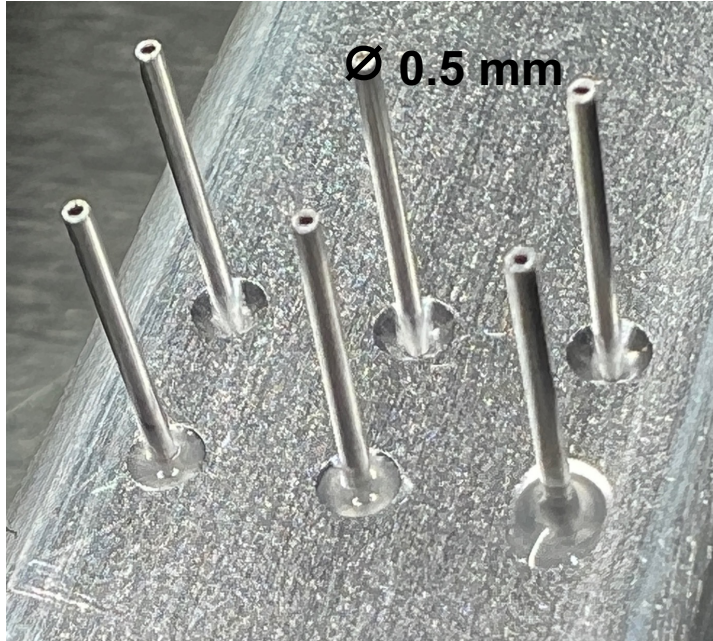
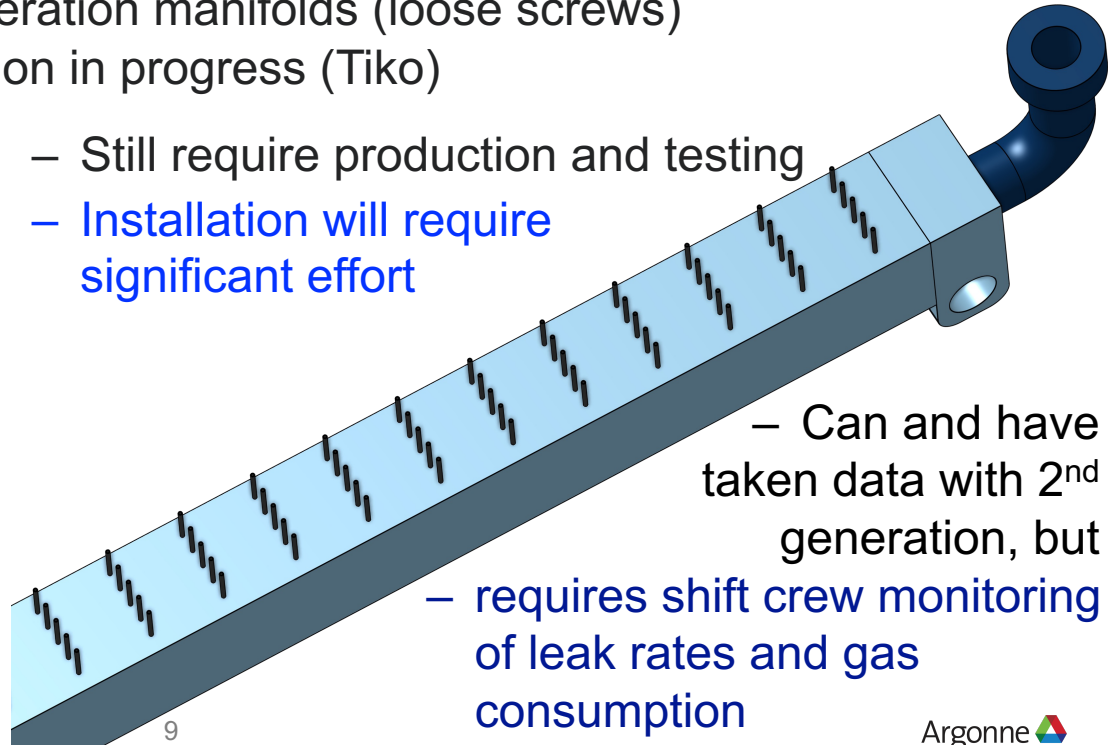
- Recurring issues with 2nd generation manifolds (loose screws)
- 3rd generation design/production in progress (Tiko)

- Still require production and testing
- Installation will require significant effort

- Can and have taken data with 2nd generation, but
- requires shift crew monitoring of leak rates and gas consumption

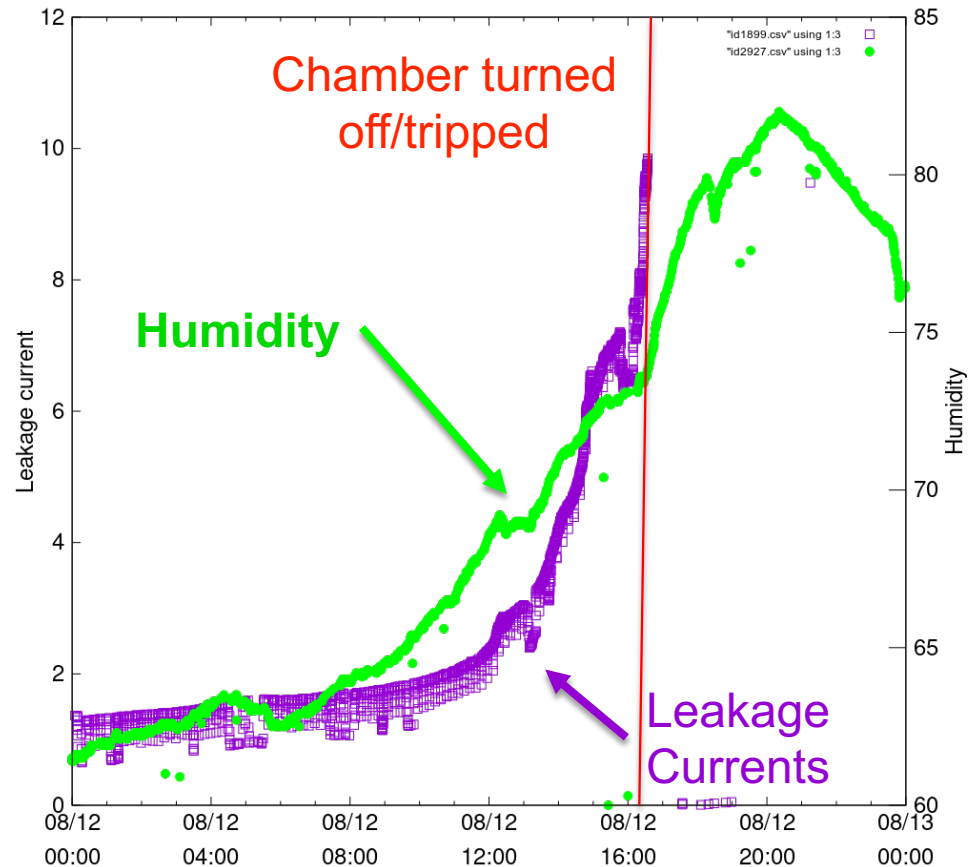
- Summer Humidity Issues
 - High humidity \Rightarrow Larger leakage currents

Right shows one (well chosen) 12 hr period as an illustration

- Humidity as measured on platform, but away from dehumidifiers

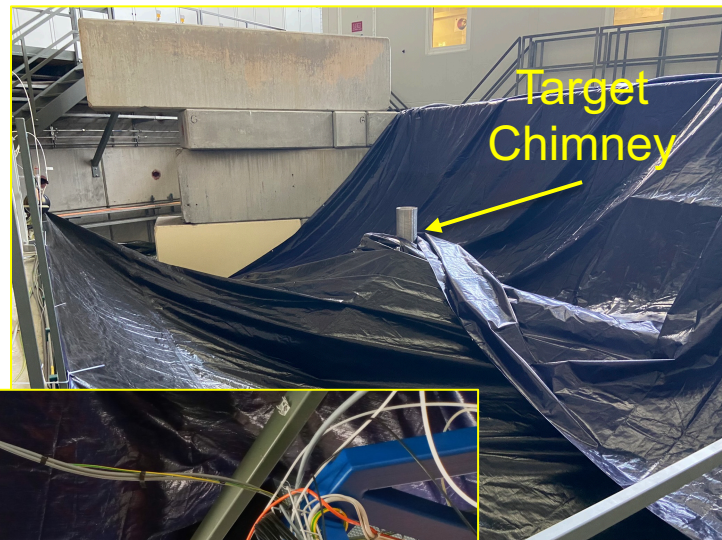
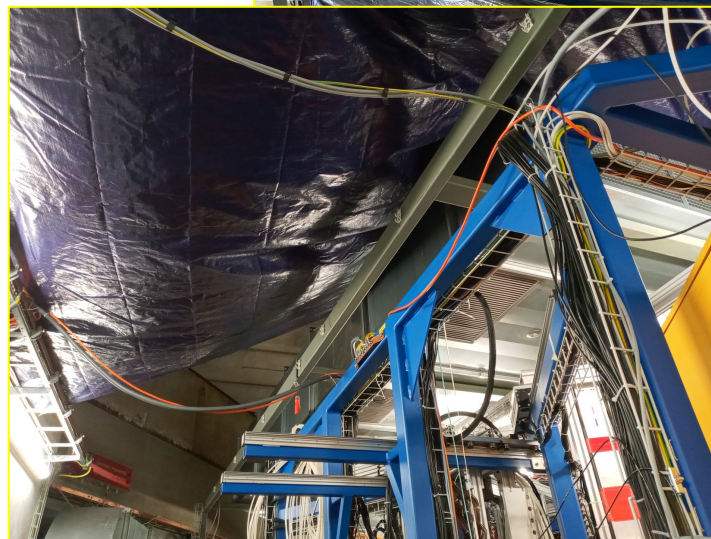
- Summer Humidity Issues
 - High humidity \Rightarrow Larger leak currents
 - Solutions
 - Dehumidifiers
 - Tent over area to keep dehumidified air in PiM1

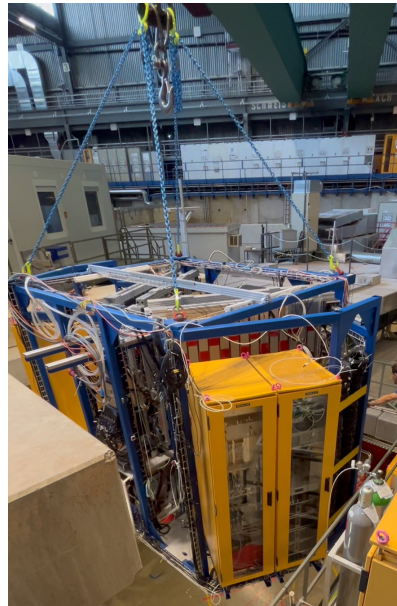
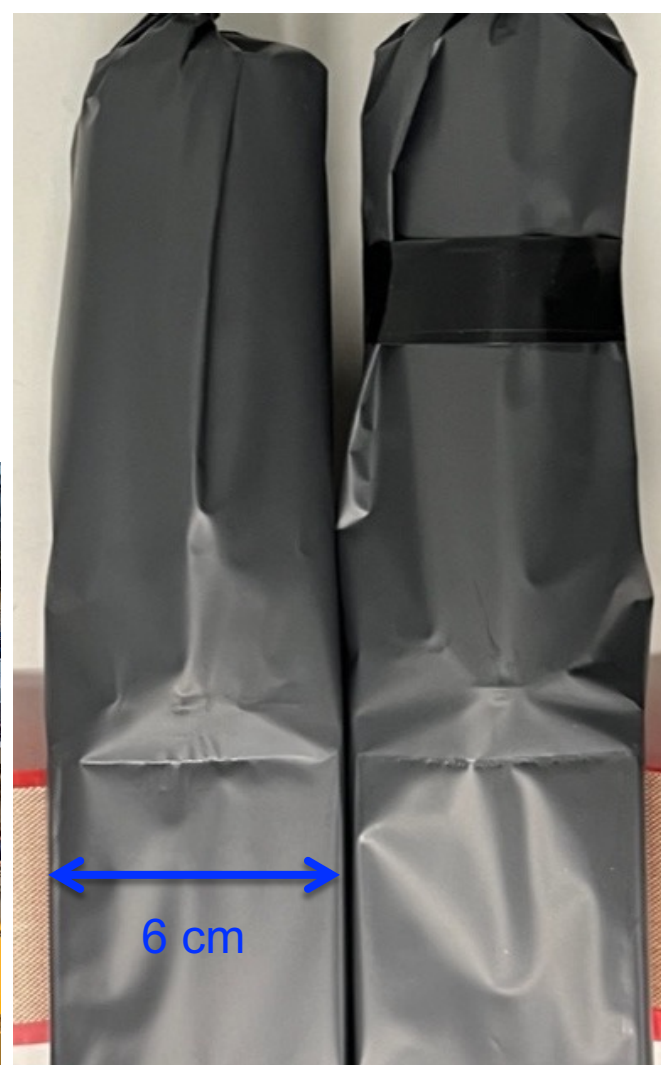
SCATTERED PARTICLE SCINTILLATORS—SPS

- Scintillator glue joints breaking
 - slight stress over long period of time
 - stress during move in/out operations
- Monitored on run-to-run basis
 - Light yield losses compensated by increasing HV and lowering threshold
- Repairs during downtimes
