LH₂ Target Operation 2023

**Konrad Deiters
for the Muse Collaboration**

Target incident after warmup (8-9 Sep, 2023)

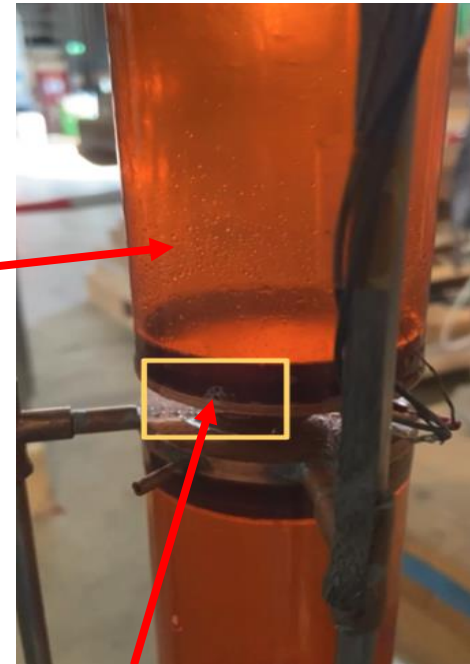
- **Note:** lack of target cell temp data **complicates interpretation**
- power for target cell heater must have stayed on when the LabView slow control froze => increased temp caused the epoxy on the copper endcaps to soften => creating a leak
- this leak was confirmed after removal and inspection of the target ladder failed.

Leak location (soap bubbles visible)
no rupture of Kapton foil

- modify written procedures to manually turn off the power to the target cell heater during regular operation
- power to the target cell heater is only turned on when a target expert is present (during fast warm up)
- open the target cell heater relay automatically by the LabView program
 - at the restart of the target slow control program
 - it needs a target expert on site to turn it back on
- install a heartbeat monitor on EPICS slow control to check if LabView slow control system is alive
