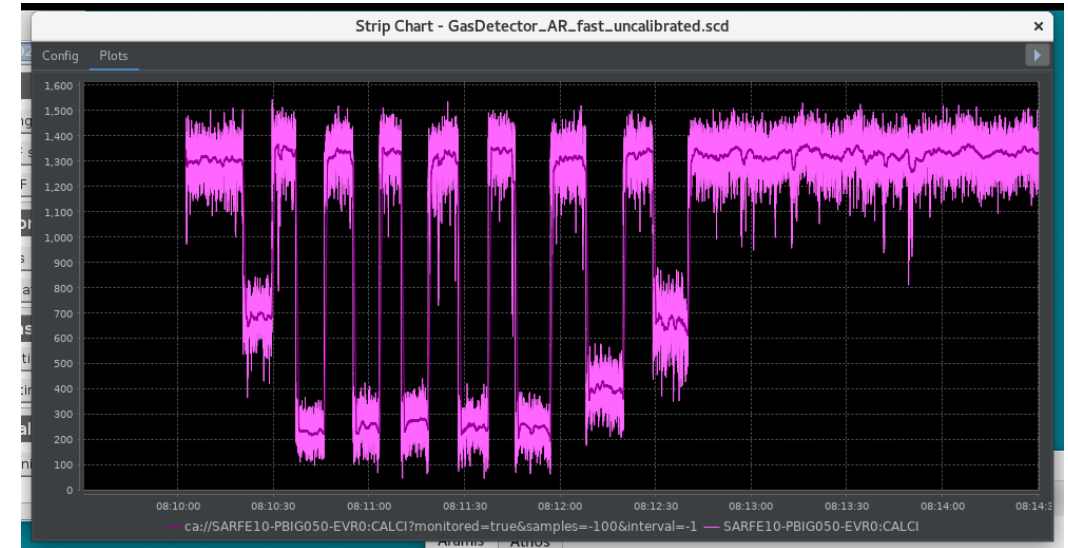
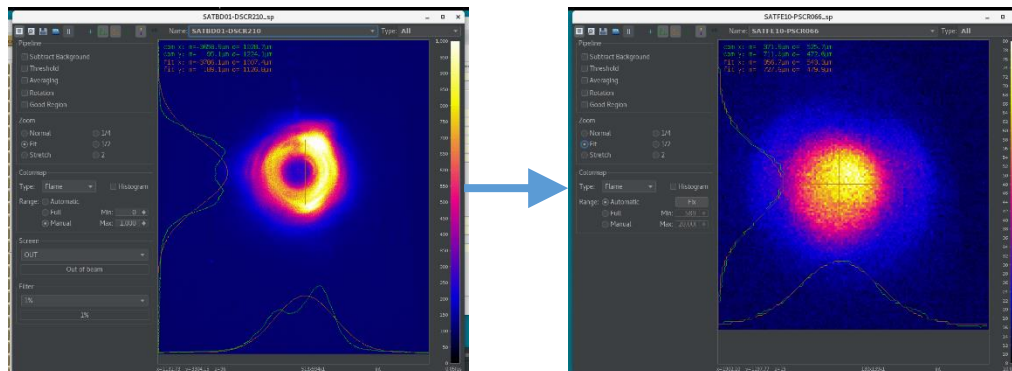
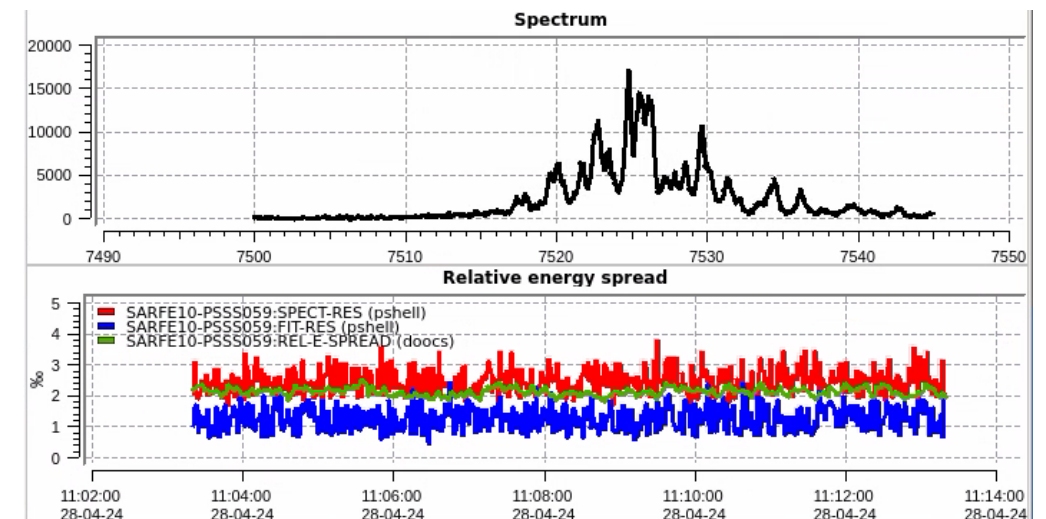
Athos pointing/mode

- Re-optimize phase shifters to improve beam mode
- (There is also a hole in the screen)

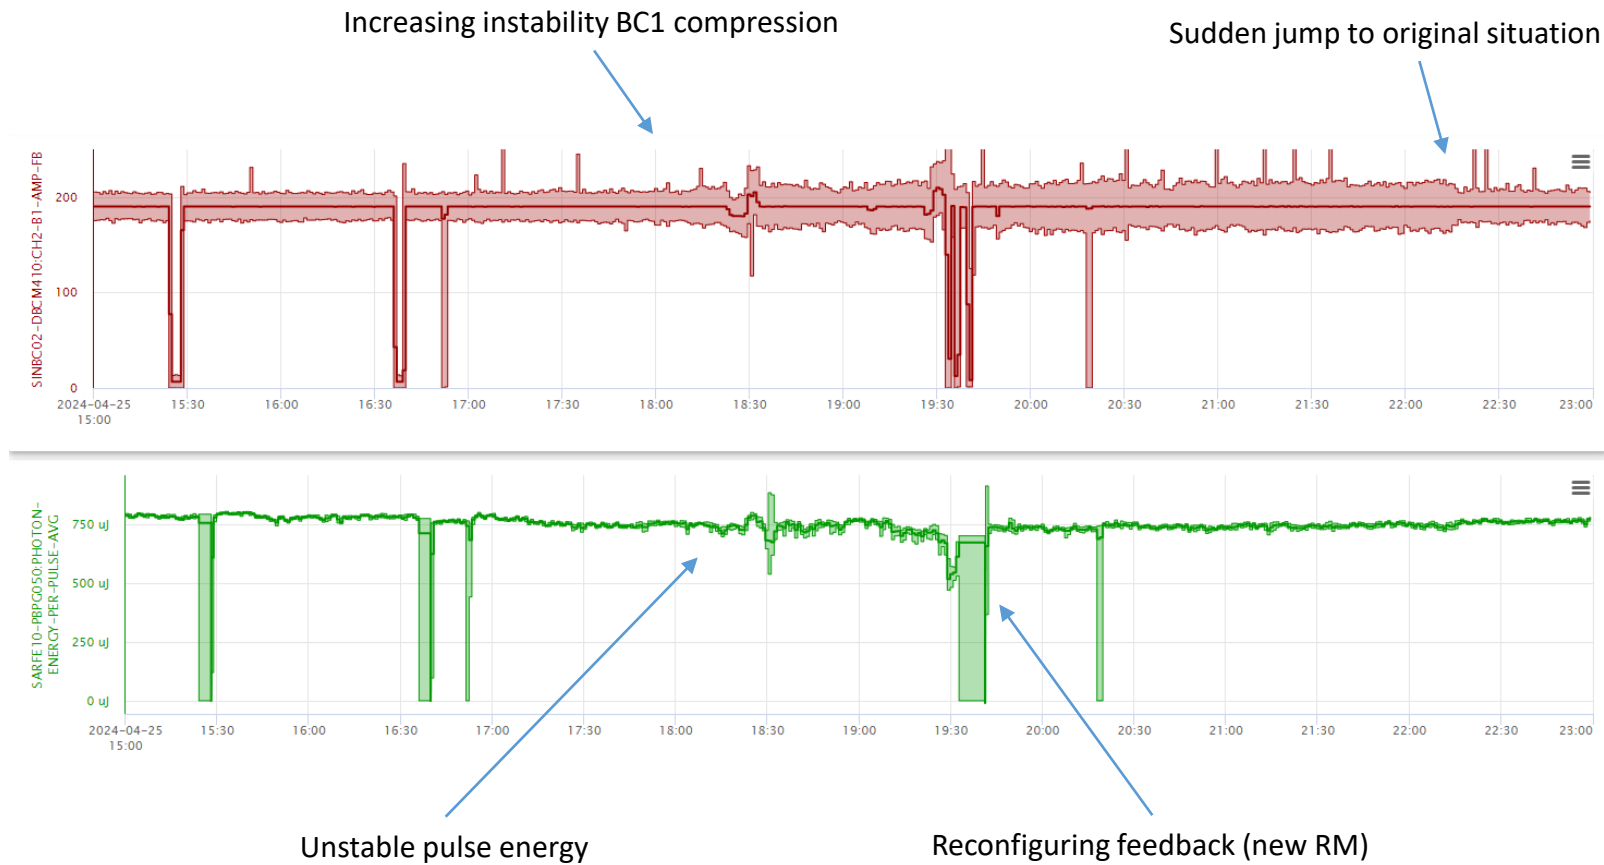
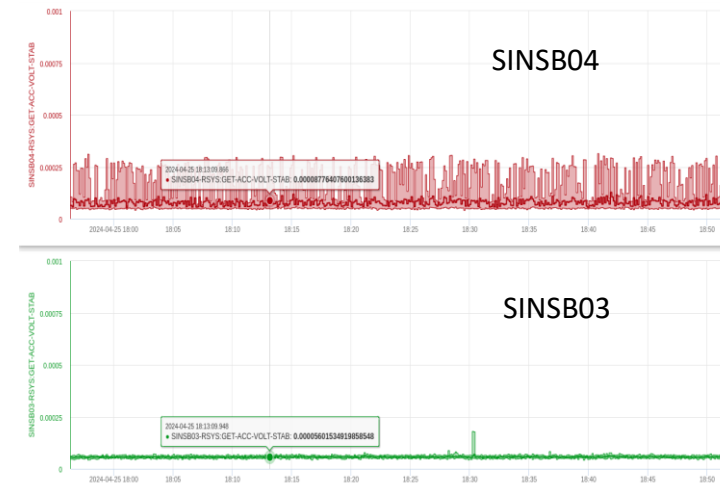
Instabilities

- Could not correlate the BCM instability to RF signal jitter (Qiao)
- (SINSB04 has higher noise due to a faulty pick-up-> this does not seem to affect the beam)
- The instability was also present with compression feedback off
- Disappeared completely after intervention on SINSB02 (on Thursday)
