# Post irradiation examination of the MEGAPIE samples at JAEA

**S. Saito<sup>a</sup>, K. Kikuchi<sup>b</sup>, K. Suzuki<sup>c</sup>, Y. Hatakeyama<sup>c</sup>,  
S. Endo<sup>c</sup>, M. Suzuki<sup>c</sup>, N. Okubo<sup>d</sup>, K. Kondo<sup>d</sup>**

<sup>a</sup>J-PARC Center, JAEA

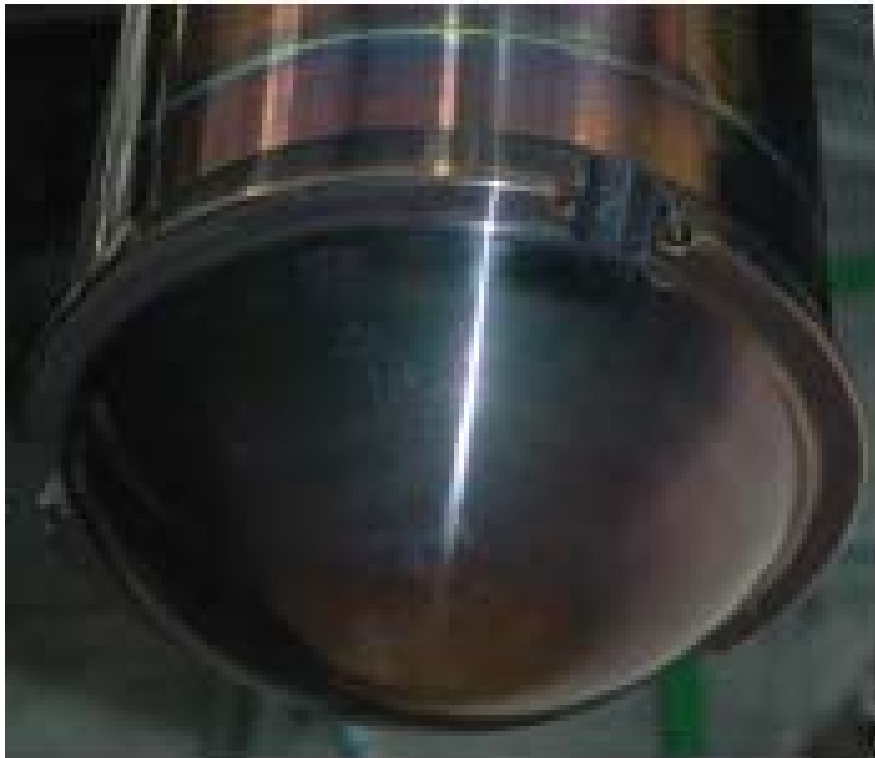
**Beam window (H02-1)**  
Material: T91

JAEA samples : Beam window  
Flow guide tube (FGT)  
All samples are without LBE.

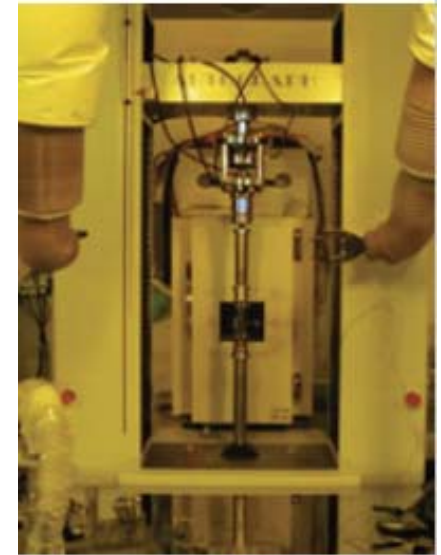
- Tensile testing machine  
Shimadzu 20 kN

- ① RT in air
  - ② 250°C (T91) and 300°C (SS316L) in Ar
  - ③ the specimens were ground flat.  
250°C (T91) and 300°C (SS316L) in Ar
- To compare the existing data.
  - To eliminate effects of surface condition and to evaluate only irradiation effect.
  - Cross-head speed: 0.1 mm/min. ( $6 \times 10^{-4}$ /s)
  - Measurement : Load, Displacement
  - SEM observation of fracture surface

Specimen

Jigs (SUS630 (17-4PH, H900)) 8

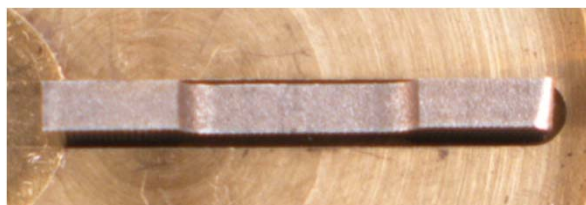
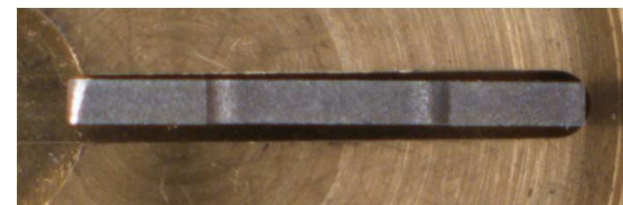
SS316L (FGT)

$t=1.49 \sim 1.53$  mm

$t=1.34 \sim 1.37$  mm

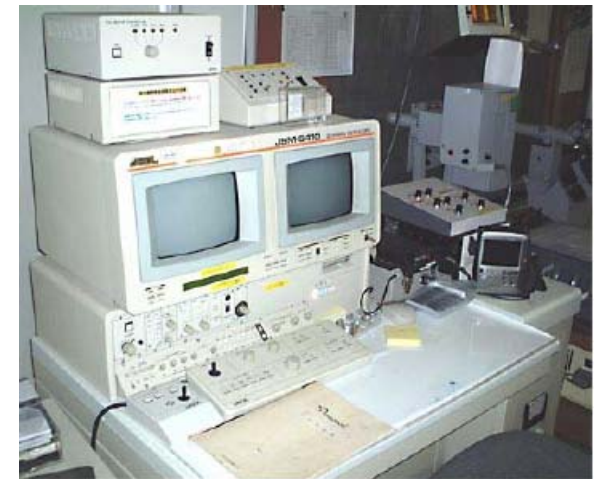
SEM

JEOL JSM-5410

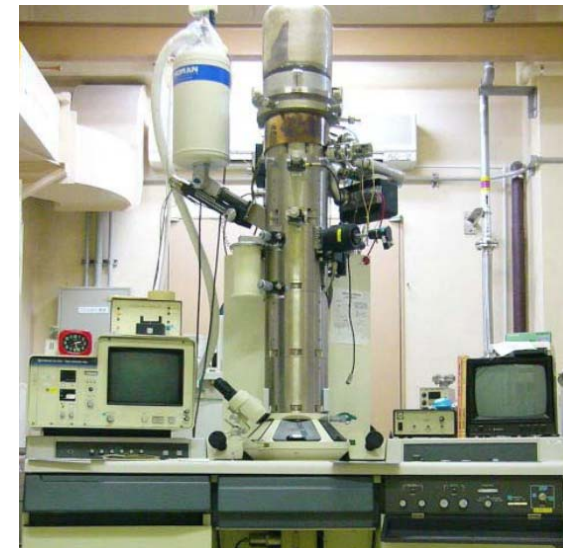
FE-TEM

HITACHI HF-2000

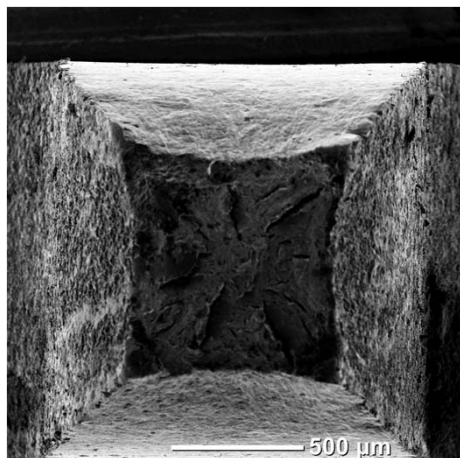
#### T91 (Beam window), Fracture surface

UTT12, Unirr., RT

RA=70.6%

TT22, 0.82dpa, RT

RA=73.3%

TT12, 1.44dpa, RT

RA=70.5%

- Brittle fracture surface were not observed.
- RA value are not changed.
