Feedback for Instrumentation & Control (safety, operations and experiment)

MEGAPIE Final TRM, Bregenz, October 2014

K. Thomsen, S. Dementjevs

Final Assembly of the Target

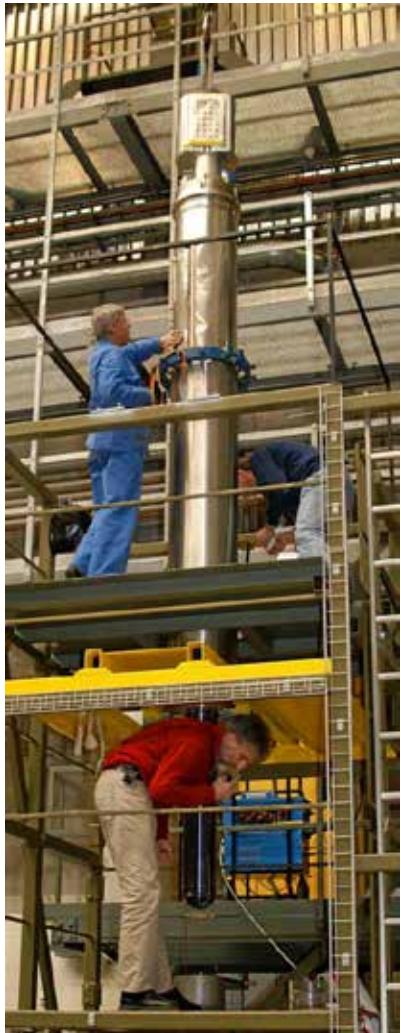
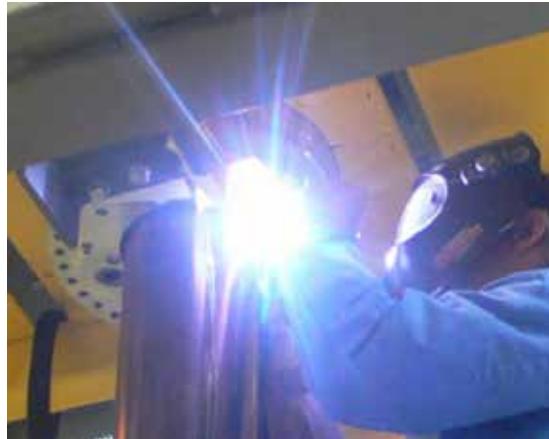
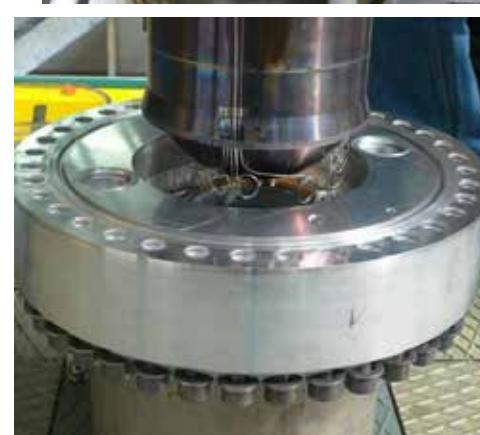
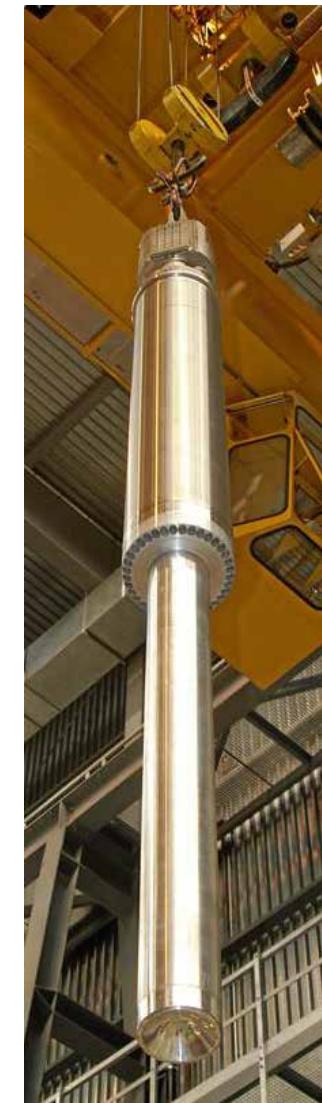
January – March 2006

Target Head Enclosure (TKE) full with stuff

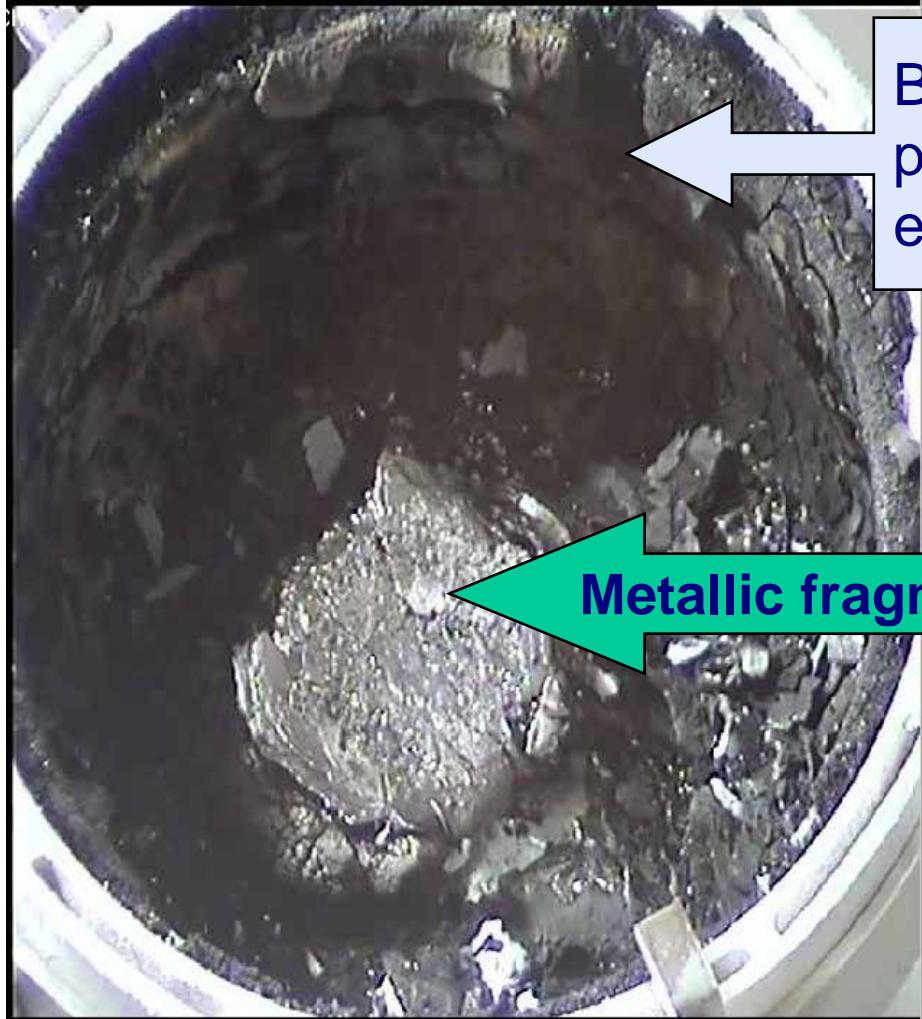
Inside of safety hull calotte after cutting up MEGAPIE

Black flaky smut inside calotte is probably remains of oil that entered the insulation gas system

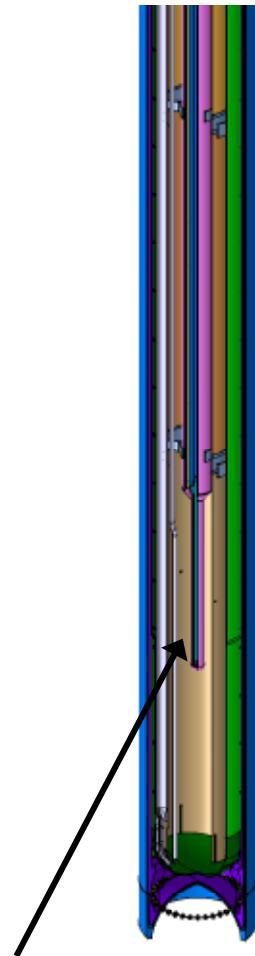
central rod
housing arrays of
fission chambers
