Mupix10 Status and MuPix11 Preparation

Review Meeting date XXX

Mupix10 Design & Specifications

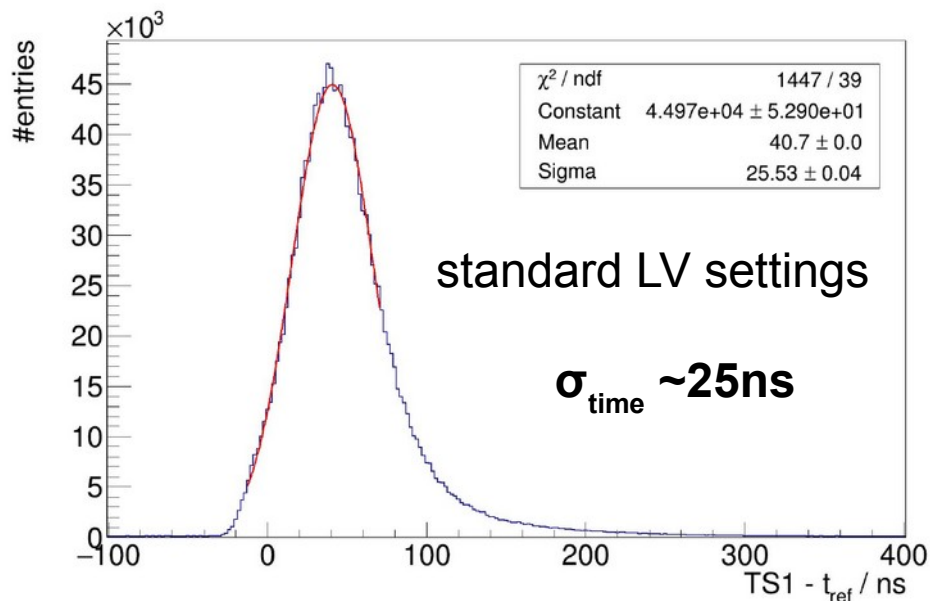
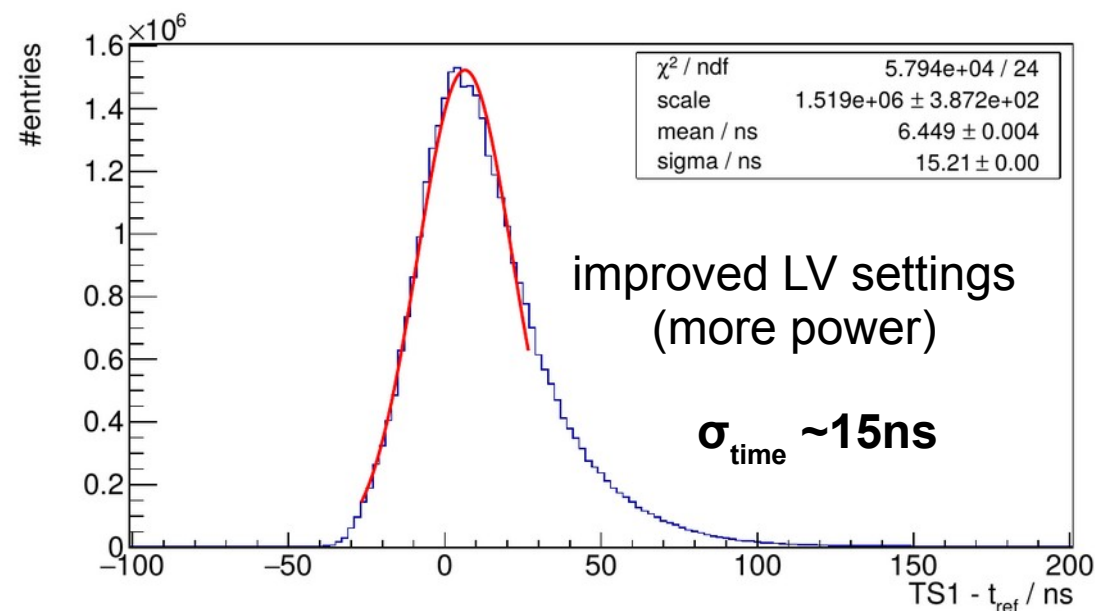
Uncorrected time resolution as measured with ^{90}Sr (bachelor F. Frauen):

MuPix10 allows to measure back (analog) the voltage inside the chip:

Number of Connections	With add. Connections	Measured Resistance	Calculated Resistance	Resistance with add. lines	Measured voltage drop	Expected voltage drop	
nominal	1.8V	vdd	8	8+8	0.3Ω	0.26Ω	~0.13Ω	50mV	~25mV
	0V	gnd	4	4+8	0.4Ω	0.33Ω	~0.11Ω	60mV	~20mV
	1.8V	vdda	10	10+16	0.9Ω	0.75Ω	~0.37Ω	160mV	~60mV
	0V	gnda	11	11+10	0.6Ω	0.36Ω	~0.19Ω	170mV	~90mV
	1.2V	vssa	8	8+6	1.0Ω	0.76Ω	~0.44Ω	130mV	~75mV

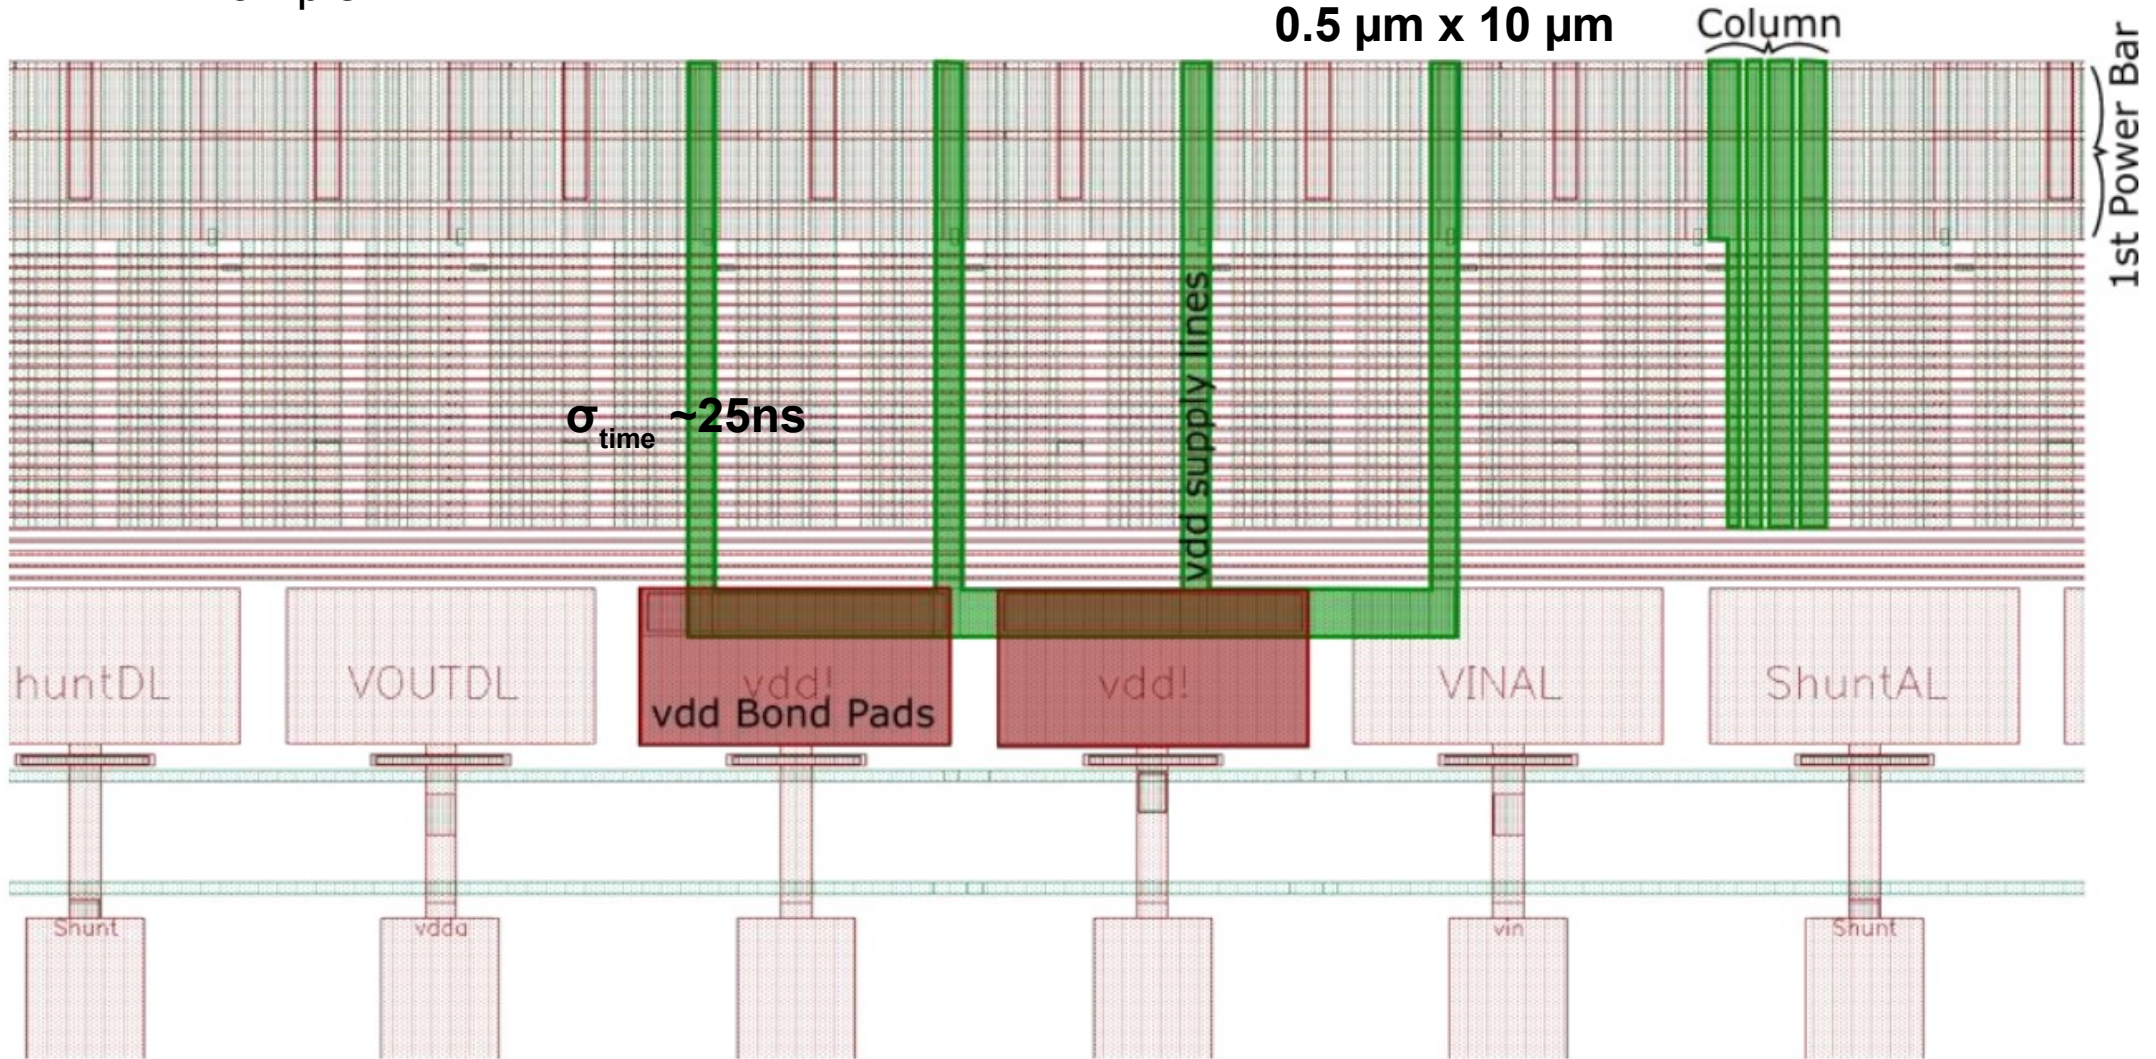
Example: VDD

Culprit: Pad to Power-Bar Connection

cross section
0.5 μm x 10 μm

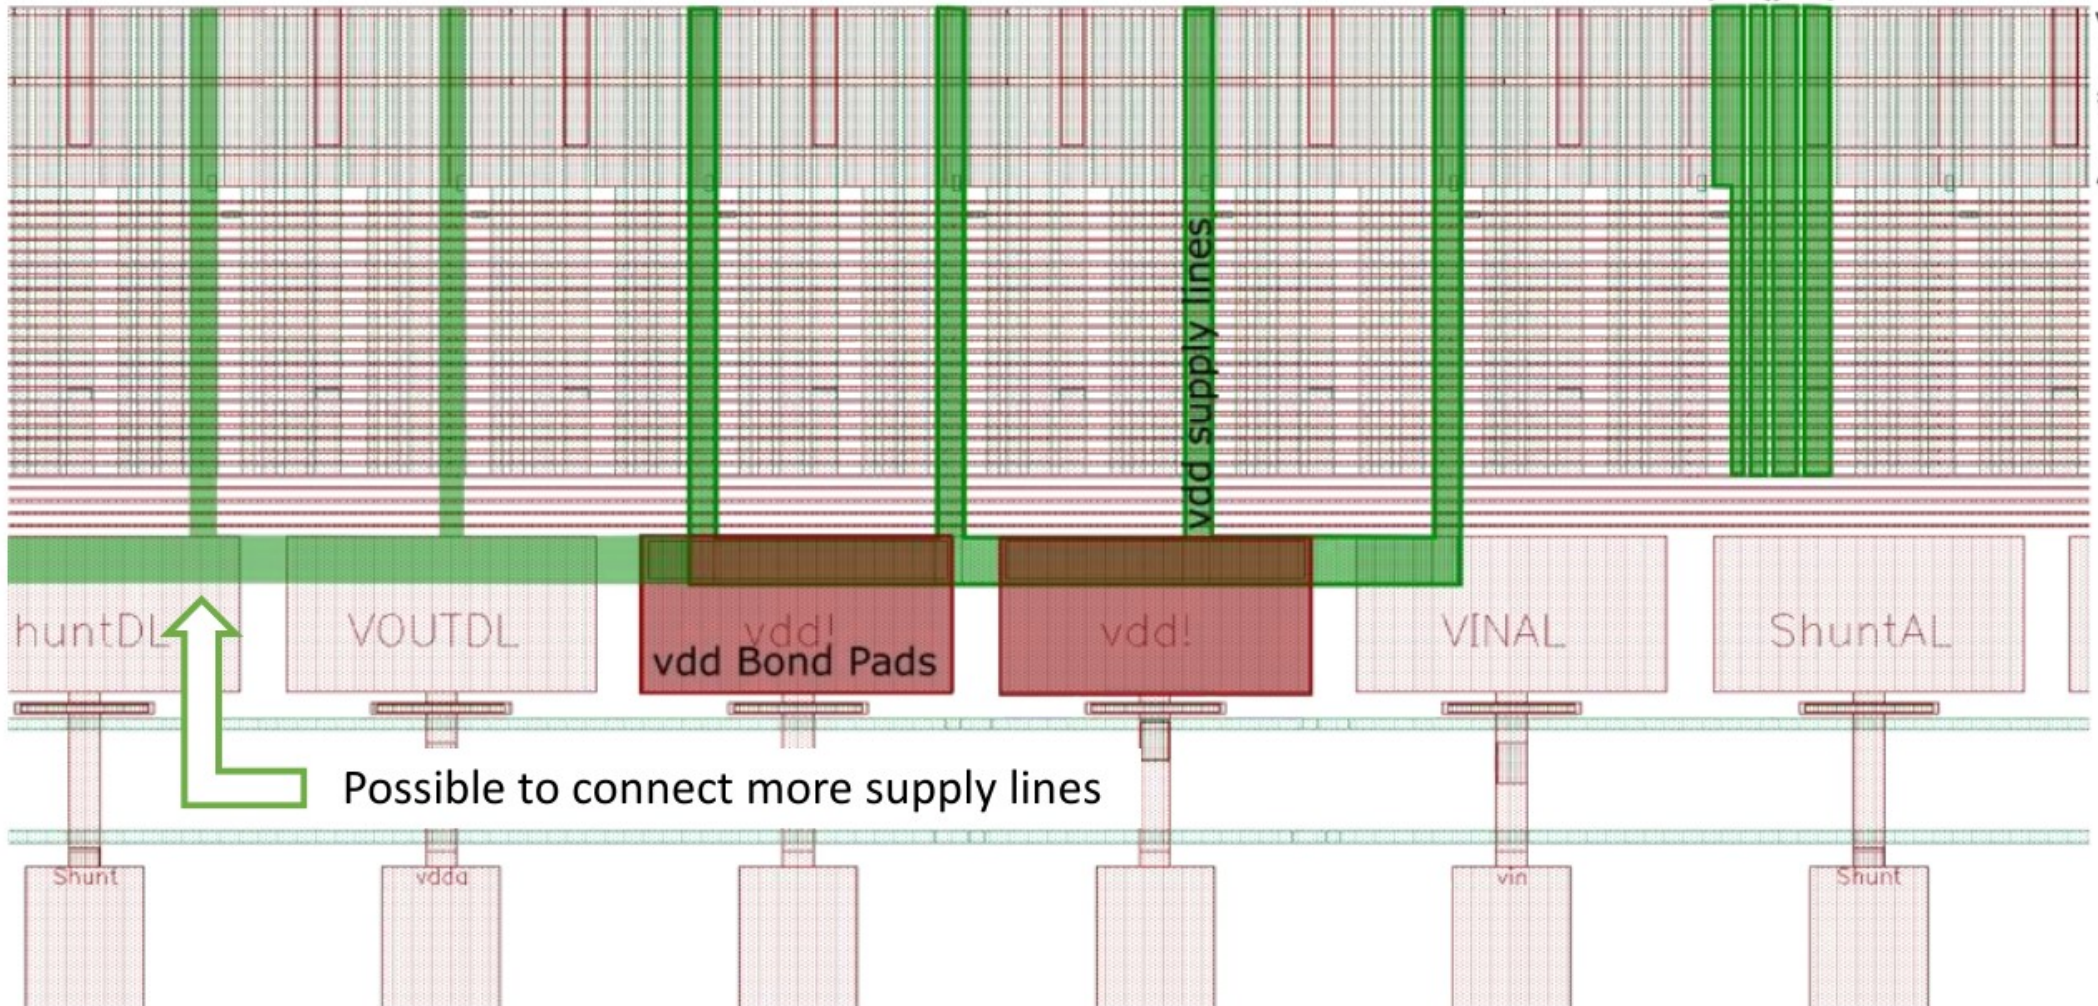
Example: VDD

Fix: Increase Connections

cross section
0.5 μm x 10 μm

Column

1st Power Bar

Possible to connect more supply lines

In addition, more metal layers are used

(similar for VDDA, VSSA, GND and GNDA)

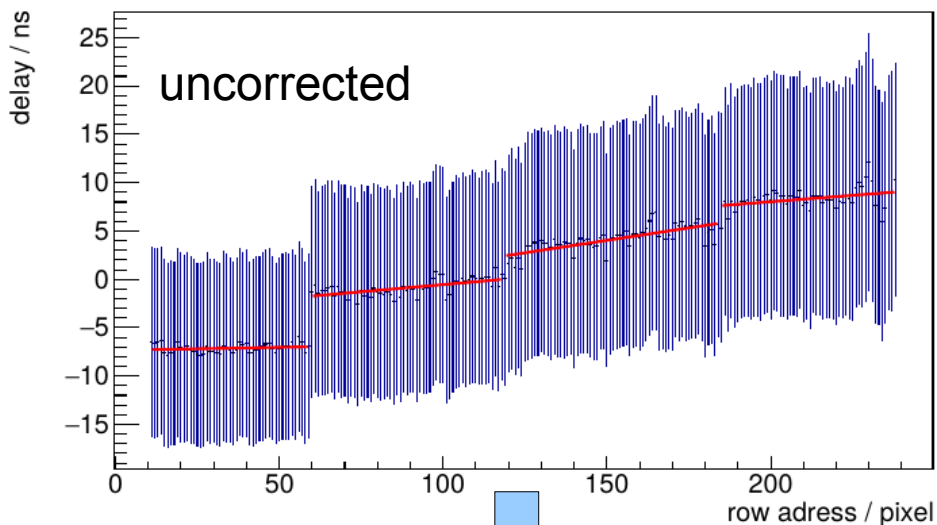
Time Resolution with Improved Powering

row dependent delay correction

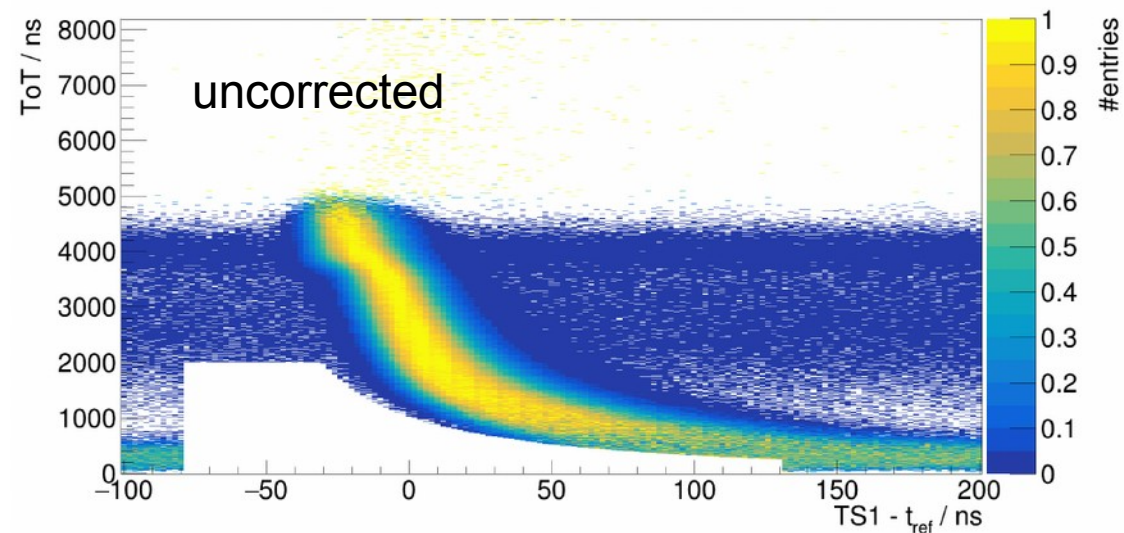
time-walk: ToT versus delay

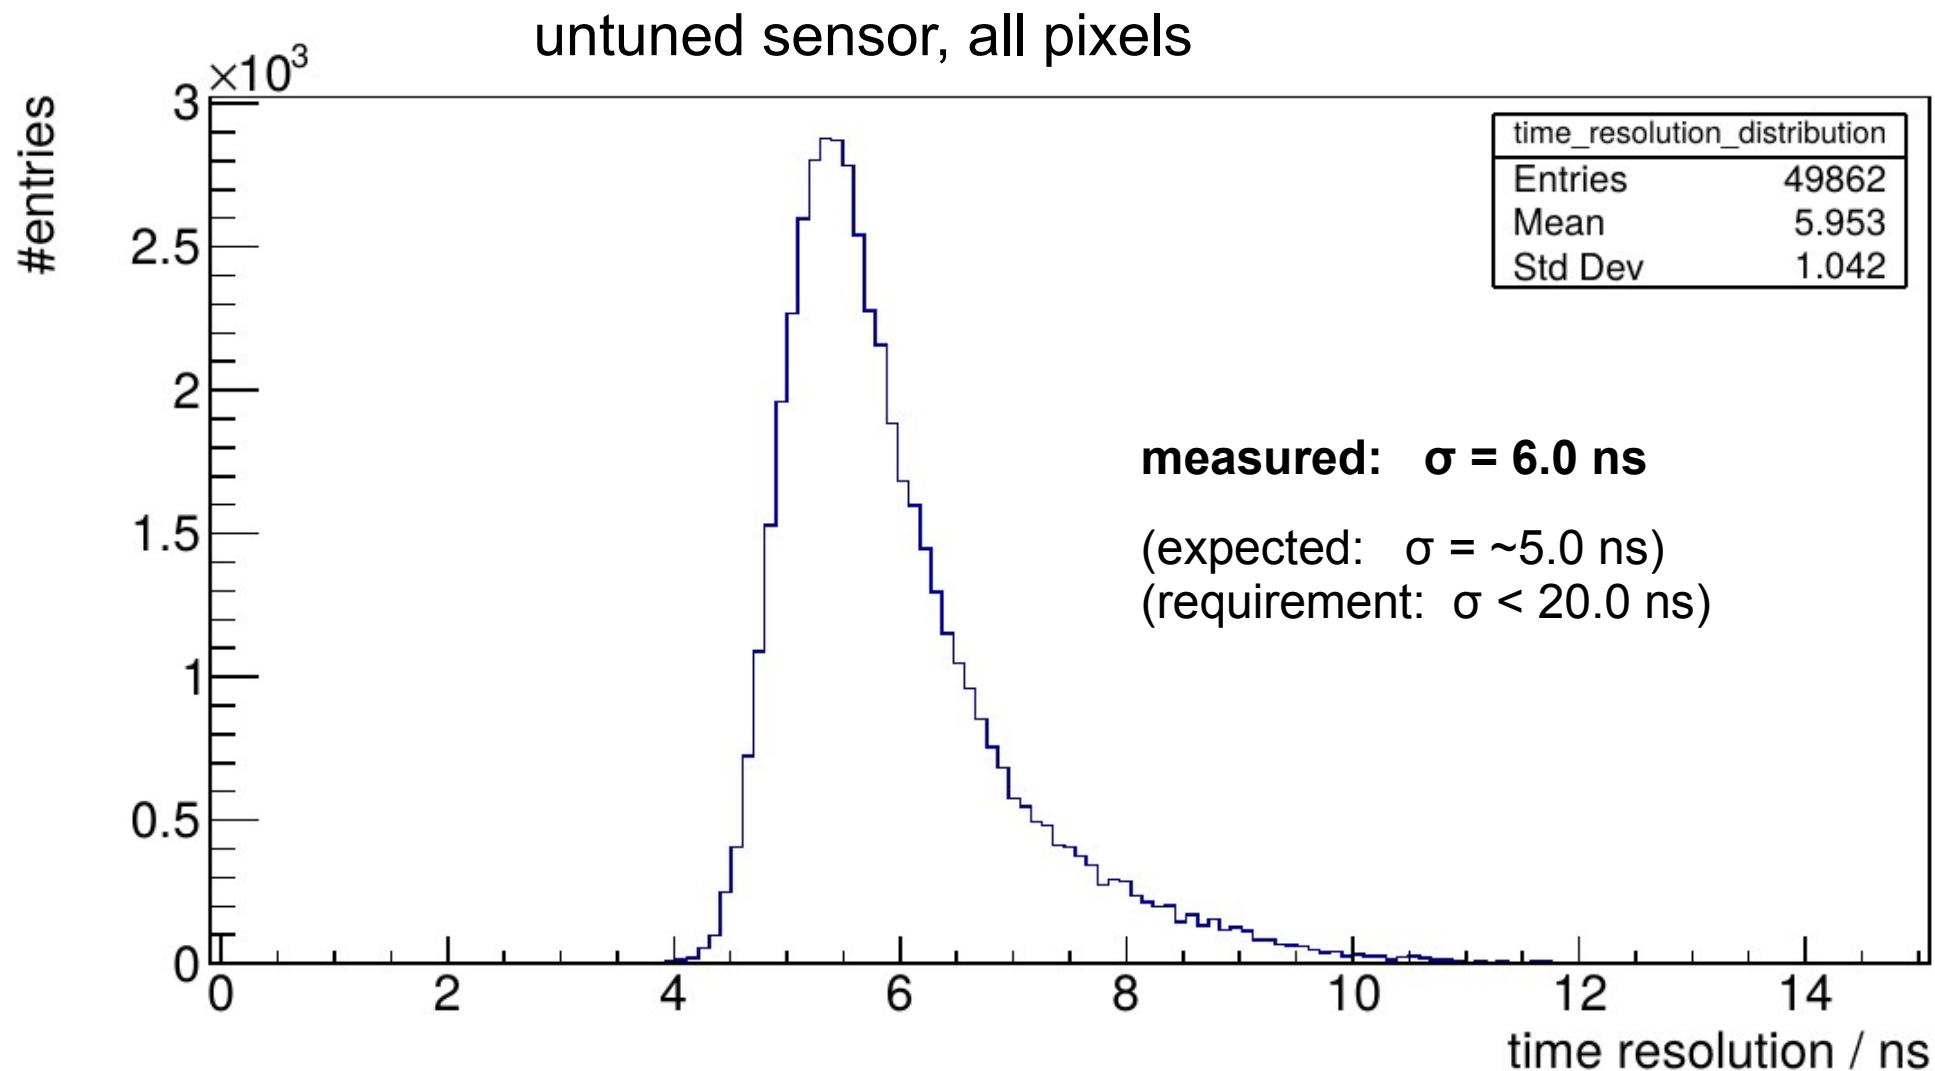
Time Resolution with Improved Powering

for comparison: ATLASpix3 (comparator in pixel) has a time resolution of about 4ns

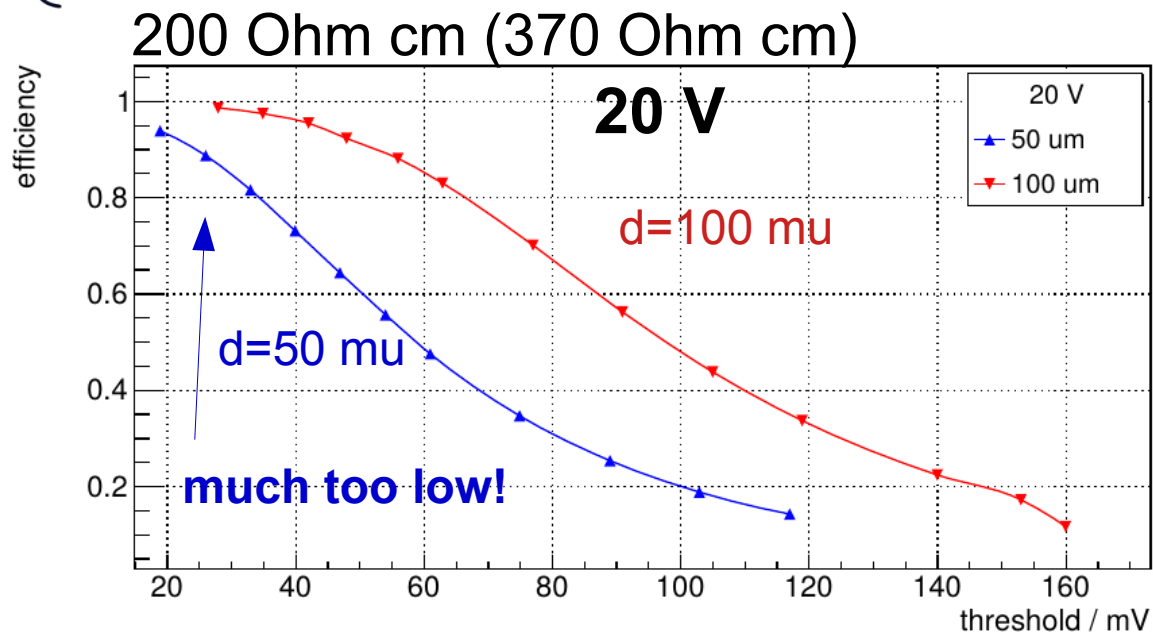
- Hit efficiency of **50 mu sensor** does not fulfill the specification
- inefficiencies originate from pixel edges and corners
- 100 mu sensor is more efficient due to contribution from diffusion

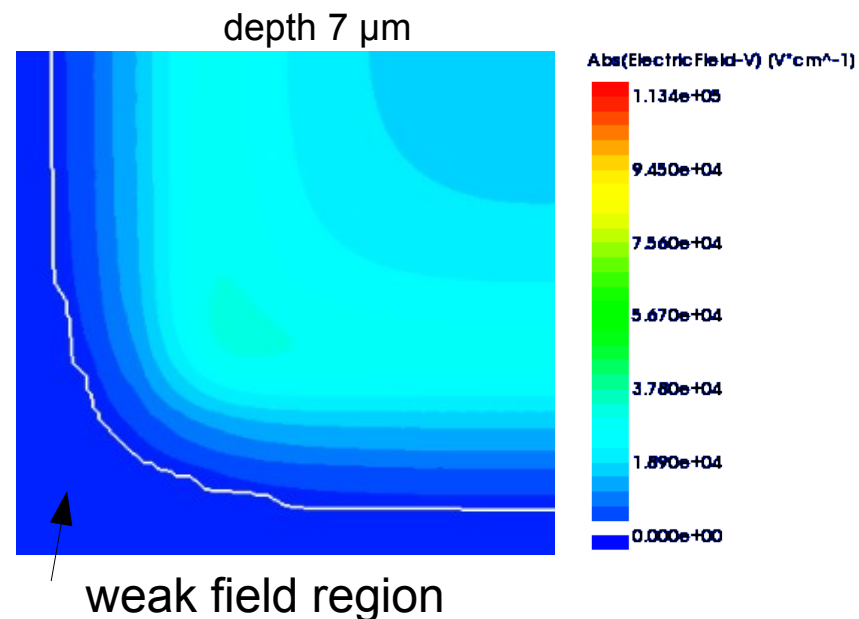
Results from TCAD simulations for 200 Ohm cm and -30V

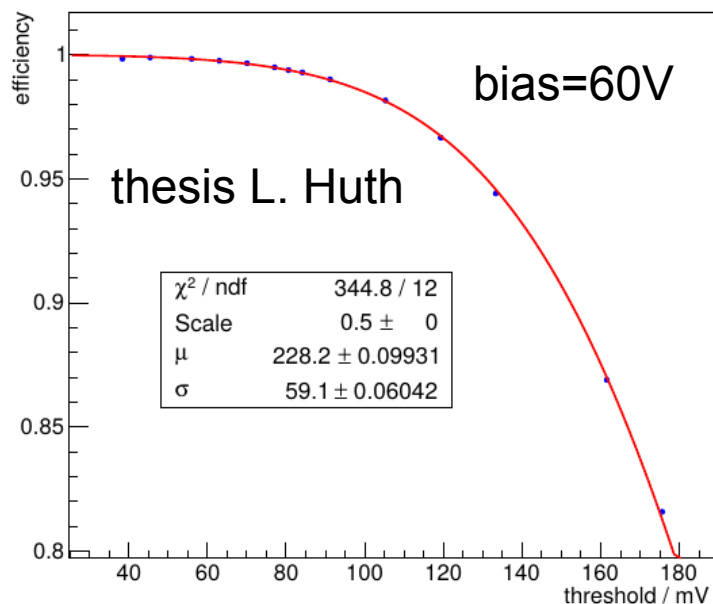
MuPix8 testbeam:
(100 um thickness, 200 Ohm cm)

50% efficiency at **229mV**

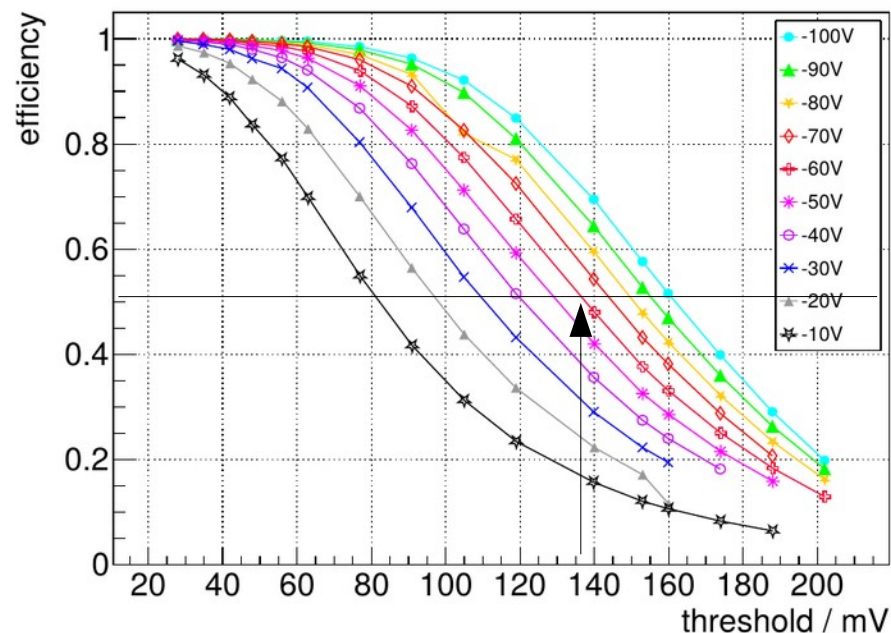
MuPix10 testbeam:
100 um thickness, 200 Ohm cm)

50% efficiency at **137 mV (56%)**

Signal is much smaller (56%) than expected from Mupix8

Amplifier and comparator basically unchanged from MuPix:

- AC coupling between source follower and comparator was slightly changed (50%)
- Capacity of baseline restoration transistor was changed

(both changes are expected to have minimal effects on performance)

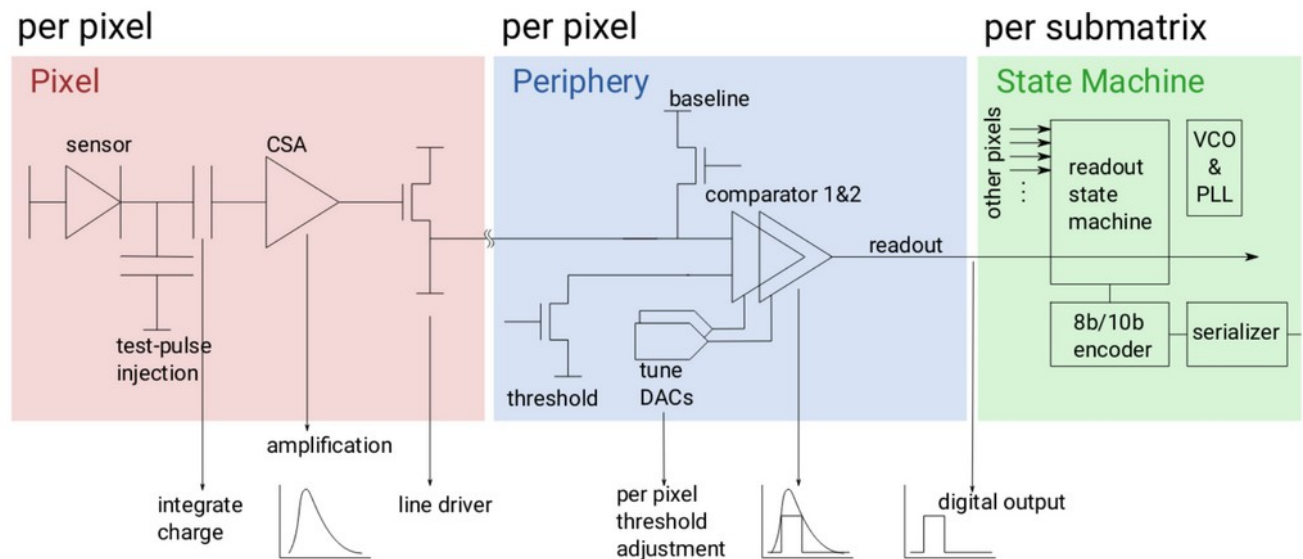
Note: the charge is collected by drift within $<1\text{ns}$. The steeper the rising edge of the comparator input, the higher the signal efficiency.

- TDAC settings were optimised for time resolution with ^{90}Sr source
- then in-chip voltage drops (issue3) were found and fixed
- TDAC re-optimisation done with ^{90}Sr yielding improved but still unsatisfactory results
- further investigations brought more findings:
 - low voltage level of comparator baseline should be avoided
 - employed timing optimisation had a bias (integrated time resolution improves when cutting out small signals)
- settings were optimised again by checking directly the rising edge

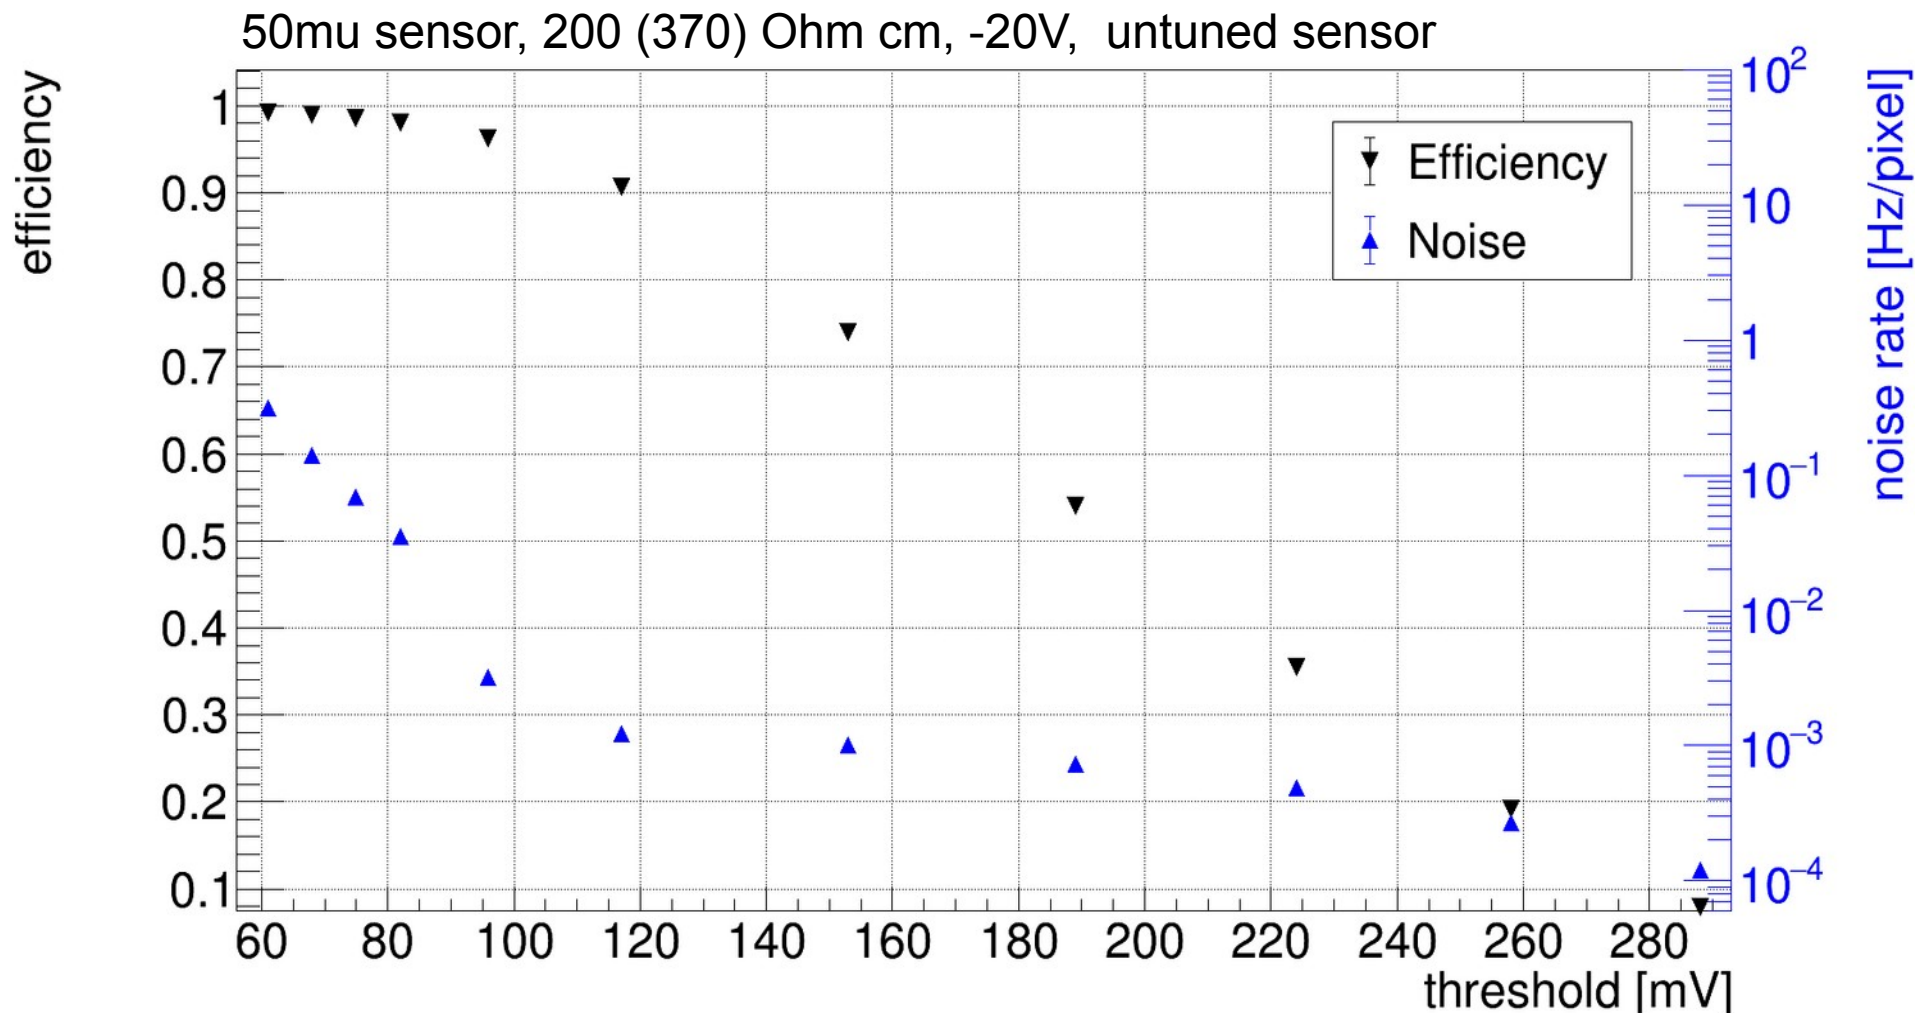
- hit efficiency >99%
- noise from a few hot pixels (untuned) increases at low threshold
- noise rate is small ($\ll 20$ Hz/pixel)

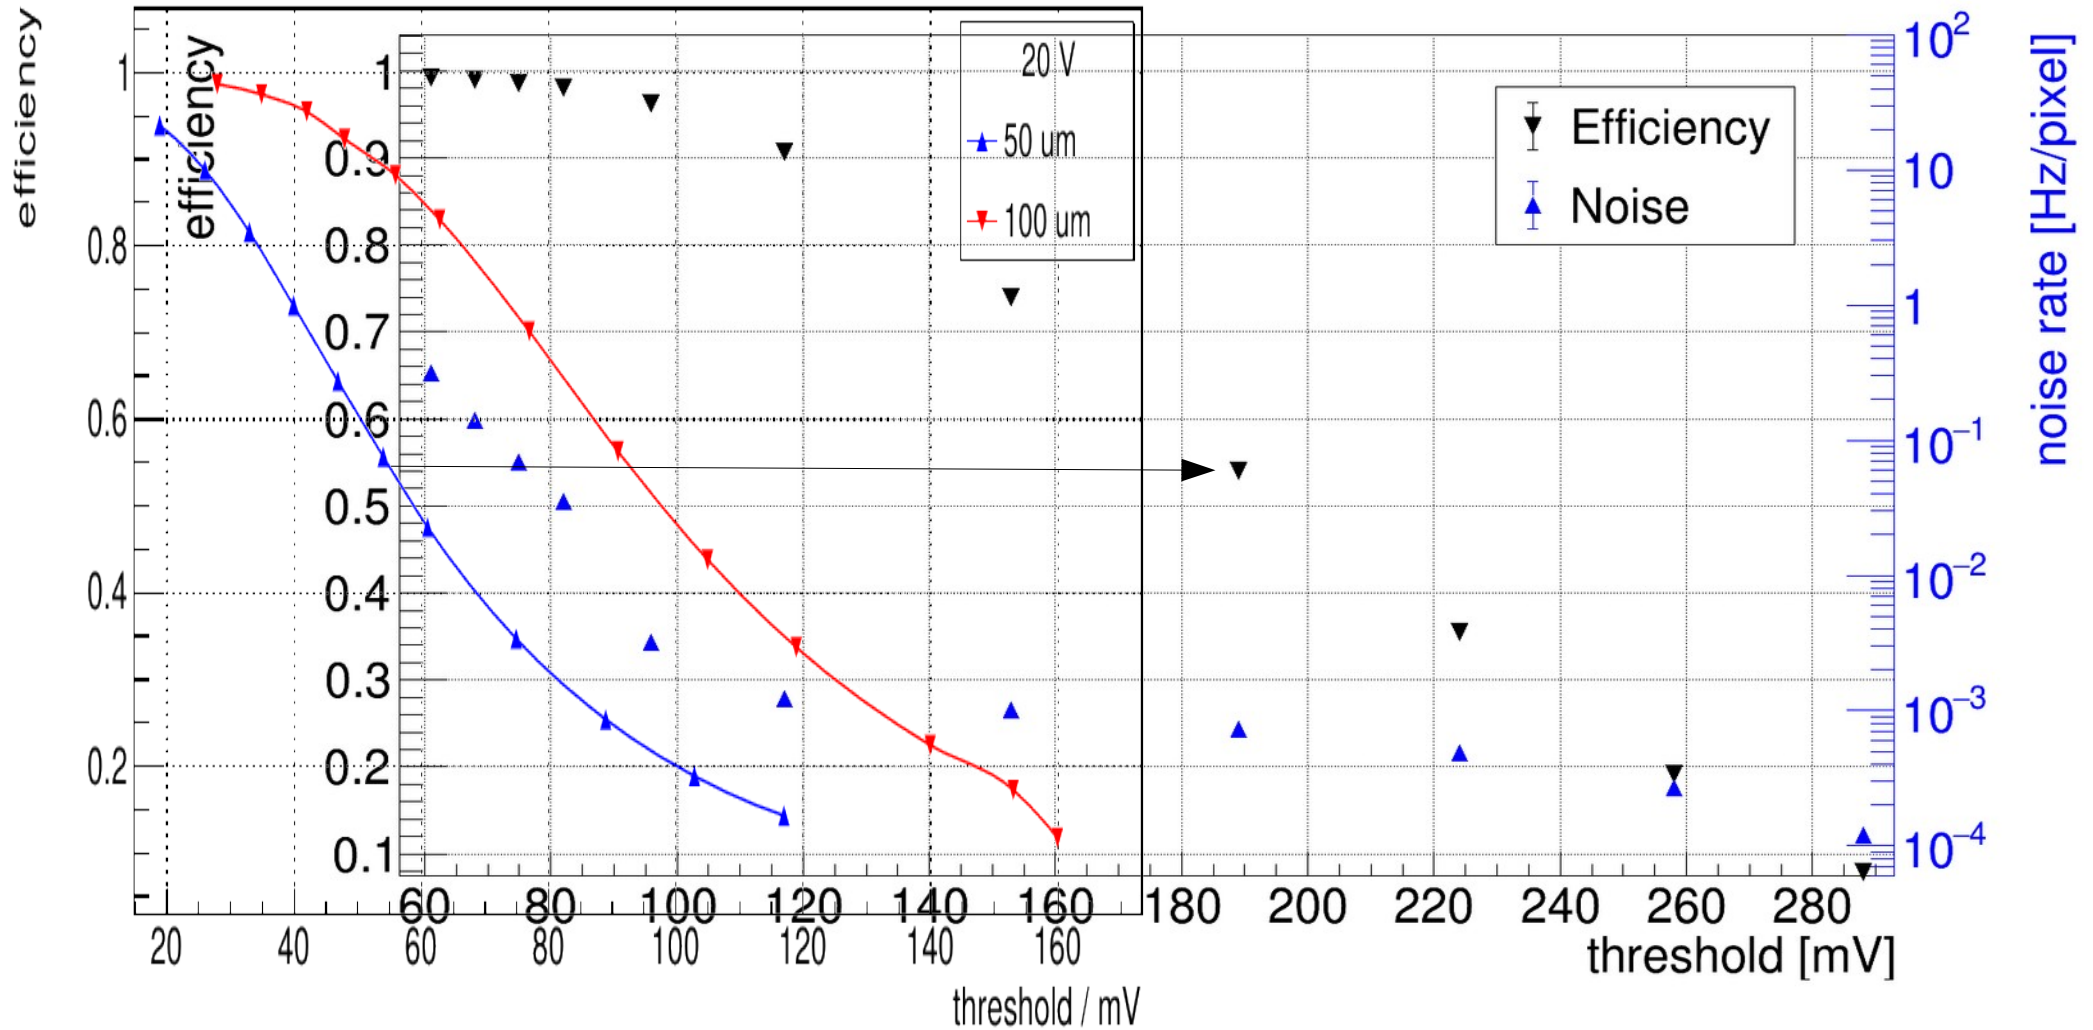
- the signal is substantially larger with the new settings!
- issue is solved and understood!

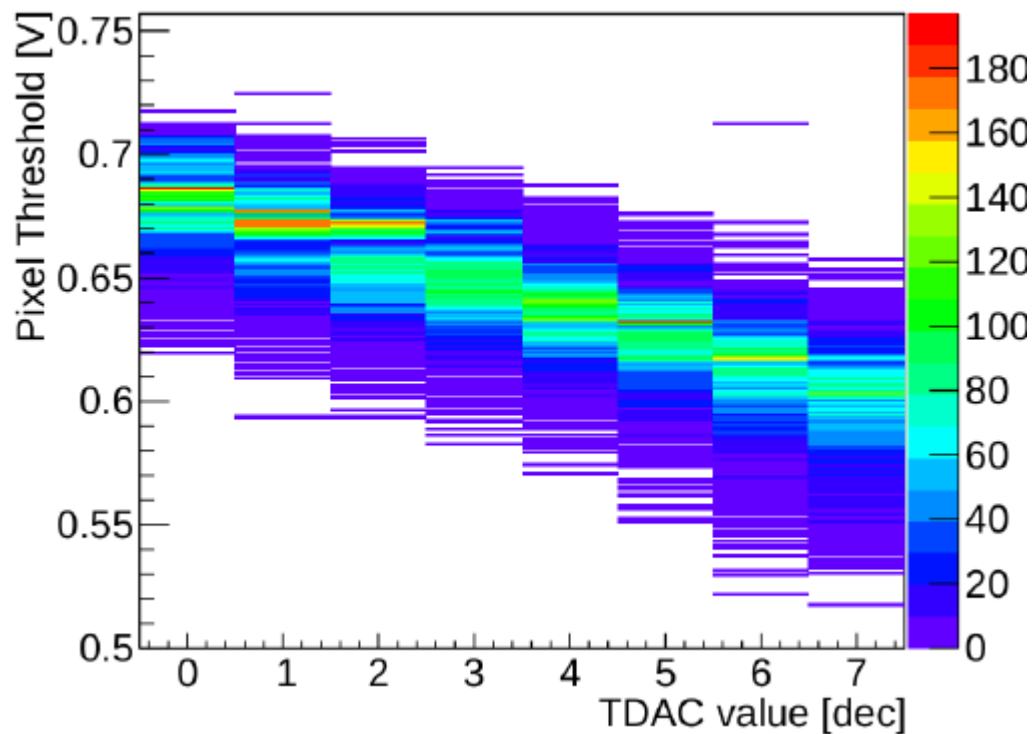
Dynamical range of VPDAC (pixel tuning)

The adjustable range is a bit too narrow

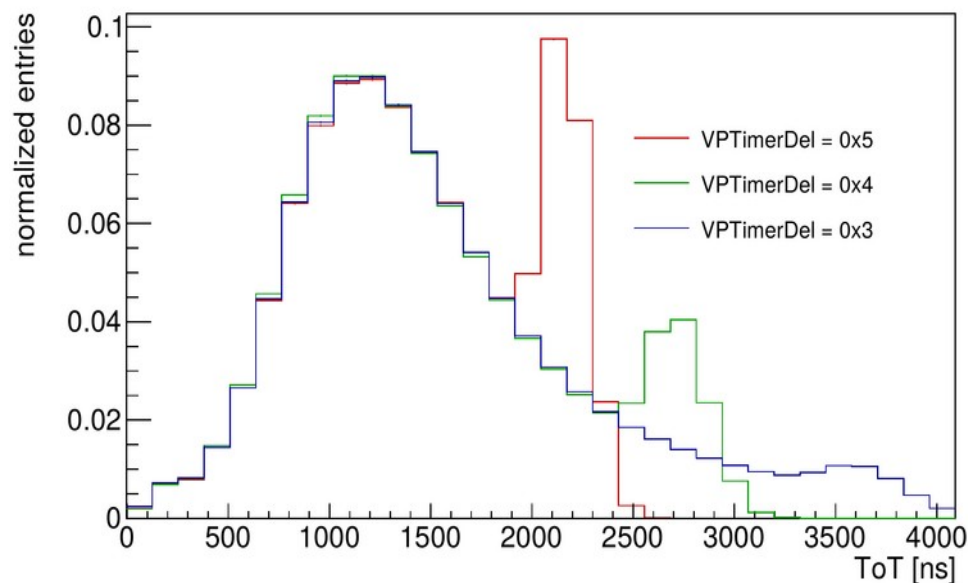
Dynamical range of delay circuitry

The delay point is given by:

delay = 10 μ s / TDAC(4 bit)

The full range (MSB) can essentially not be used

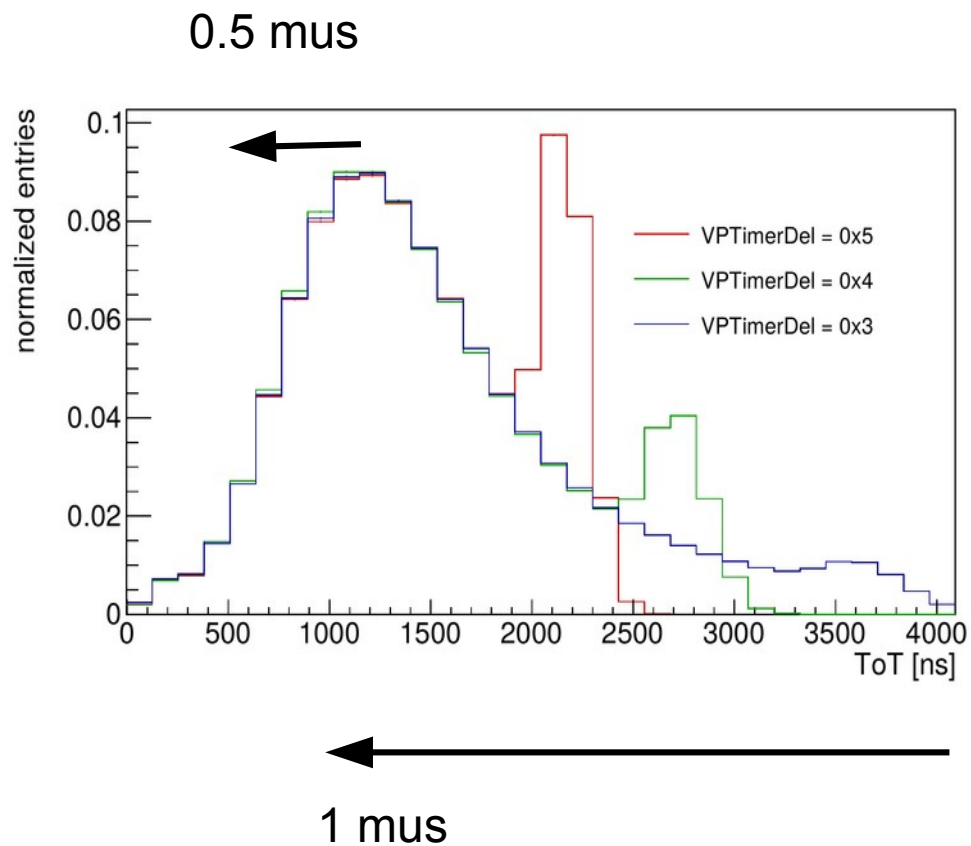
Baseline Restoration

Baseline restoration should be speed up by a factor 2-4

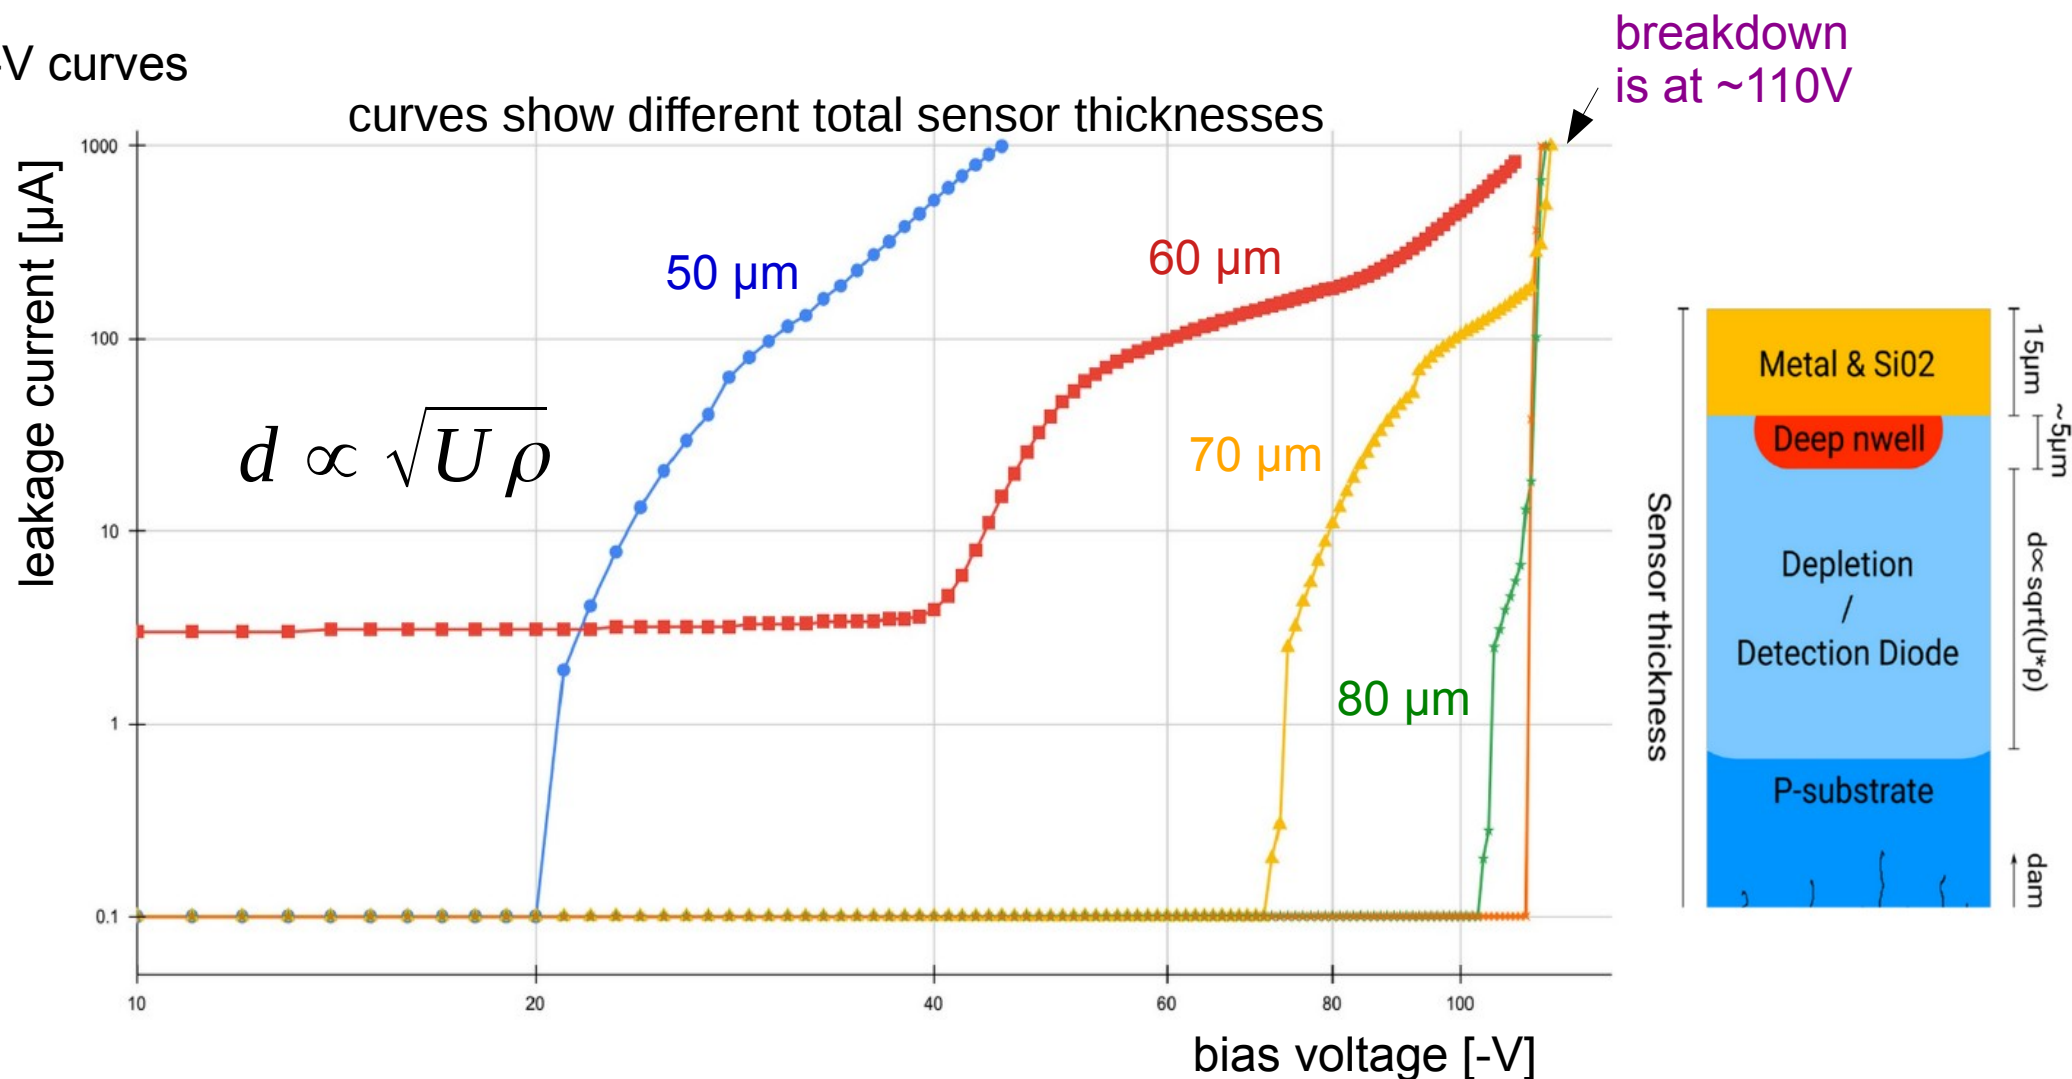
I-V curves

- Sensors **thinned to 50 μm** allow for only **20-25 V depletion**
- Data are well compatible with a substrate resistivity of **~370 Ohm cm** (nominal 200) assuming that the depletion **touches the back-side**

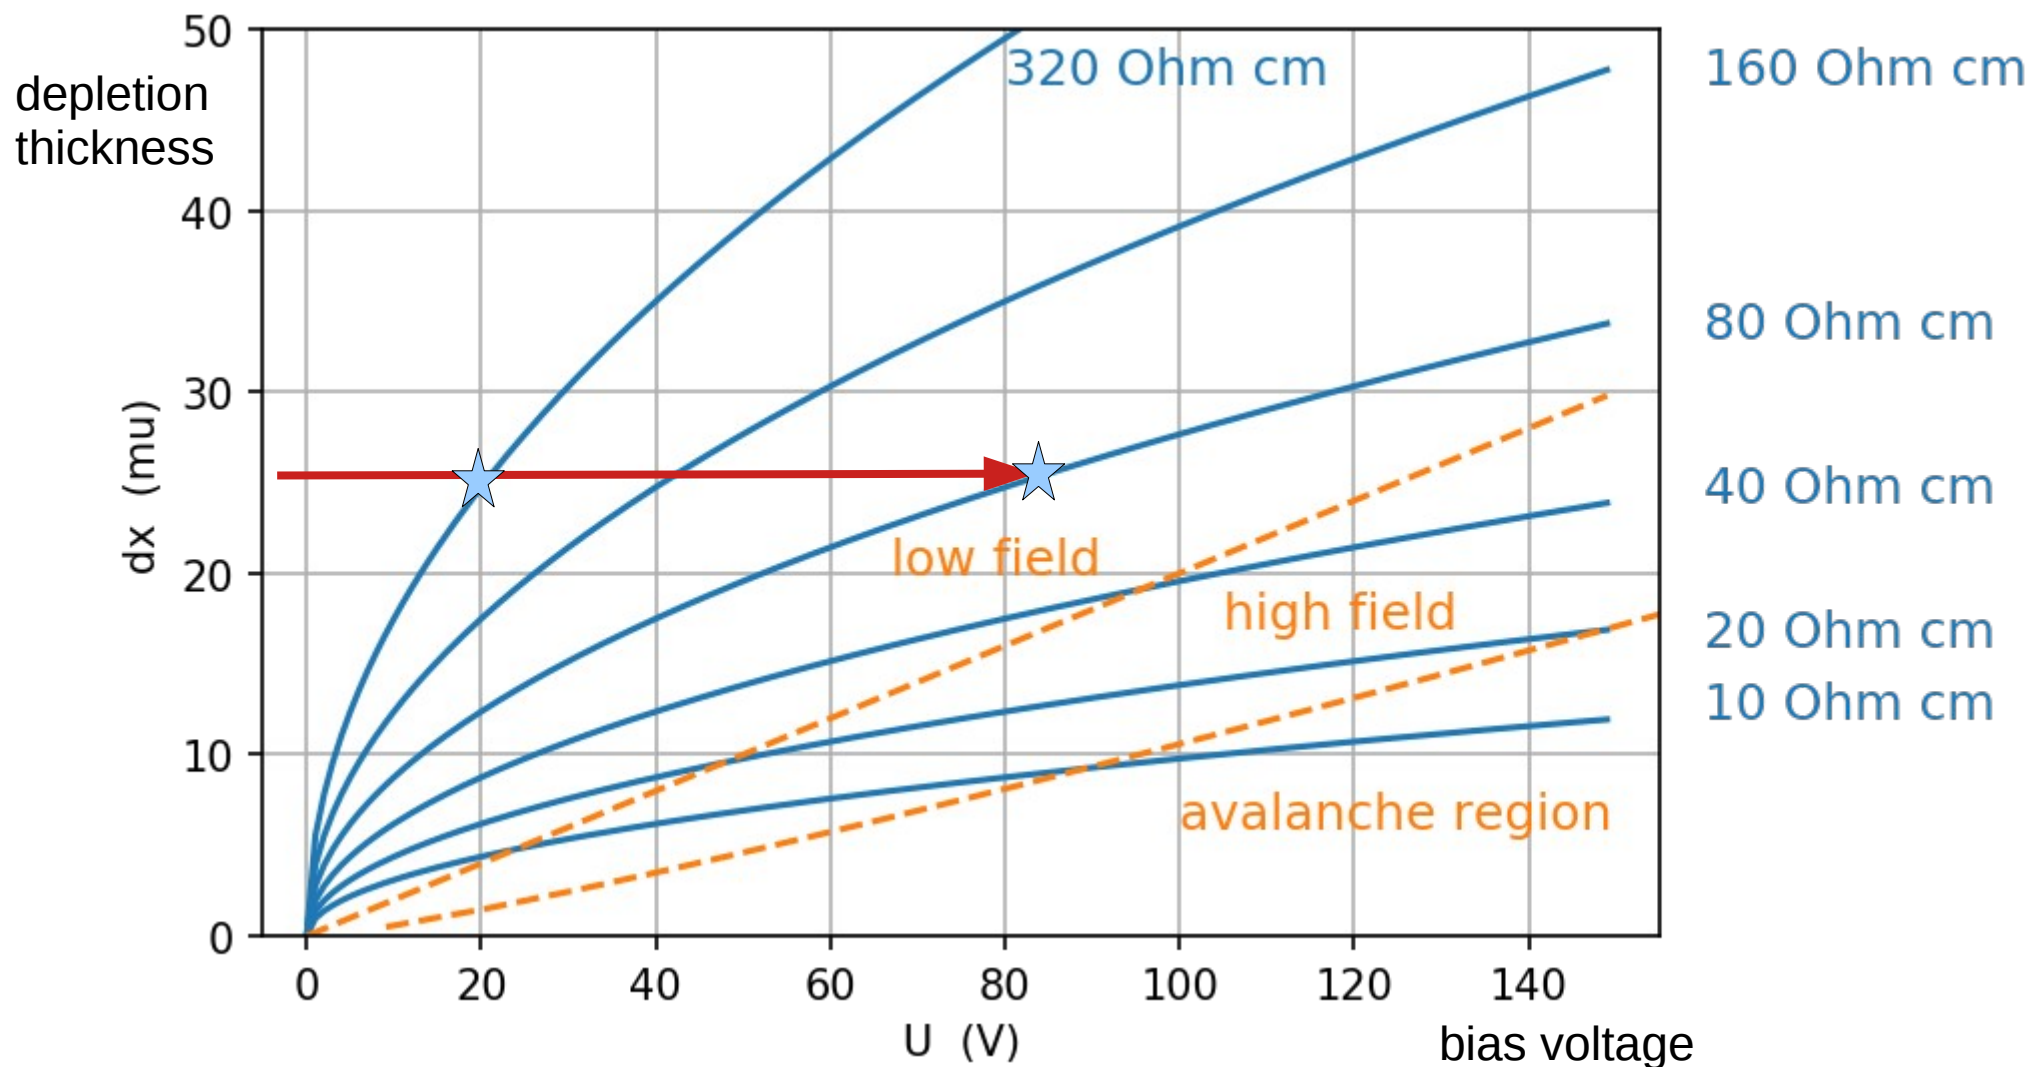
Depletion and Bias Voltage Relation

- **50 μm sensor allows only 25-30 μm depletion**
- **Optimal resistivity is $\geq 80 \text{ Ohm cm}$ \rightarrow full depletion possible @100V**
