Mupix10 Status and MuPix11 Preparation

Review Meeting date XXX

Mupix10 Design & Specifications

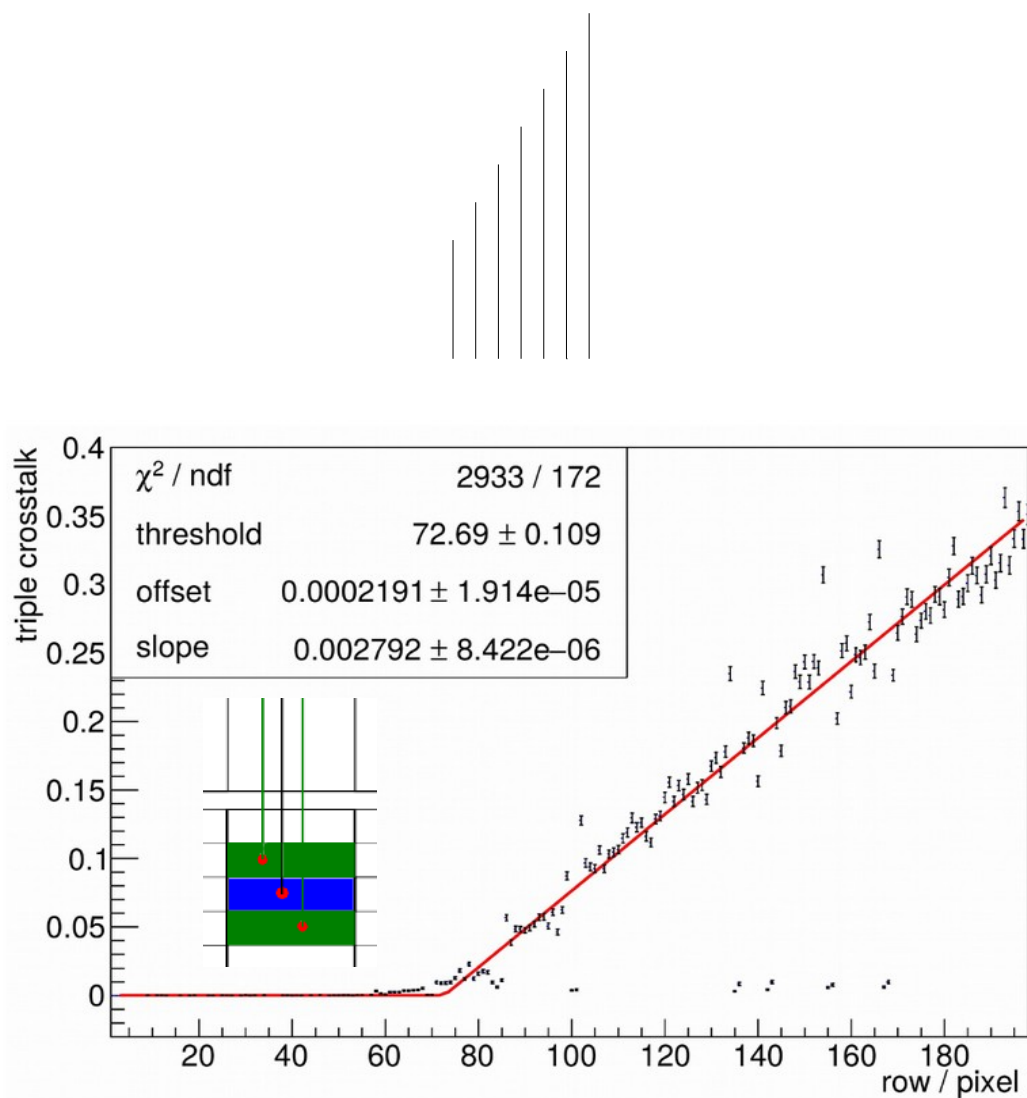
Mupix8 Layout

Triple cross talk probability

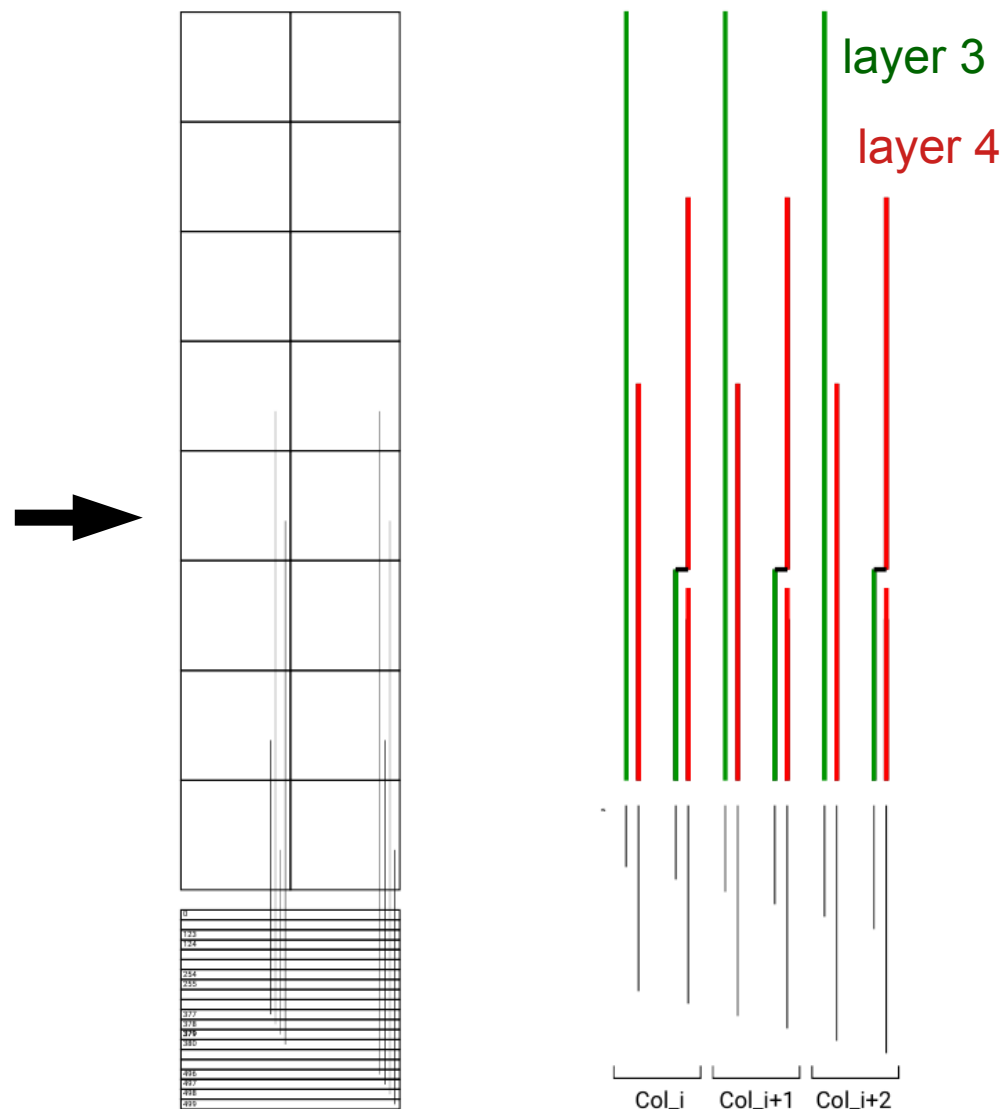
New Mupix10 Layout

double column

2-metal layers

Mupix10 integrated cross talk probability less than 1.5 % (Mupix8 ~12%)

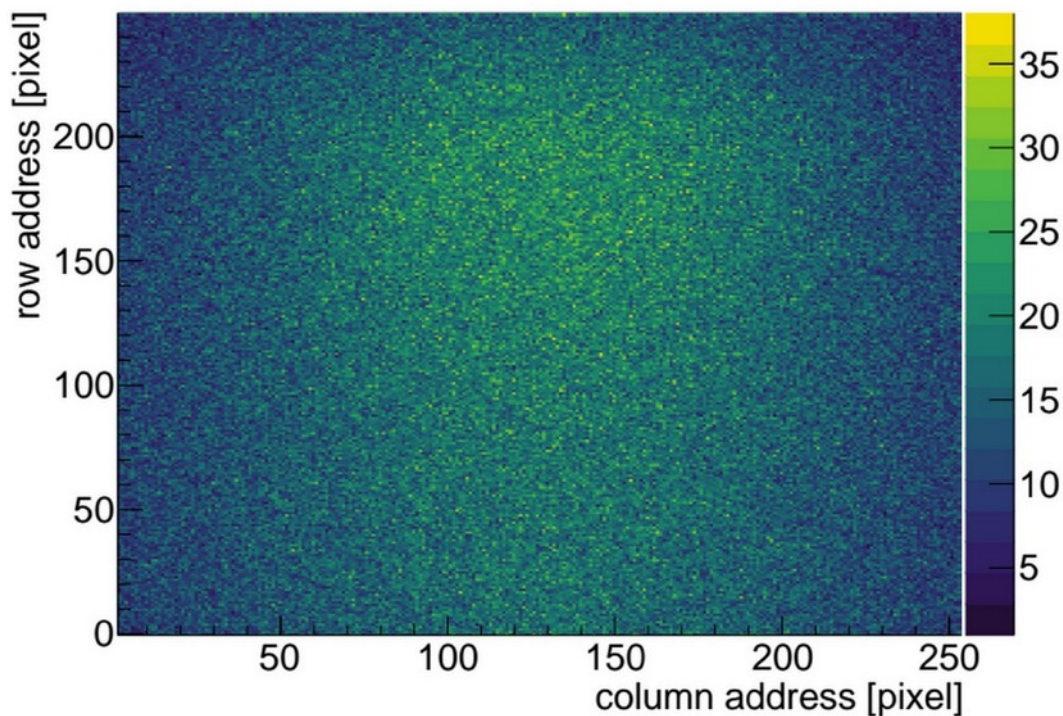
Hit map (electrons @DESY)

- telescope: 3+1 (DUT) layers
- DESY & PSI testbeams (despite Corona)
- MuPix works fine in general!

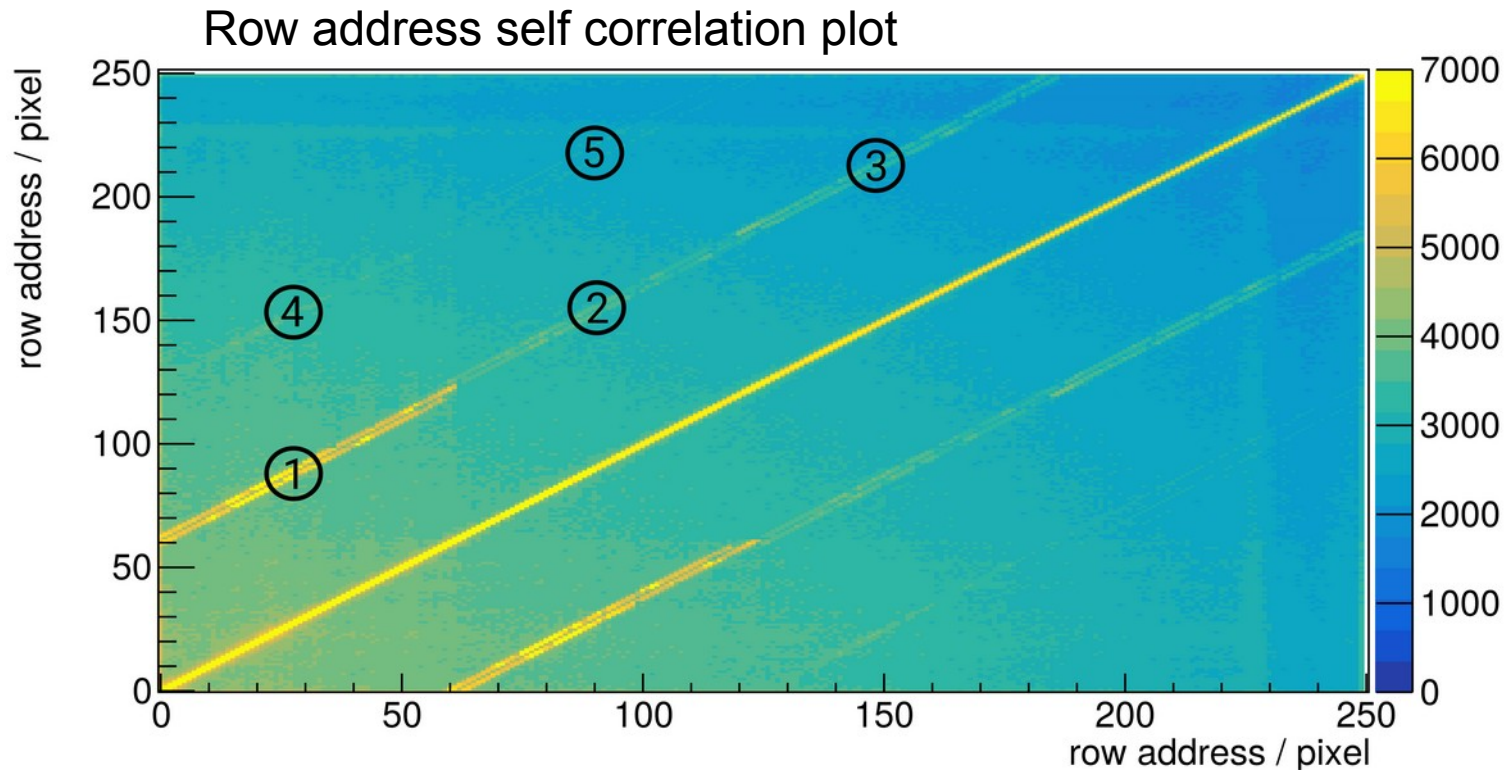
MuPix10 routing pattern

Top view

Cross section
