Inner layer status

Thomas Rudzki - Pixel construction meeting - Oxford 2021

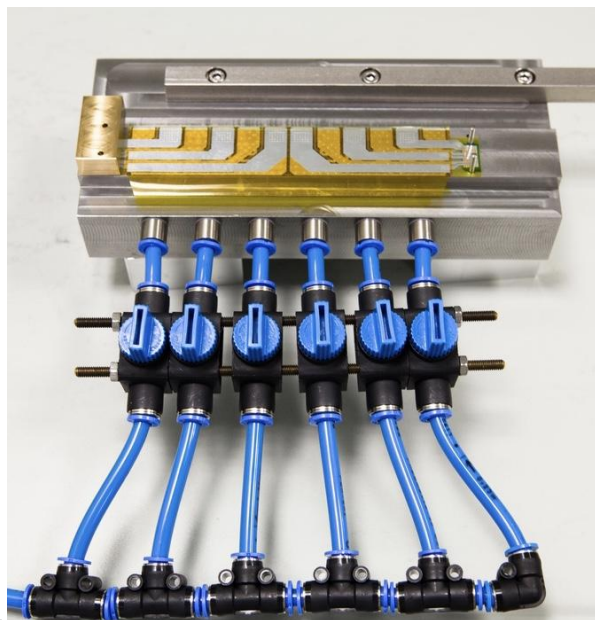
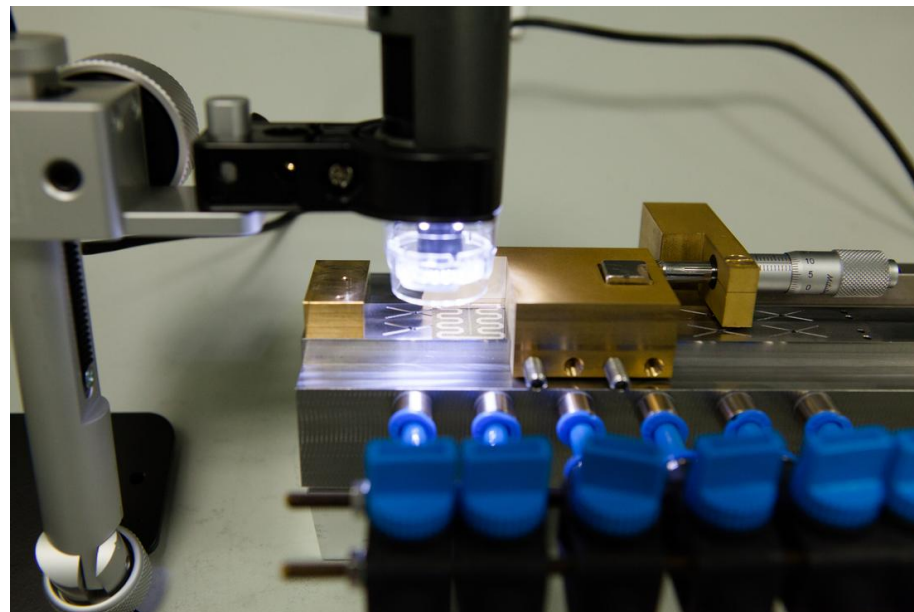
- Ladder assembly tool:

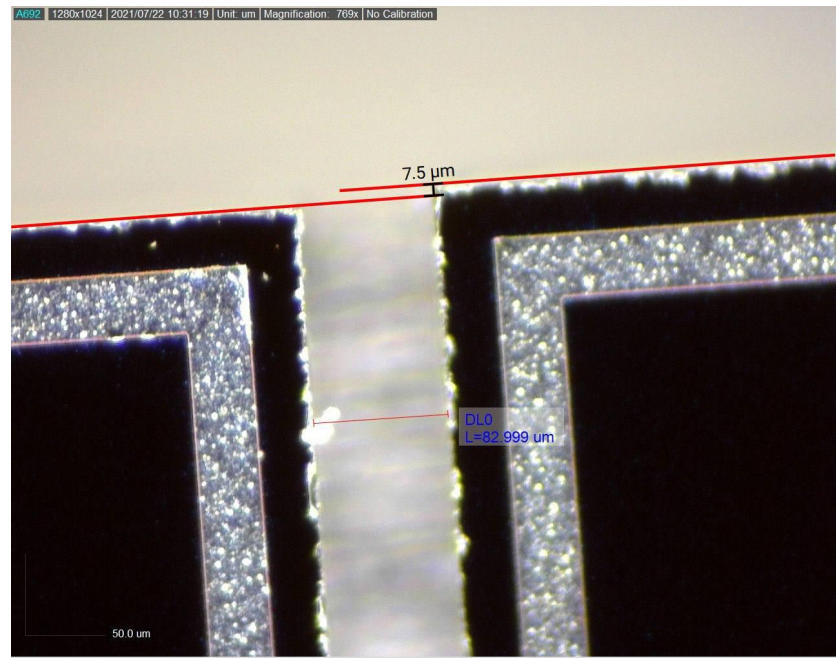
- Ladder assembly tool:
 - $< 5 \mu\text{m}$ precision for horizontal and vertical placement
 - avg. vertical displacement: $(9 \pm 3) \mu\text{m}$
→ systematics from slide
(can be produced multiple times, choose beste)

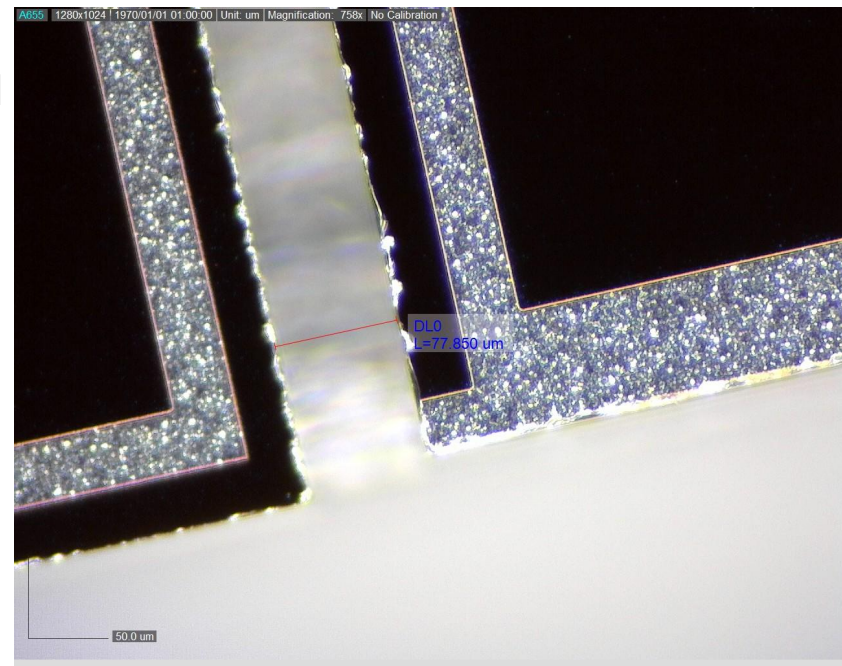
- Ladder assembly tool:
 - $< 5 \mu\text{m}$ precision for horizontal and vertical placement
 - avg. vertical displacement: $(9 \pm 3) \mu\text{m}$
→ systematics from slide
(can be produced multiple times, choose beste)
 - avg. gap size: $(80 \pm 4) \mu\text{m}$

- Tool for MuPix10 existing, should fit MuPix11 (same dimensions)
- Precision will be proved in spring 2022
→ MuPix10 ladder production

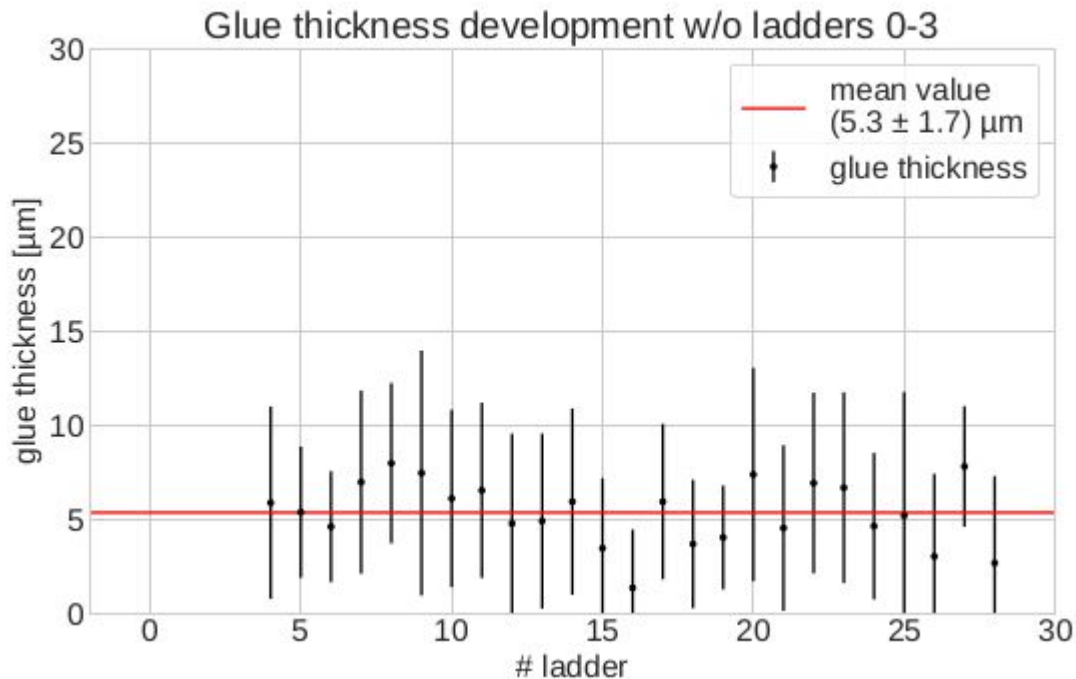
Gluing:

average glue thickness of
~5 μm by hand achieved

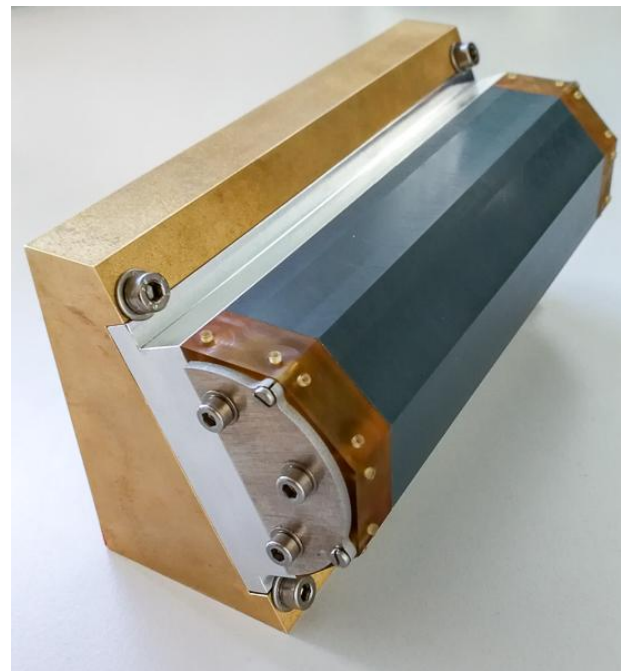
Module assembly:

- Tooling worked fine
- Have to be produced for final length
- Production foreseen until summer 2022

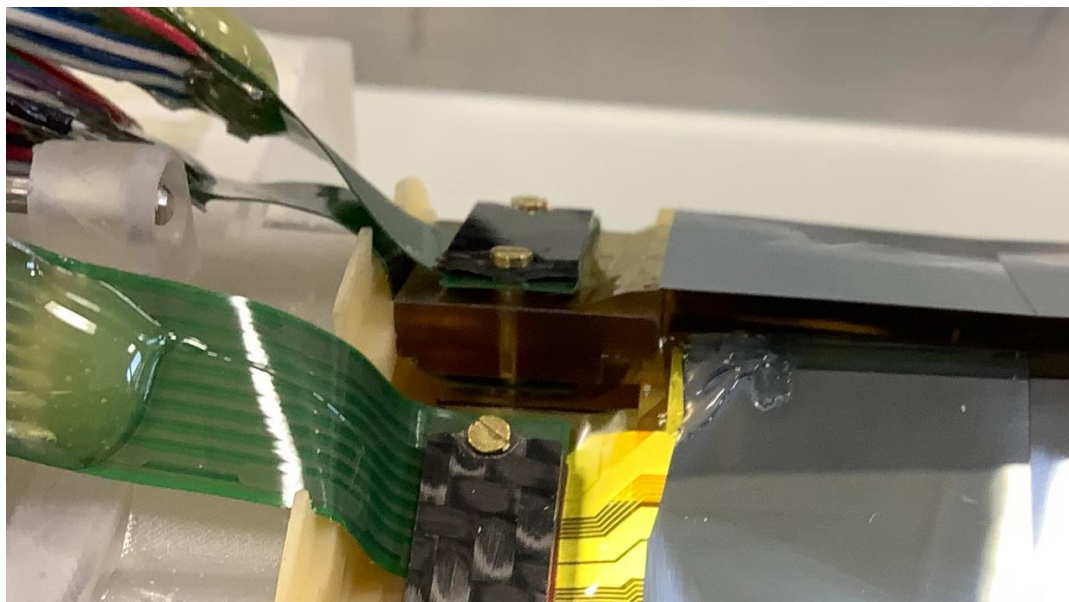
- Barrel assembly
- Clearance between chips and end pieces while mounting (when not spring loaded)

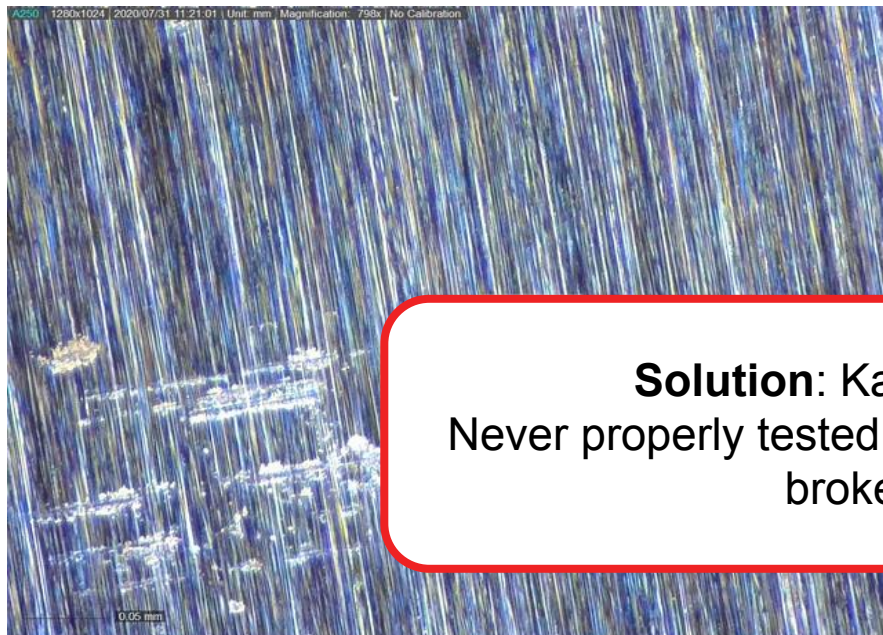
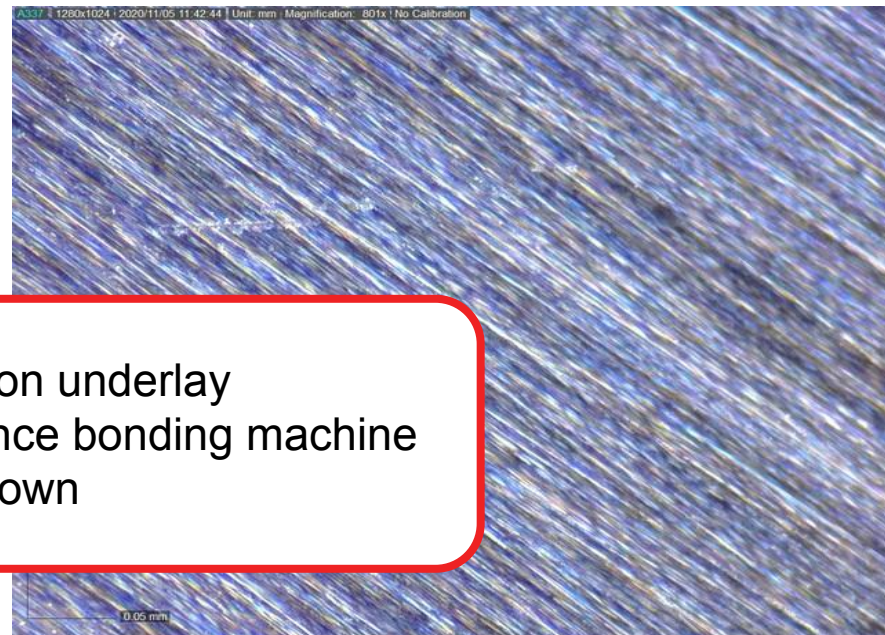
Backside scratches for chips on aluminum chuck

Solution: Kapton underlay
Never properly tested since bonding machine
broke down

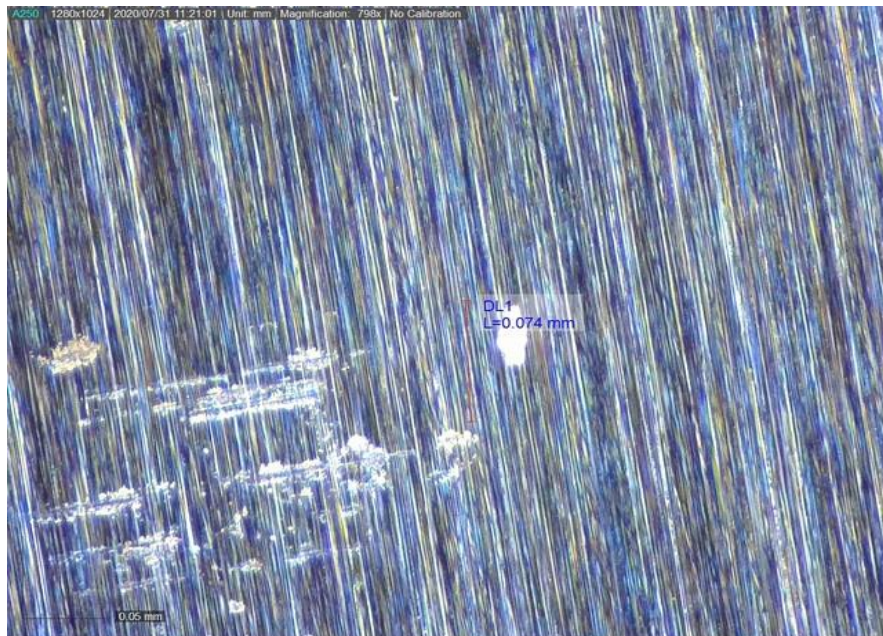
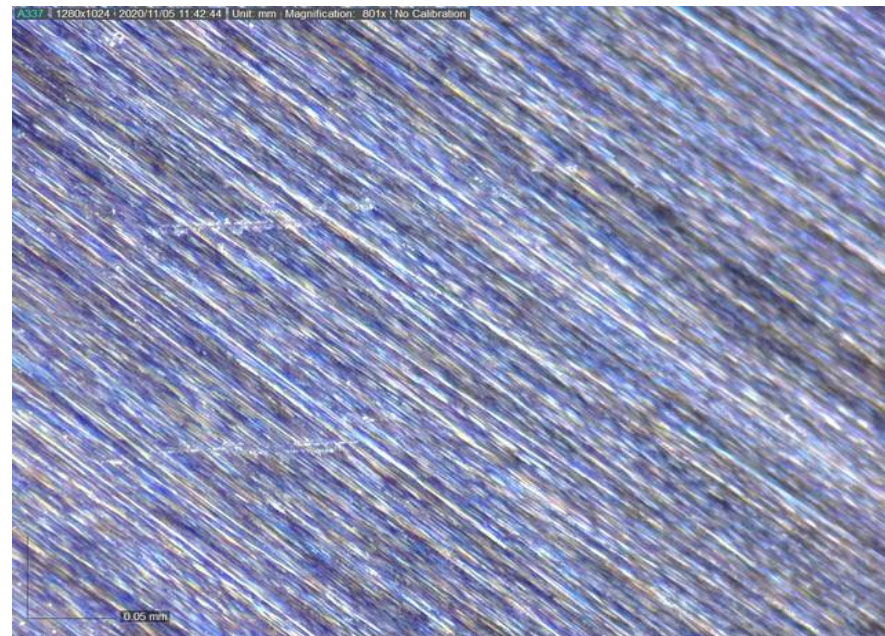
Backside scratches for chips on aluminum chuck

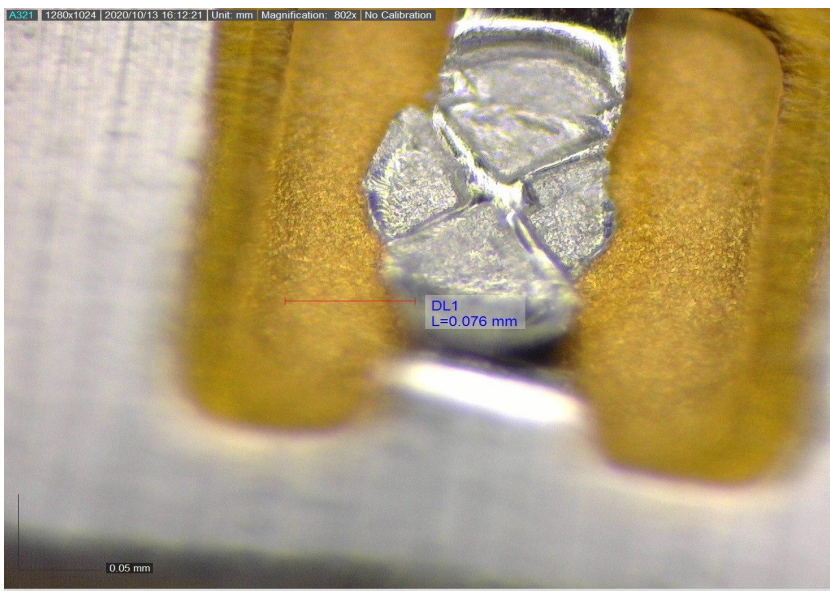
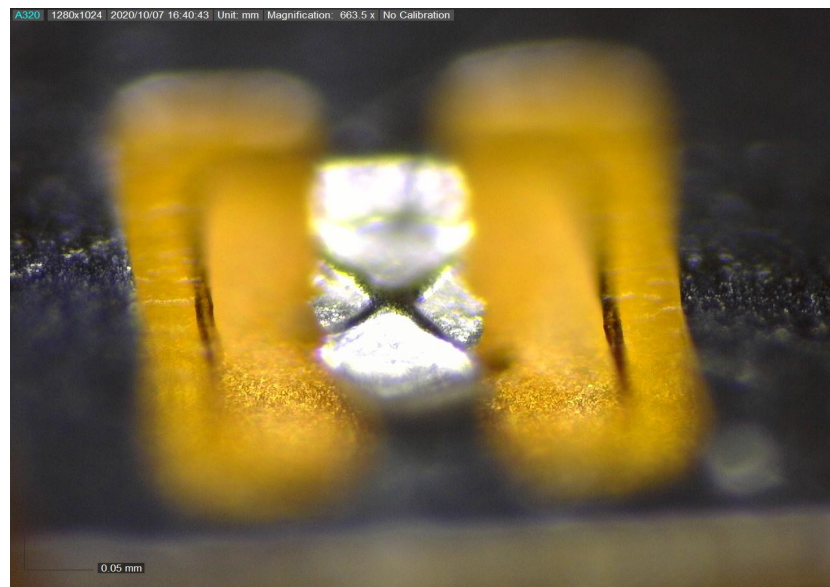
Loose bonds after time for improper settings

Solution: Extensive parameter tests with test structures, too little time was spent on this during mock-up production

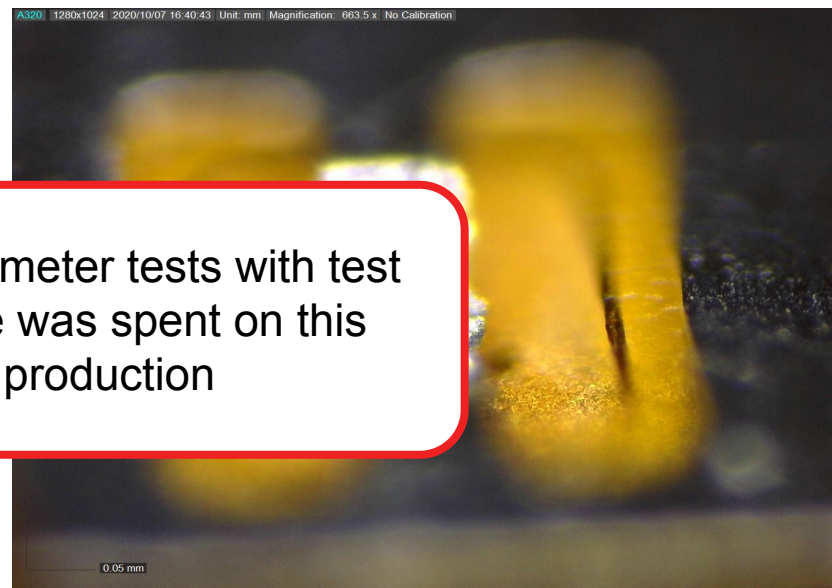
Loose bonds after time for improper settings
