# WireChar Multiphysical characterization of $\text{Nb}_3\text{Sn}$ wires and REBCO coated conductors

**Carmine SENATORE, Marco BONURA, Tommaso BAGNI, Francesco LONARDO**

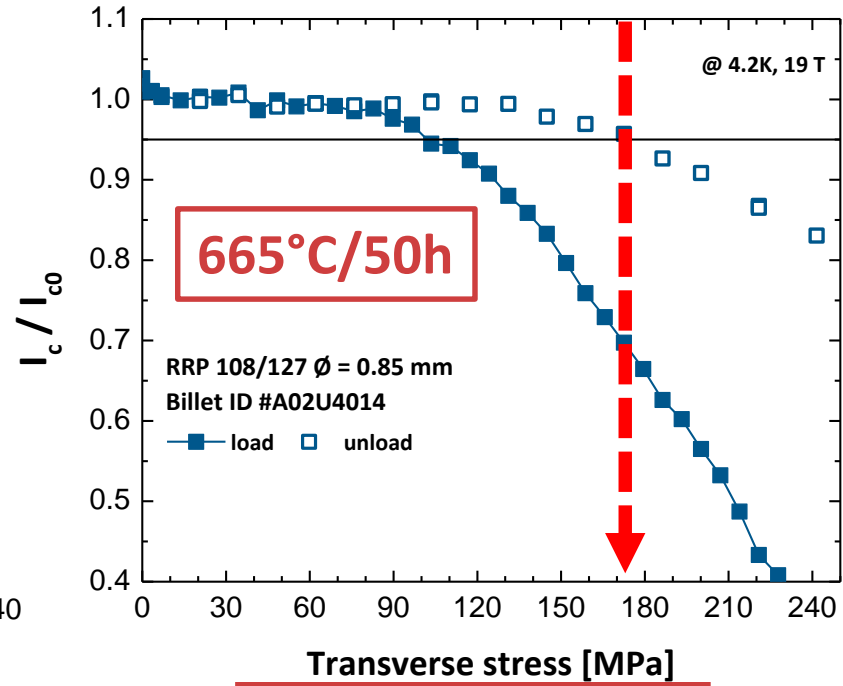
RRP,  $\varnothing = 0.85$  mm

Tested in a 1.15 mm groove

$\sigma_{irr} \approx 175$  MPa

- RRP wires are definitely more robust than PIT wires
- A reduction of  $\sigma_{irr}$  is measured for the RRP wire reacted at lower temperature (650°C)

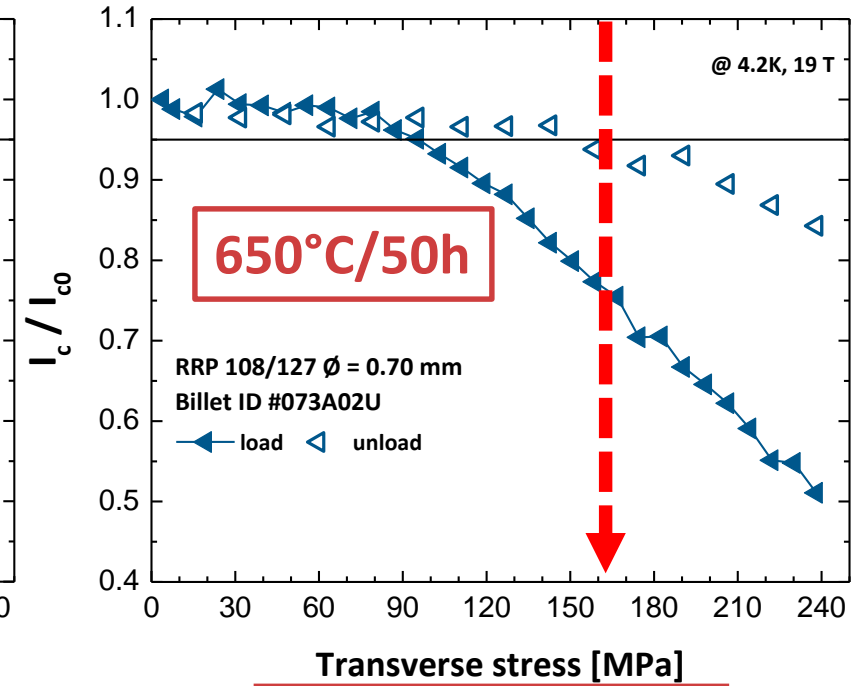
RRP,  $\varnothing = 0.7$  mm

Tested in a 1 mm groove

$\sigma_{irr} \approx 155$  MPa

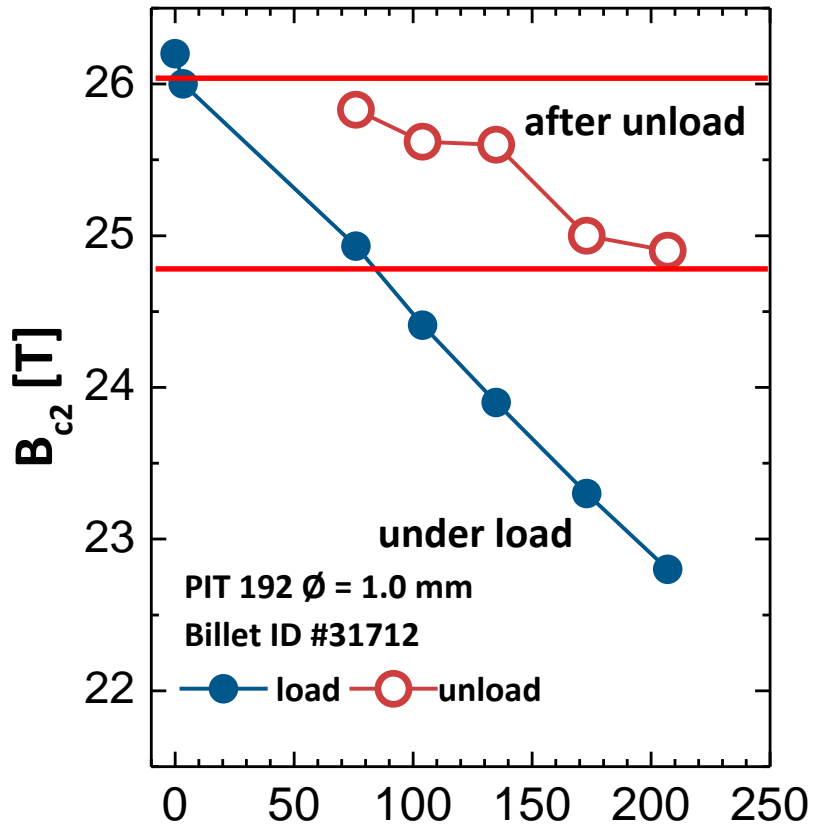
PIT,  $\phi = 1.0$  mm

After unload from  $\sigma = 210$  MPa

$$\Delta B_{c2}^{\text{unload}} \approx 1 \text{ T}$$

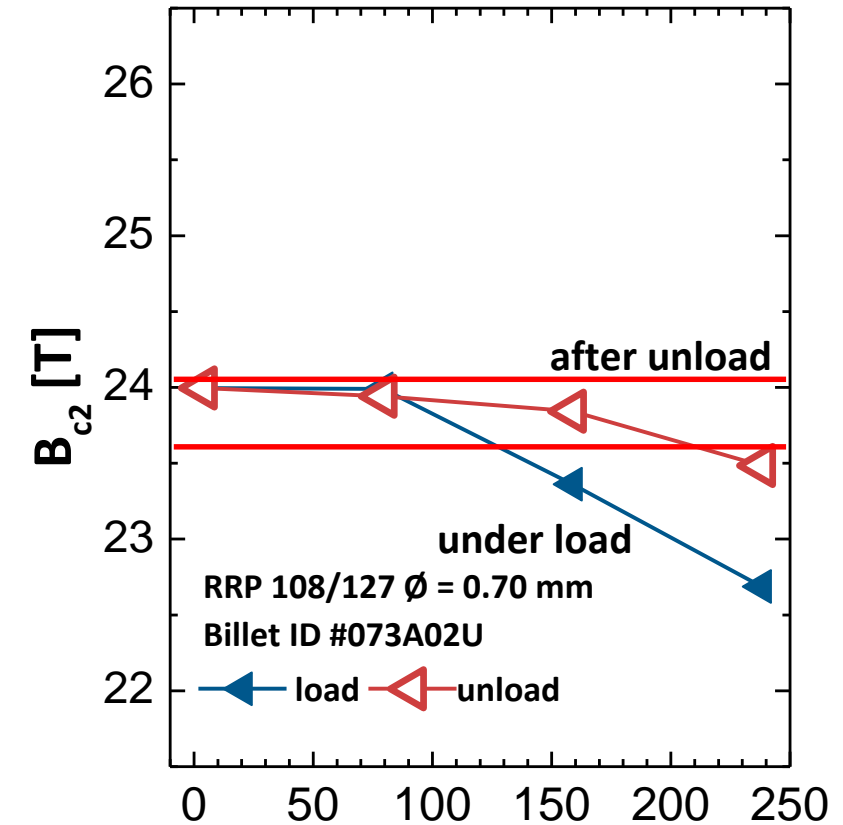
RRP,  $\phi = 0.7$  mm

After unload from  $\sigma = 240$  MPa

$$\Delta B_{c2}^{\text{unload}} \approx 0.5 \text{ T}$$

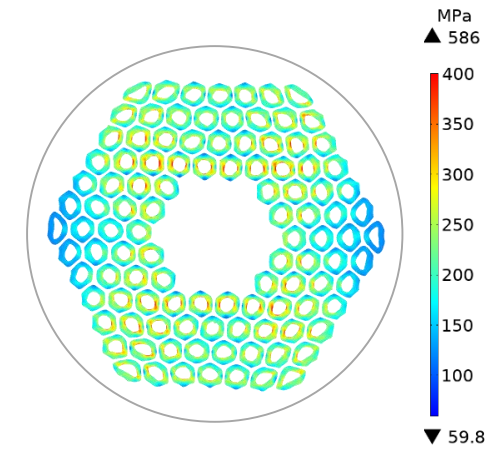
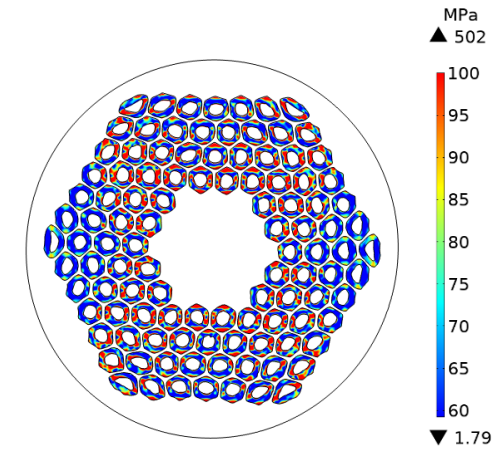
von Mises stress in  $\text{Nb}_3\text{Sn}$   
under load at 30 kN

Plastic strain in Cu after  
unload from 30 kN

von Mises stress in  $\text{Nb}_3\text{Sn}$   
after unload from 30 kN  
(residual stress)

2D plain strain model to visualize the stress and strain distributions in the wire reproducing the experimental conditions of an epoxy impregnated wire under transverse load

Three domains:  $\text{Nb}_3\text{Sn}$ , Cu and bronze – no voids

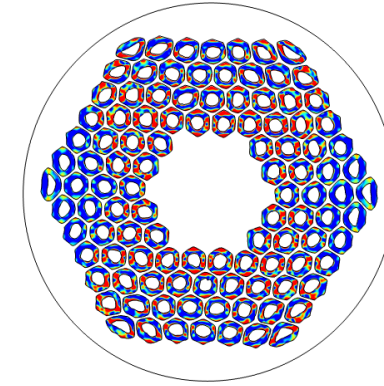
von Mises stress in  $Nb_3Sn$   
under load at 30 kN

Plastic strain in Cu after  
unload from 30 kN

von Mises stress in  $Nb_3Sn$   
after unload from 30 kN  
(residual stress)

According to the simulation, 15% rolling is associated with a reduction of the residual stresses  
This is due to a better redistribution of the load between matrix and superconductor

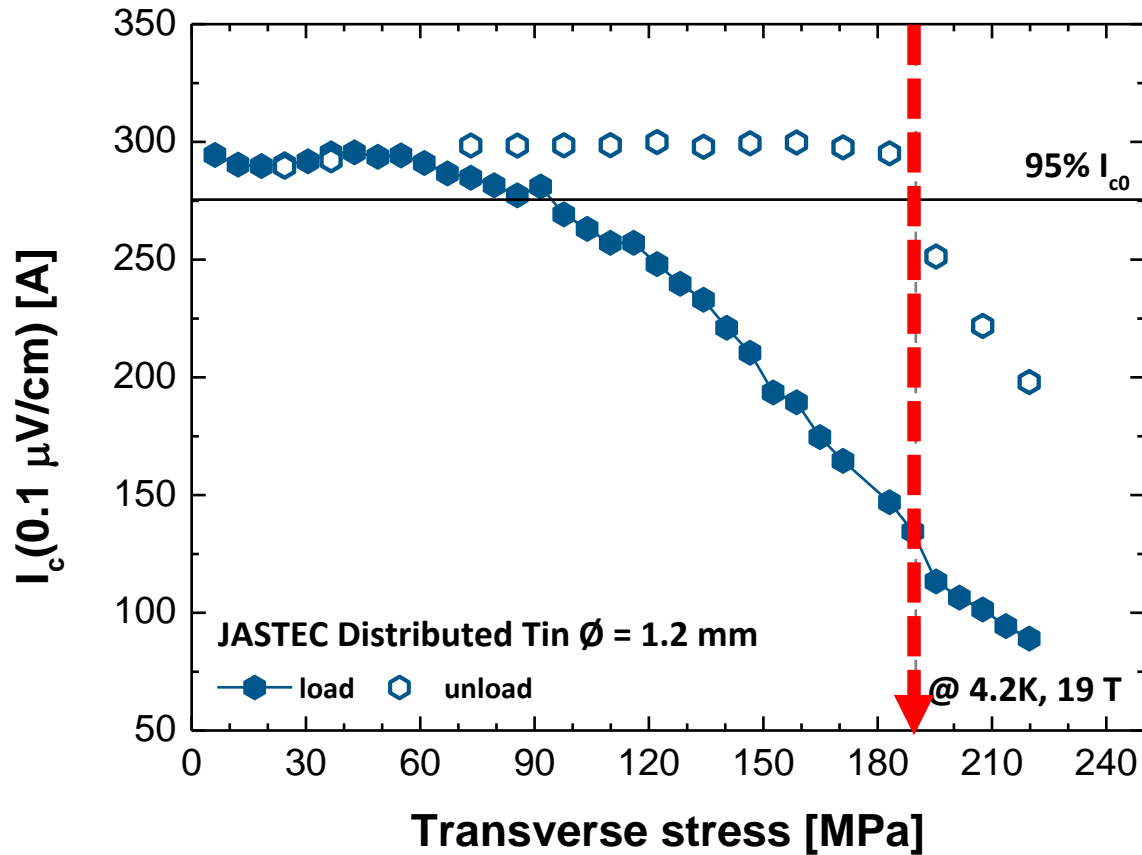
The abrupt decrease of  $I_c$  after unload at 190 MPa is a clear sign of degradation driven by the formation of cracks

The Cu/non Cu ratio is only 0.3  
This can explain the marginal role of residual stresses

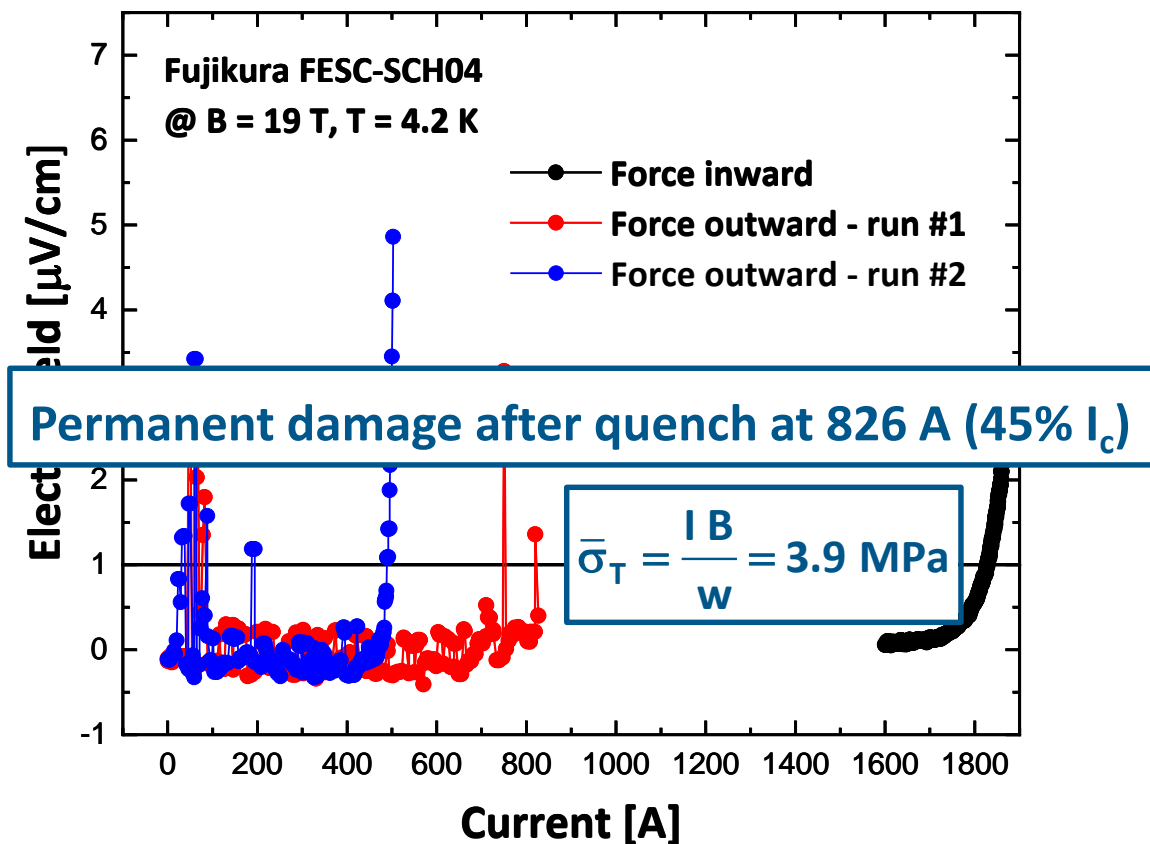
- The REBCO tape is mounted with the superconducting layer outward
- The Lorentz force is outward and tends to detach the REBCO layer from the substrate
- A transverse tensile stress in the range 1 – 10 MPa is generated

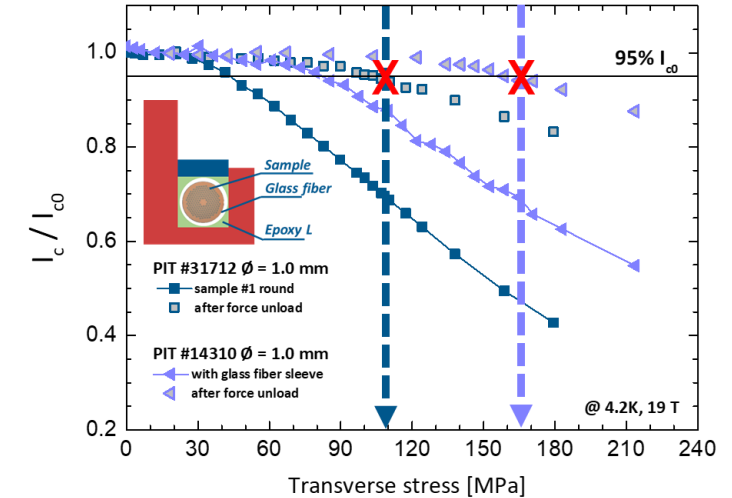
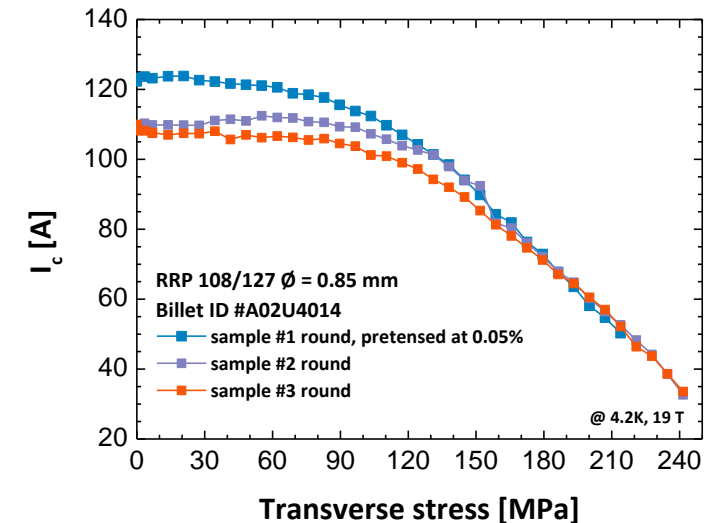
Wire in a glass fiber sleeve + Epoxy L

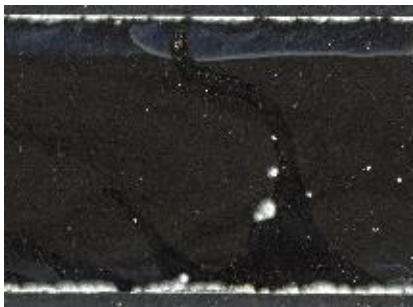
Type: FESC SCH04  
Tape ID: 19-0008

Delamination strength ~ 4 MPa  
(45%  $I_c$ )

$\bar{\sigma}_T = 3.9$  MPa     $F_L$  outward  
 $\bar{\sigma}_T = 4.1$  MPa     $F_L$  inward

Longitudinal damage on both  
edges of the CC + Blisters

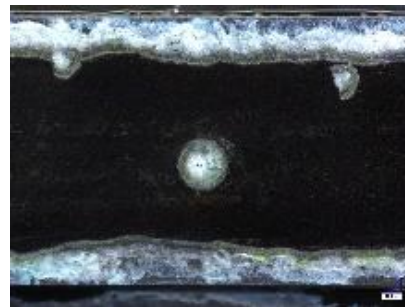
Type: FESC SCH02  
Tape ID: 23-0010

Delamination strength ~ 4.3 MPa  
(39%  $I_c$ )

$\bar{\sigma}_T = 4.3$  MPa     $F_L$  inward

Longitudinal damage on both  
edges of the CC + Blisters

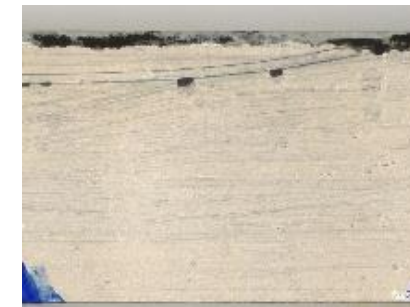
Type: SCS4050-AP  
Tape ID: M3-1464-7

Delamination strength ~ 5.5 MPa  
(82%  $I_c$ )

$\bar{\sigma}_T = 5.5$  MPa     $F_L$  inward

Longitudinal damage on 1 edge  
of the CC + Blisters
