**CMS Pixel Detector**  
**Phase-1 upgrade, status & plans**  
**Danek Kotlinski**  
**PSI 29/10/2018**

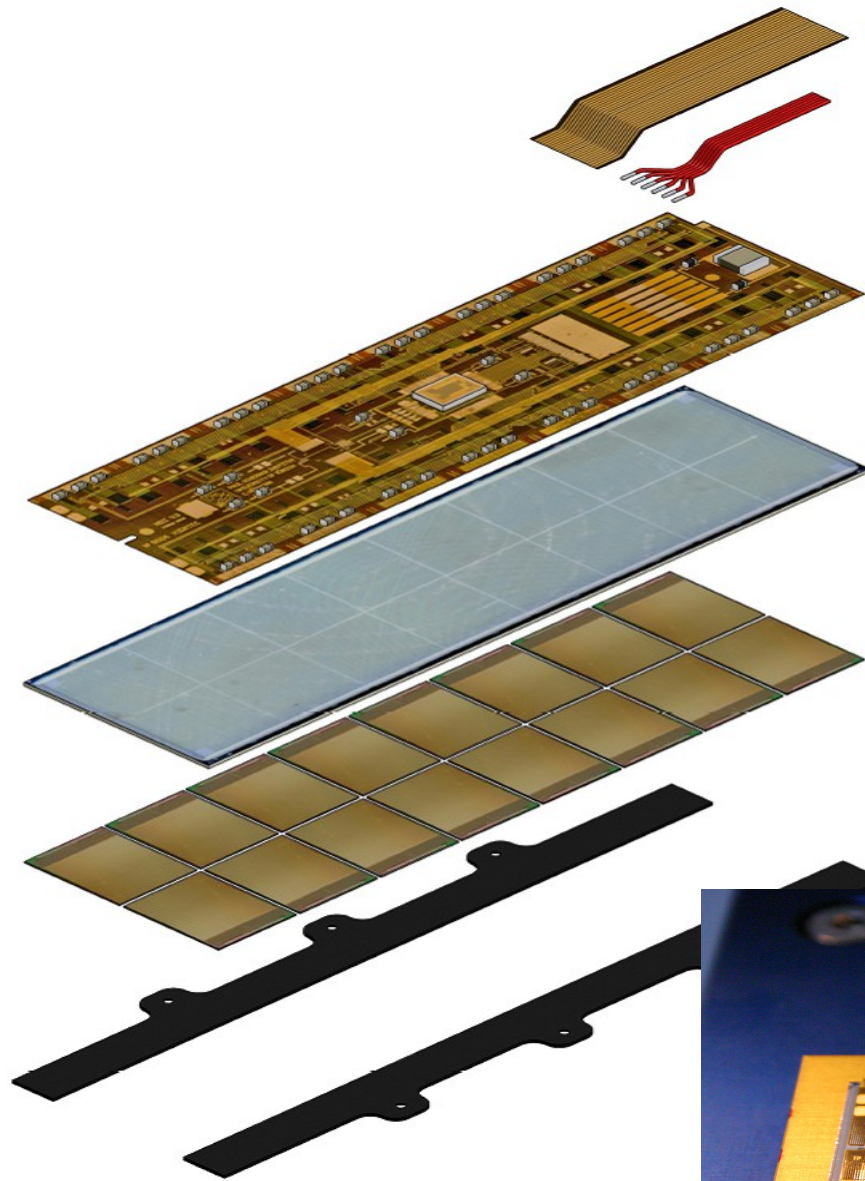
# CMS Module Design

Cables: signals & power

HDI print with the TBM chip

Si sensor (280um)

16 ROCs (180um)

Ready module (1200 produced @PSI)

Base strips: Si<sub>3</sub>N<sub>4</sub>

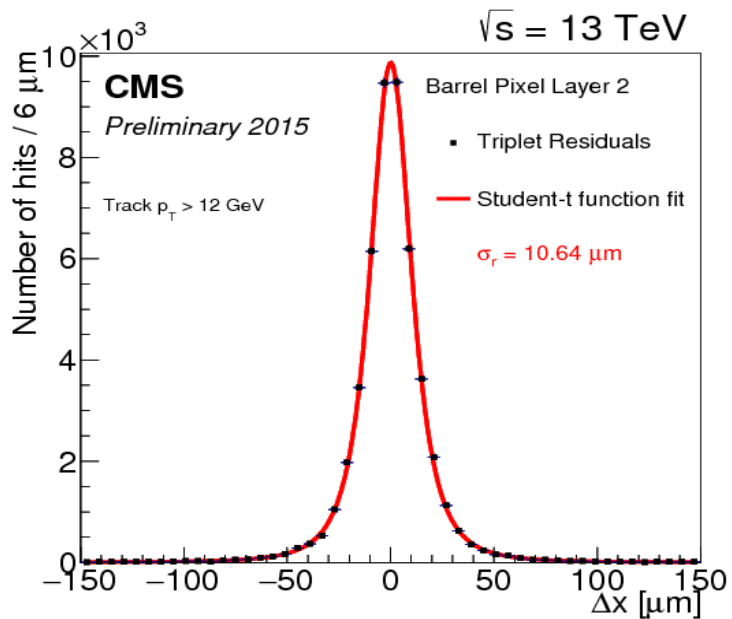
Pixel barrel position resolution measured with 2015 collisions.

Transverse ( $r\phi$ ) direction

Position resolution – 10.6  $\mu\text{m}$

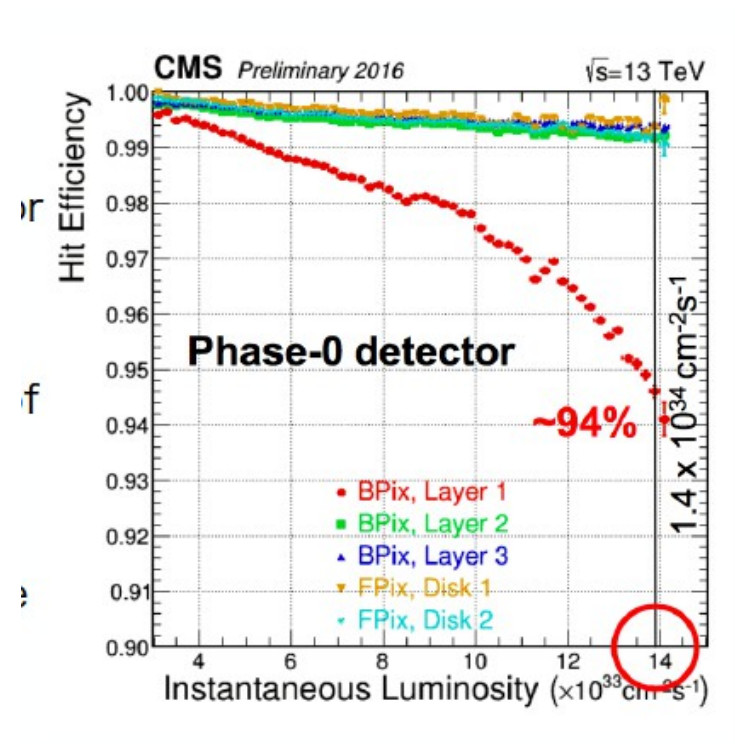
Hit efficiency versus luminosity

Loss of efficiency beyond  $10^{34}$

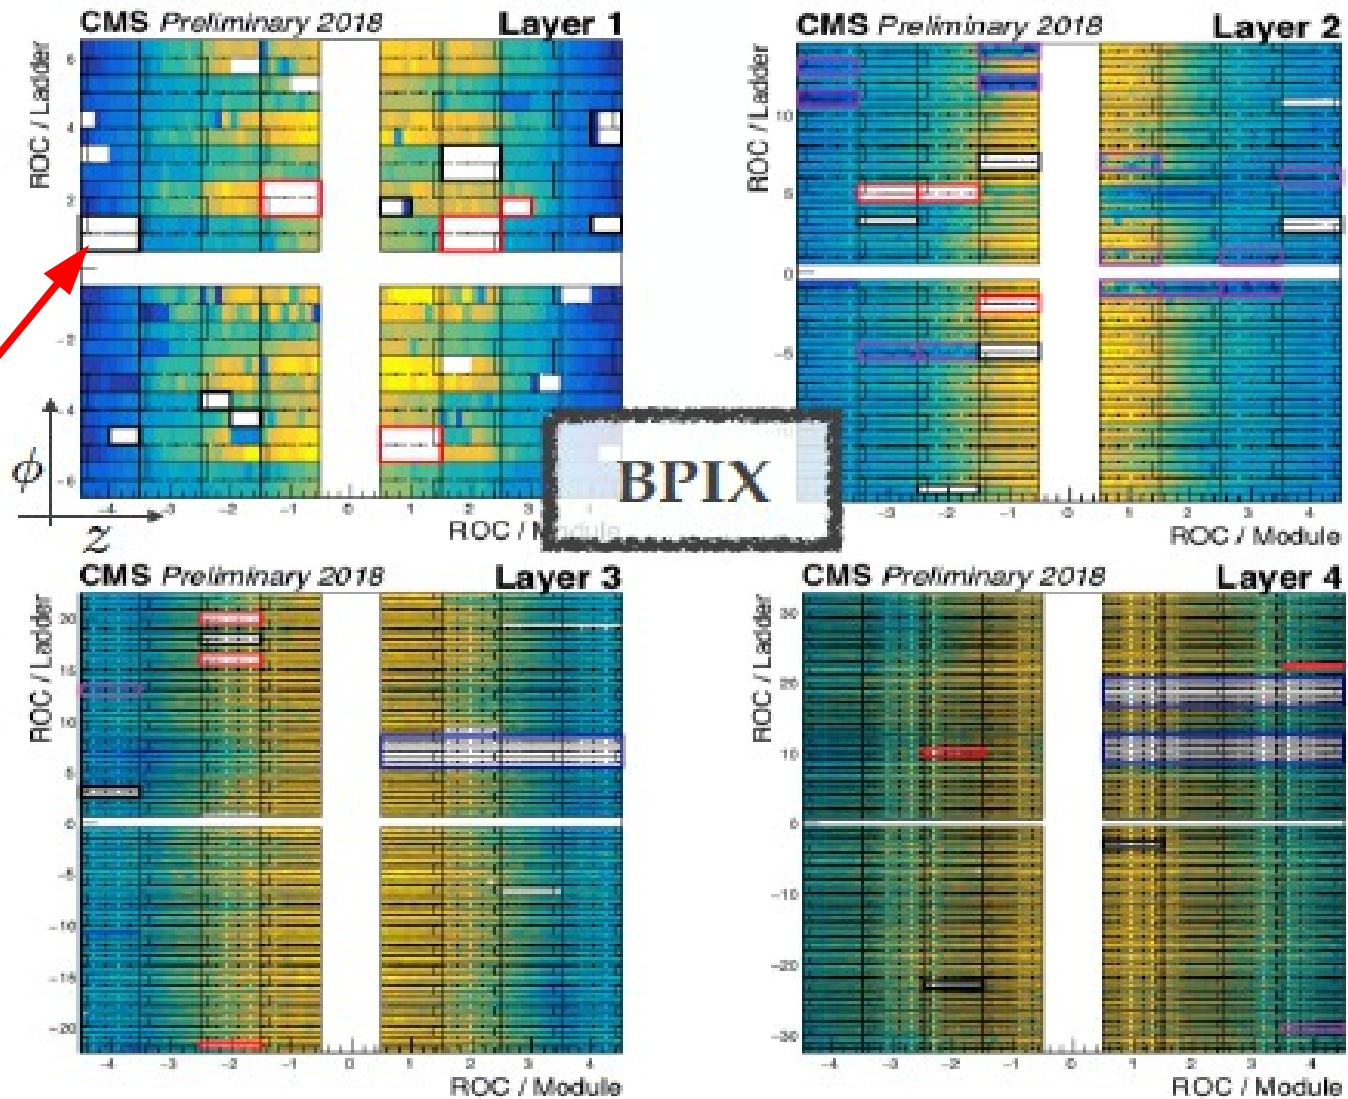
# BPix efficiency map

Unexpected  
new holes.  
New bad  
modules!

The modules stayed bad even after repeated resets and reprogramming. However they recovered a few days later.

Eventually it was determined that a power cycle revives stuck modules. From the granularity of the failures it was concluded that the problem is in the TBM chip (Rutgers/USA).

A logic mistakes allows for a possible locking of a circuit in the TBM.

A reset does not clear the locking condition.

SEUs can cause the locking & the relevant FlipFlop was not SEU protected -> large rate.

**Only a power cycle helps!**

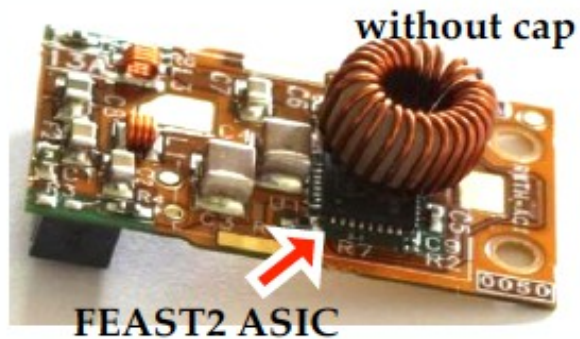
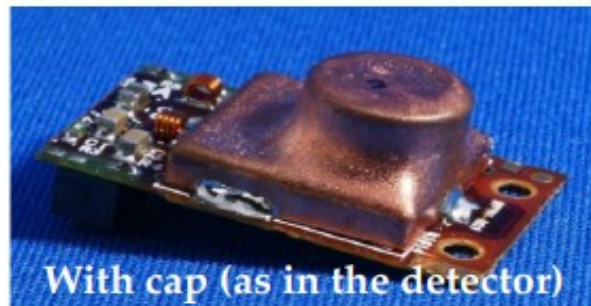
## Converter circuit for Pixel

- ▶ Developed by CERN
- ▶ Safe for operation in magnetic field (4T)
- ▶ Radiation hardness
  - 500 Mrad (Si)
  - $5 \times 10^{14}$  n/cm<sup>2</sup> (1MeV eq)
- ▶ enable/disable control
- ▶ Next version of FEAST ASIC is the baseline for the powering system of ATLAS and CMS pixel and strip tracker for High Luminosity LHC.
  - This upgrade project was the first large-scale application of the chip.

Most transistors in the FEAST chip are radiation tolerant by using the so called Enclosed-Layout-Transistors (ELT). Apparently high voltage transistors cannot be designed in this way. For the 10V power transistors FEAST uses nLDMOS design which is sensitive to radiation.

These transistors can be protected by adding an ELT transistor to cut the radiation induced leakage current. **For one 10V transistor this protection was forgotten making it fail after about 0.5Mrad.**

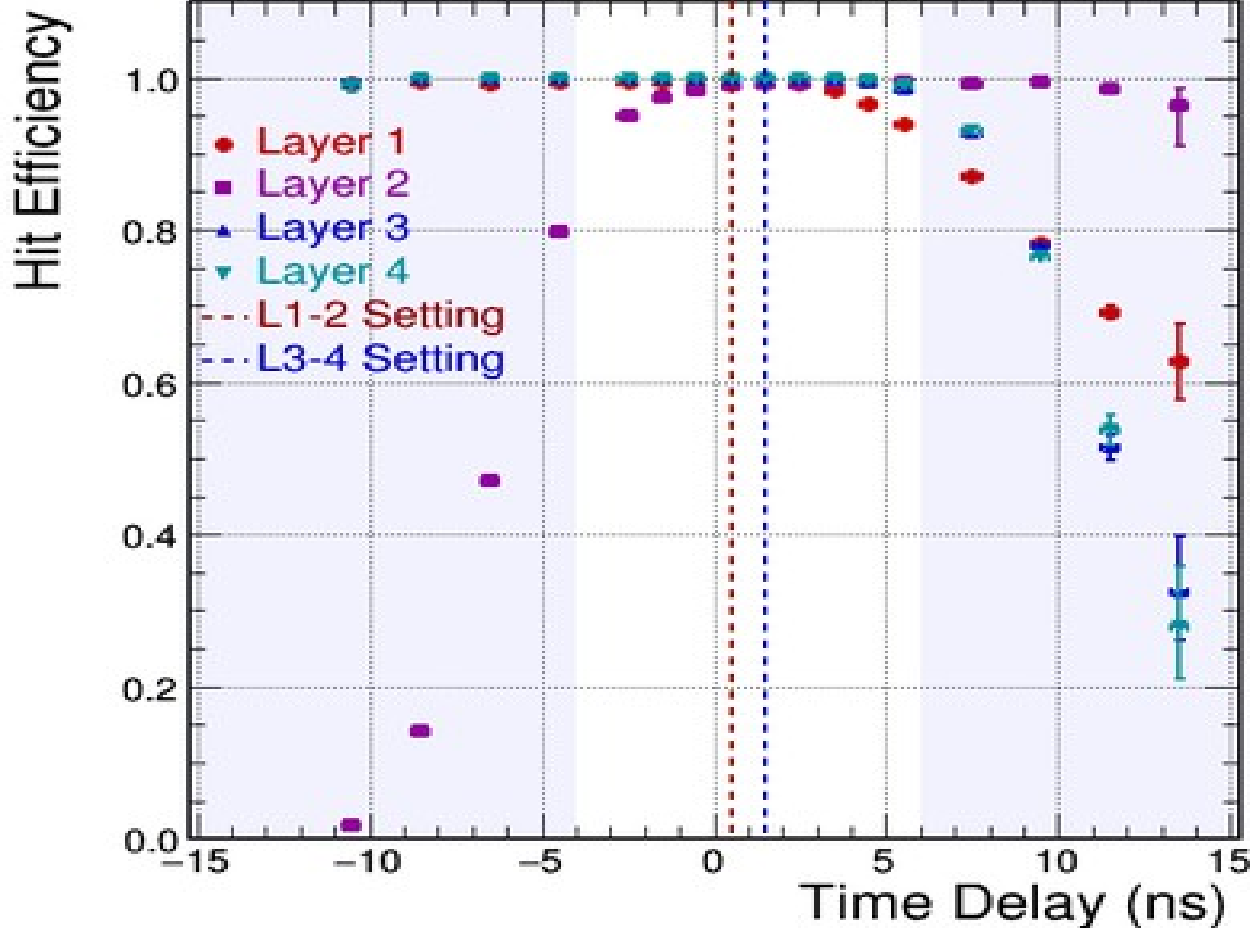
## Timing Problem

Layer 1 ROC shifted by  $\sim 12$  ns with respect to layer 2-4 ROC.

The shift comes from the PROC being faster.

Cannot be compensated because Layers 1 & 2 are on the same clock line.

Manged to find a common working point nevertheless there are some negative consequences.

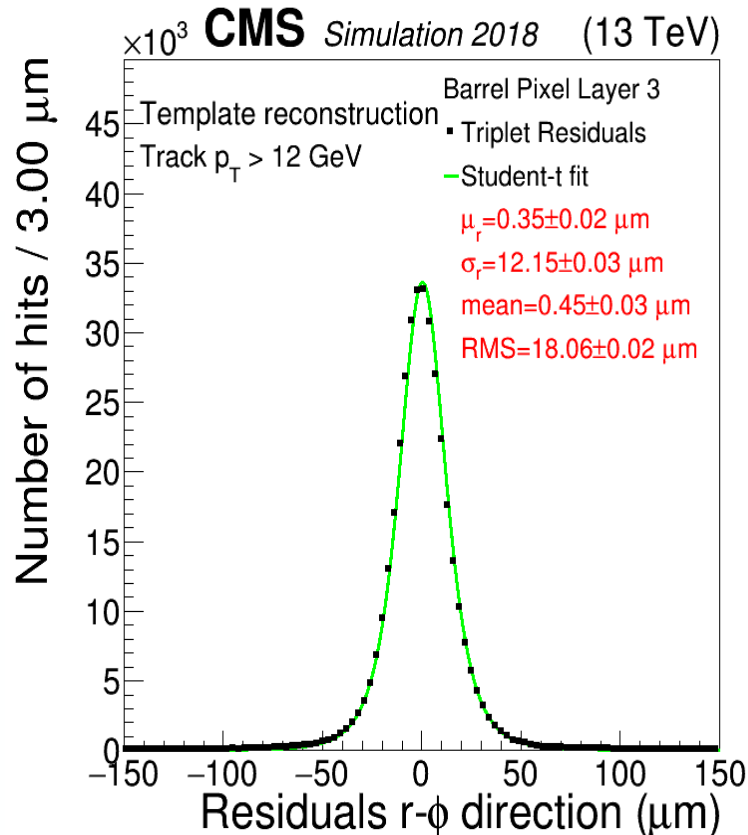
The Resolution is  $< 12 \mu\text{m}$

like in phase-0

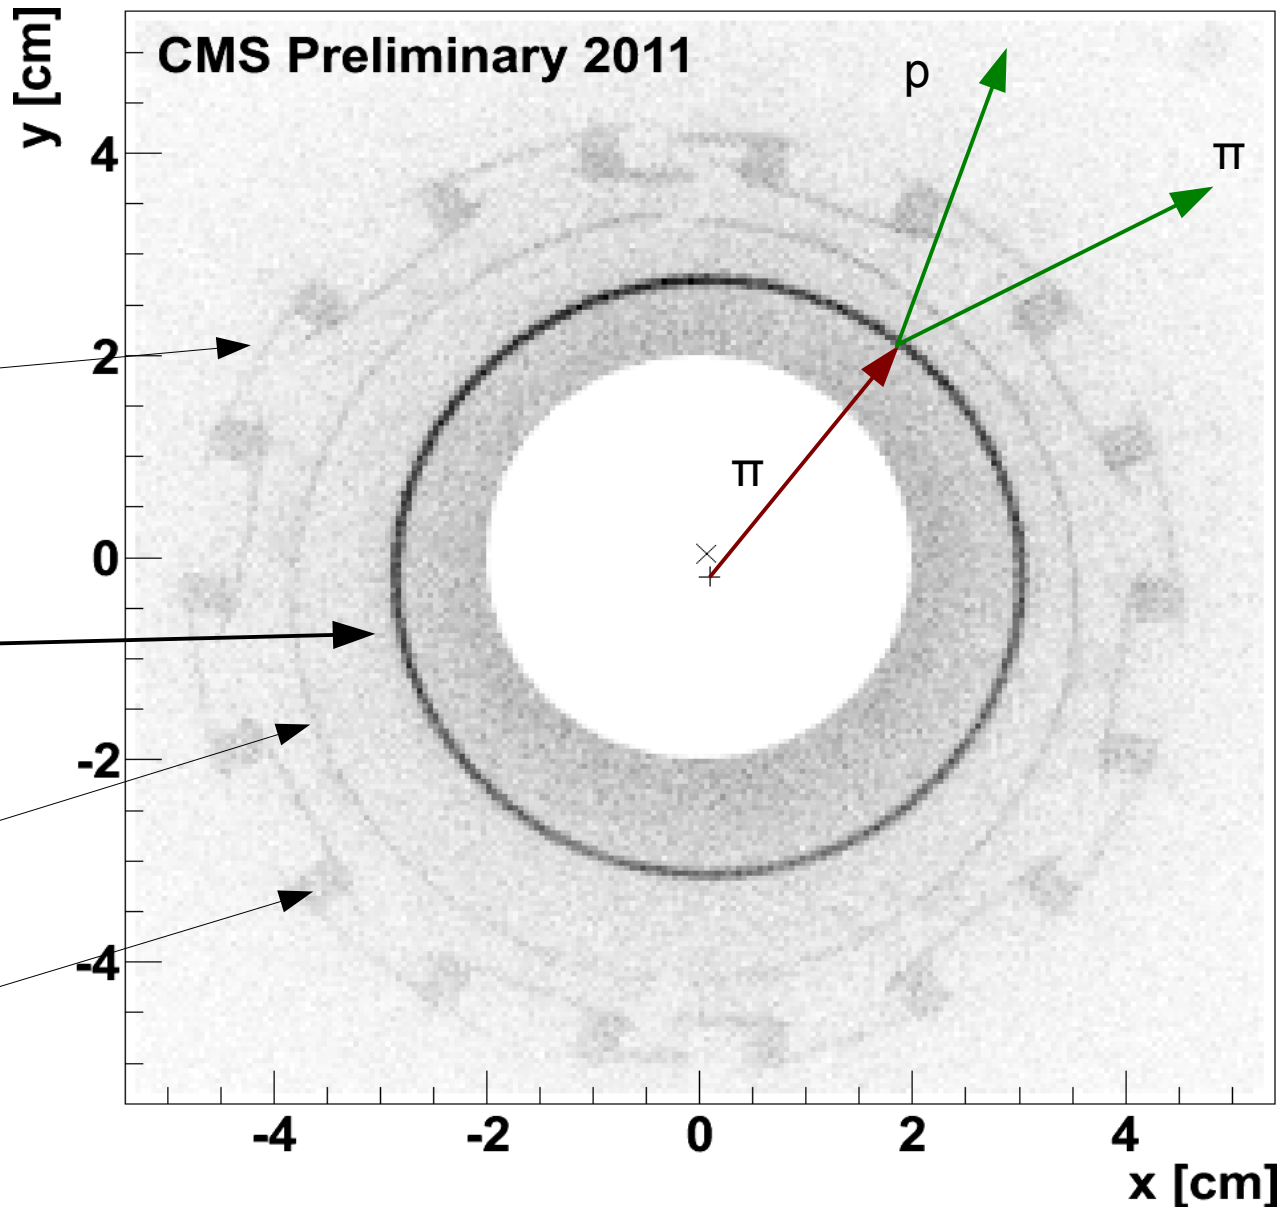
Material close to the proton beam measured through secondary interactions (vertexes of nuclear/hadronic interactions).

Pixel module

Beam pipe

Kapton-Al shield

Cooling pipe

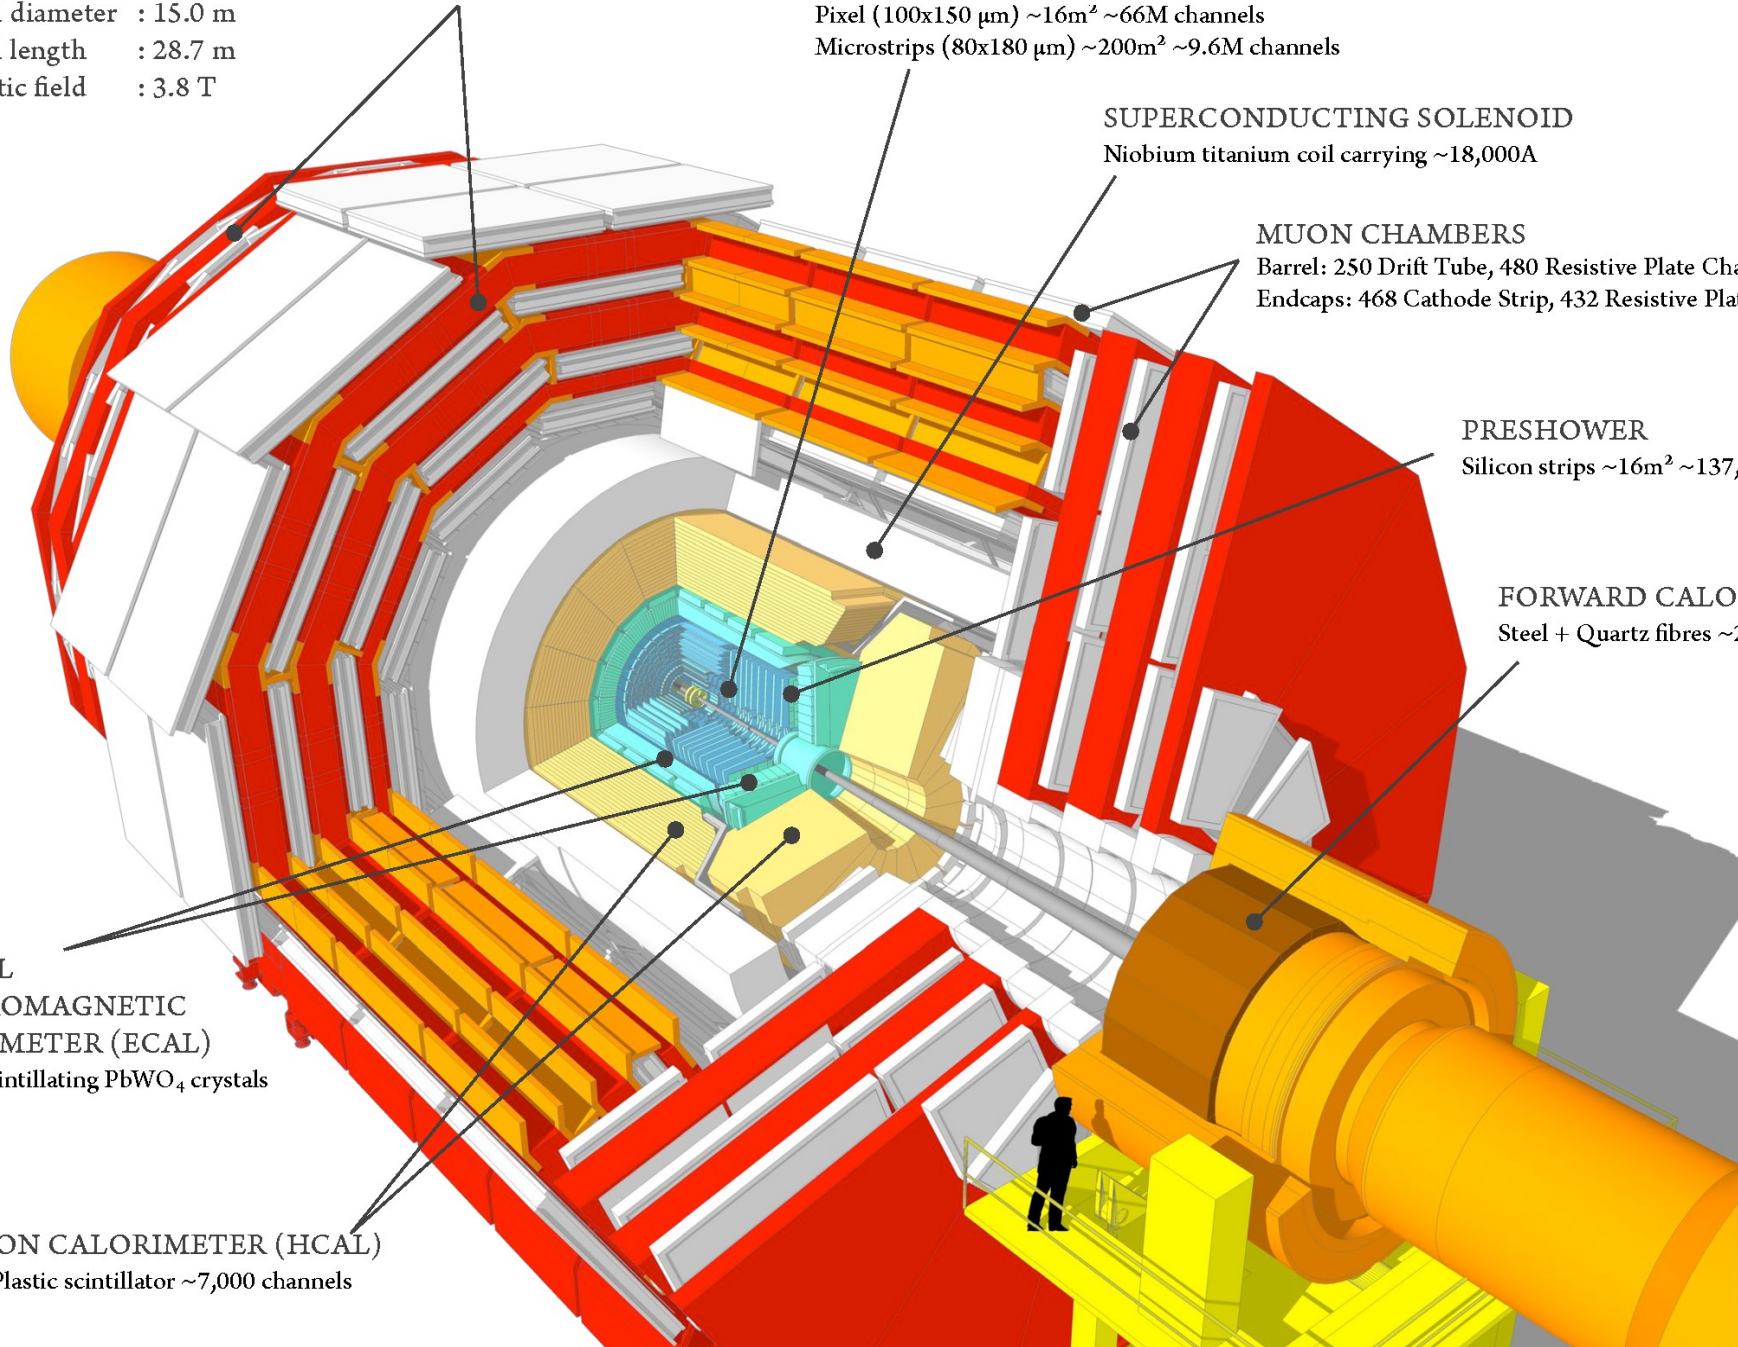
# CMS DETECTOR

Total weight : 14,000 tonnes  
Overall diameter : 15.0 m  
Overall length : 28.7 m  
Magnetic field : 3.8 T

STEEL RETURN YOKE  
12,500 tonnes

SILICON TRACKERS  
Pixel ( $100 \times 150 \mu\text{m}$ )  $\sim 16\text{m}^2 \sim 66\text{M}$  channels  
Microstrips ( $80 \times 180 \mu\text{m}$ )  $\sim 200\text{m}^2 \sim 9.6\text{M}$  channels

SUPERCONDUCTING SOLENOID  
Niobium titanium coil carrying  $\sim 18,000\text{A}$

MUON CHAMBERS  
Barrel: 250 Drift Tube, 480 Resistive Plate Chambers  
Endcaps: 468 Cathode Strip, 432 Resistive Plate Chambers

PRESHOWER  
Silicon strips  $\sim 16\text{m}^2 \sim 137,000$  channels

FORWARD CALORIMETER  
Steel + Quartz fibres  $\sim 2,000$  Channels

CRYSTAL  
ELECTROMAGNETIC  
CALORIMETER (ECAL)  
 $\sim 76,000$  scintillating  $\text{PbWO}_4$  crystals

HADRON CALORIMETER (HCAL)  
Brass + Plastic scintillator  $\sim 7,000$  channels
