POWGEN T0 Baseplate Upgrade A Lesson In Configuration Management

September 19, 2018

DENIM VII 2018

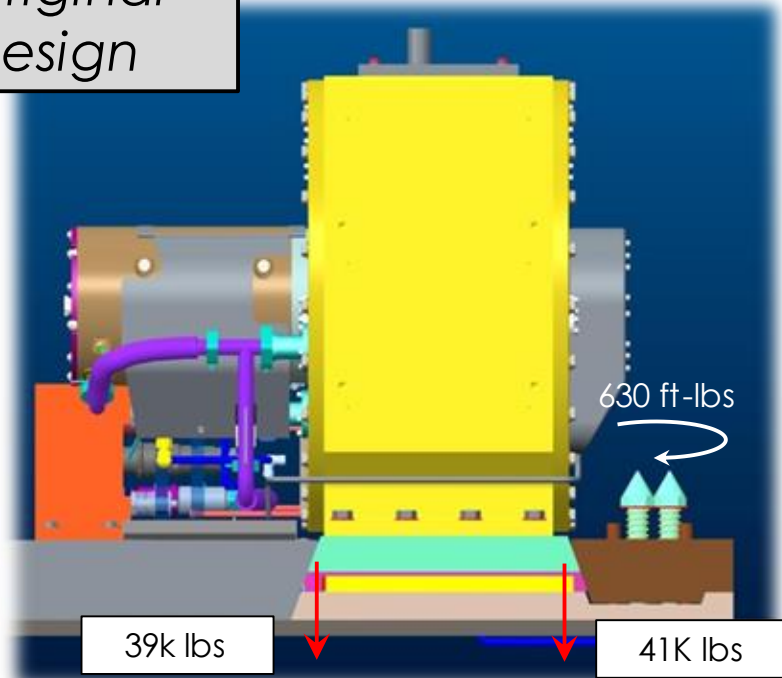
Original Design

Maximum torque wedge clamp screws
~630 ft-lbs

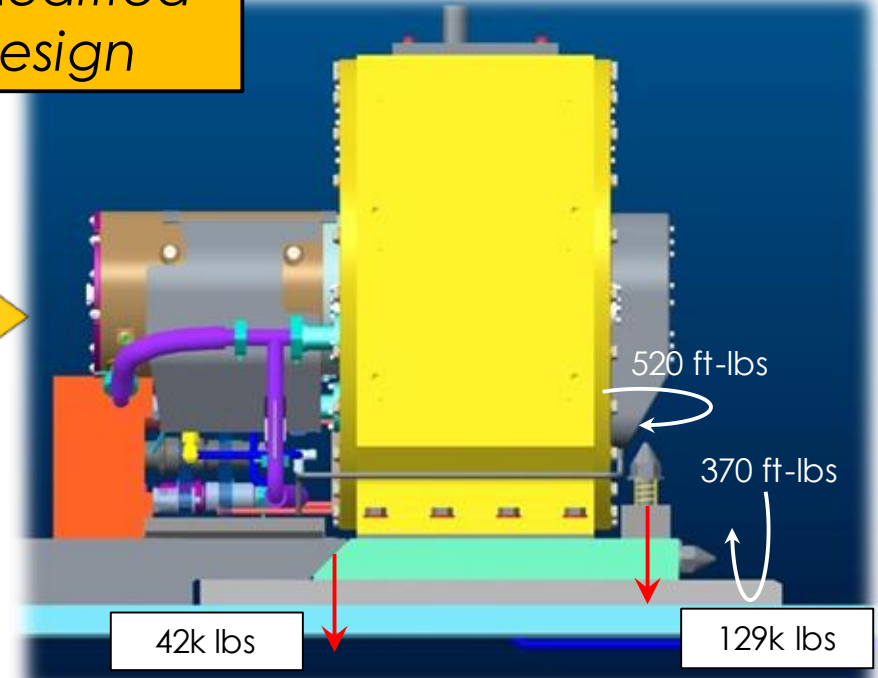
Modified Design

Maximum torque upstream clamp screws
~370 ft-lbs

Maximum torque downstream clamp screws
~520 ft-lbs

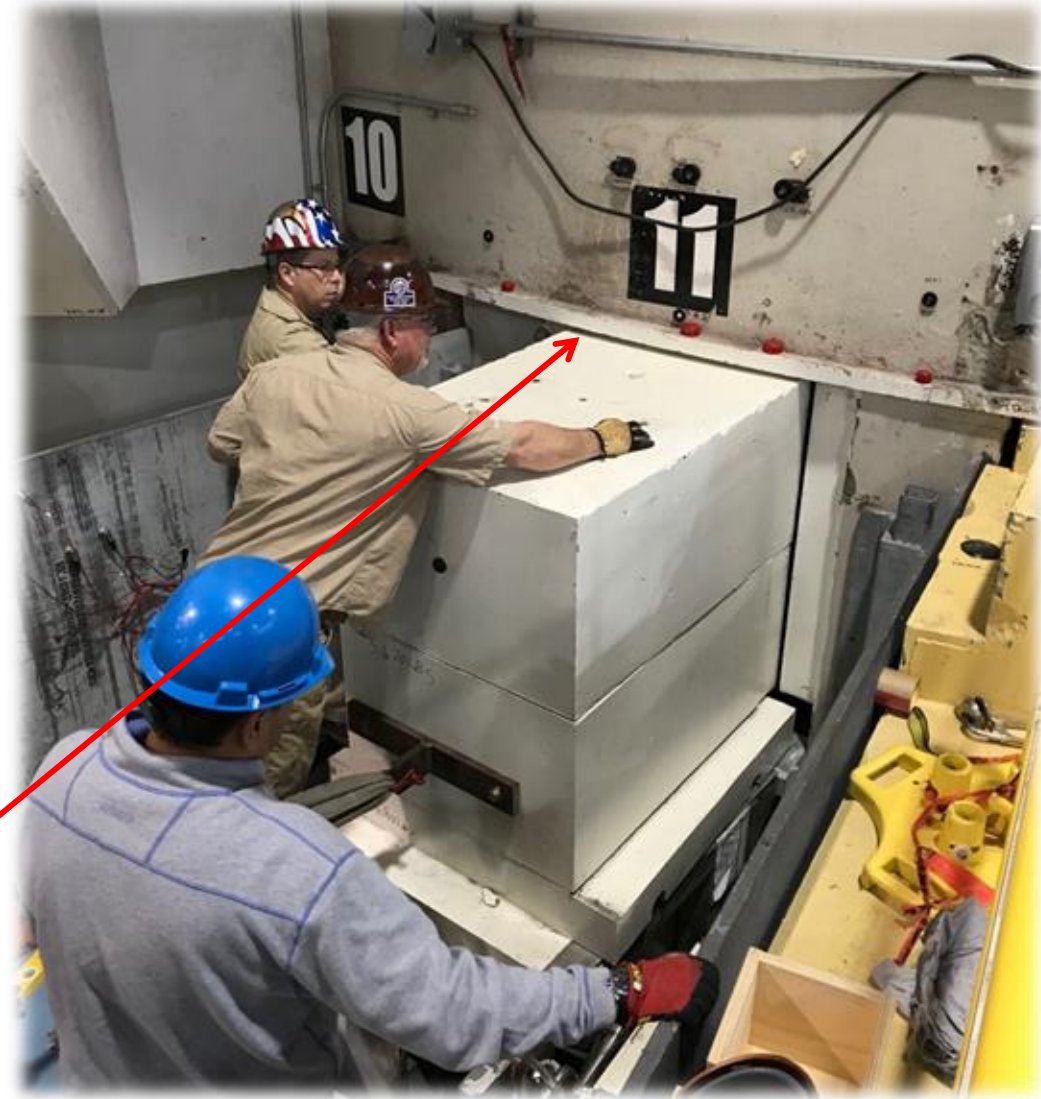
When the downstream ends of the three stacked blocks are pulled all of the way against the installation fixture ...

the upstream end is still under the lintel...

there is no way to get them out!

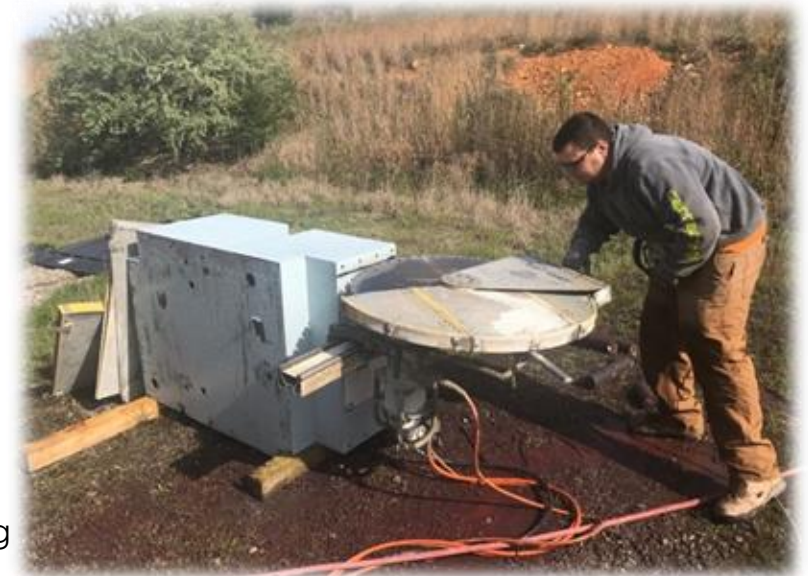
Concrete cutting

- George investigates, and finds photographs taken during the original installation of these blocks
- The blocks were designed to be stacked upon the installation fixture, and then be pushed into place on cam rollers
- But the stack of blocks was larger than the hole
- So they started cutting the block

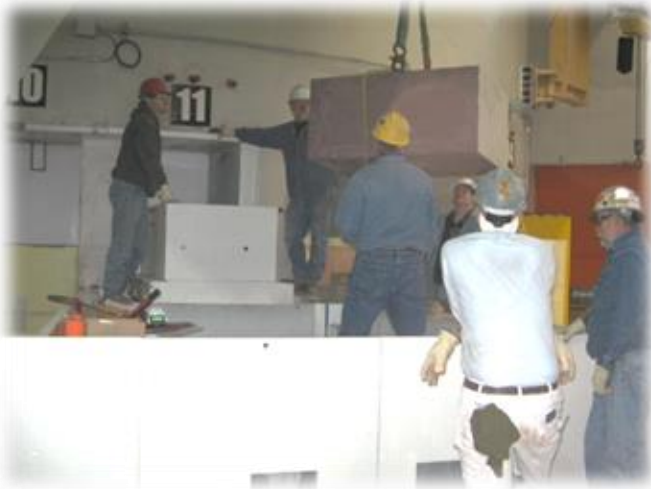
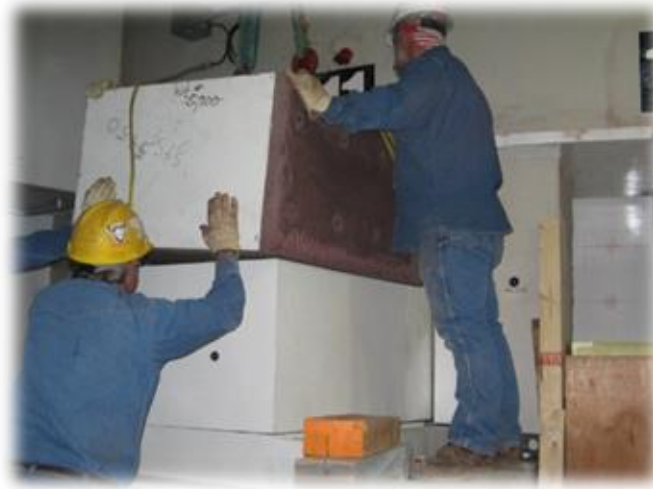
Riggers test lift the top block. The exposed High Density Concrete can be seen on the sides and bottom of the top block

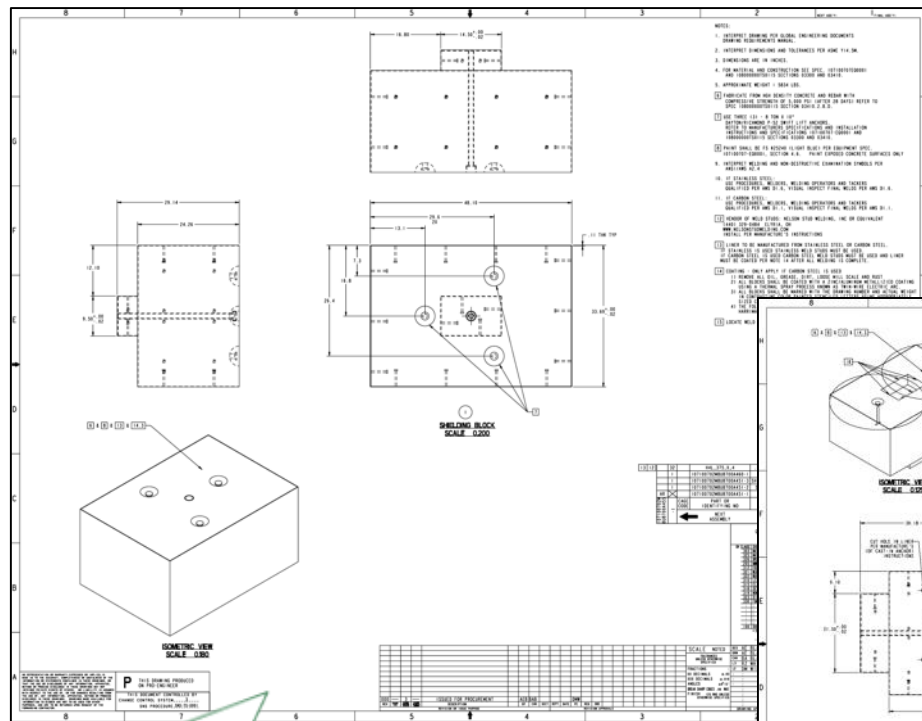
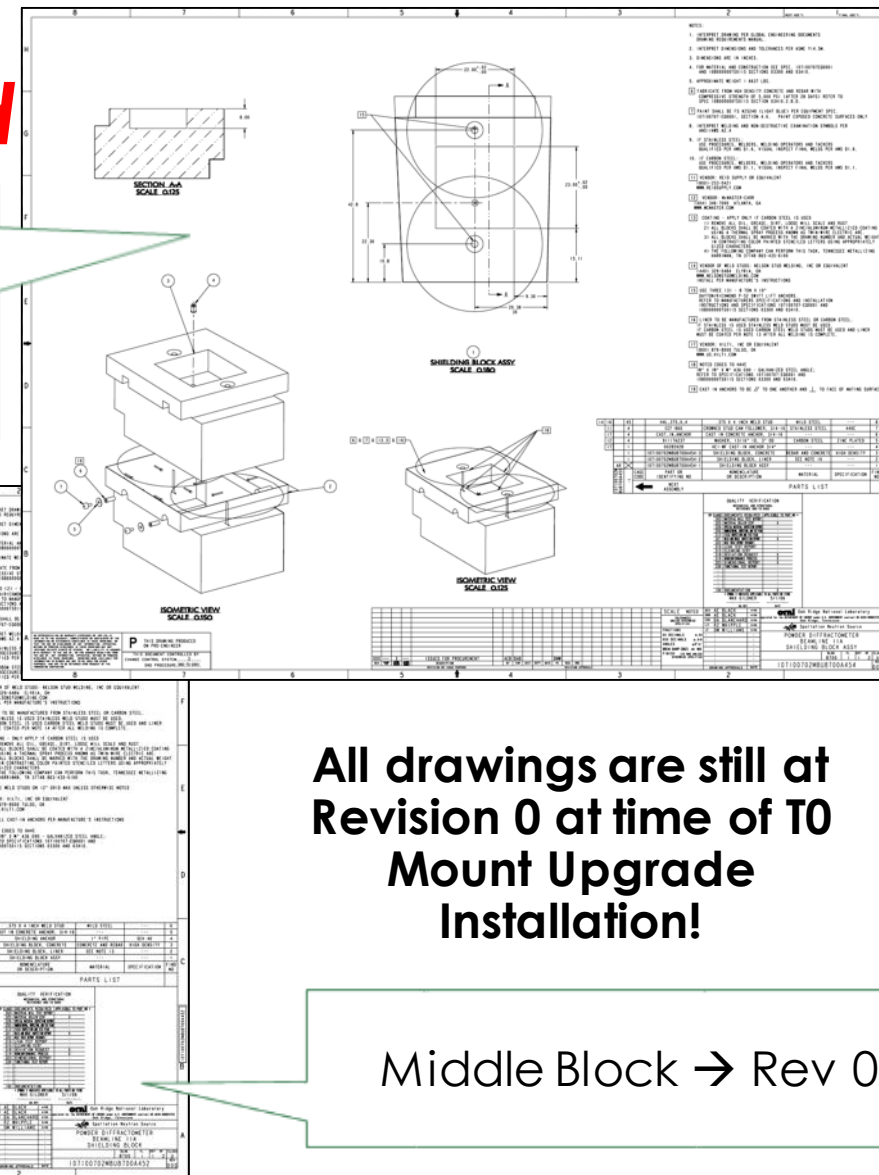
But the drawings are never updated

Top Block → Rev 00

Bottom Block →
Rev 00

**All drawings are still at
Revision 0 at time of T0
Mount Upgrade
Installation!**

Middle Block → Rev 00

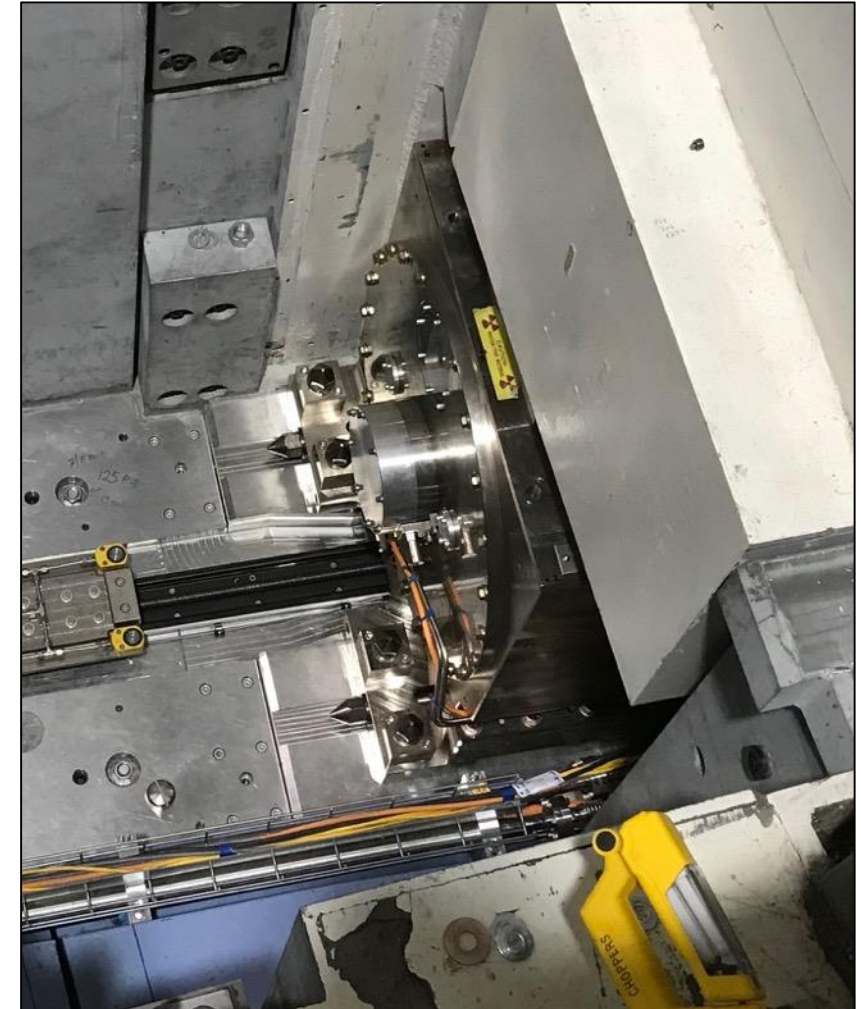
- Full Speed Testing Of POWGEN T0 Chopper mounted to new baseplate design results in **0.7 mm/s** vibration
- We started at 10 mm/s and got to 5 mm/s with temp fix

POWGEN T0 Chopper Installed on new mounting plates
