LCLS-II RF System Checkout Lessons Learned

Andrew Benwell, Jing Chen, Jorge Diaz-Cruz, Sonya Hoobler, Rick Kelly, Andre McCollough, Mark Petree, Alex Ratti, SLAC, Menlo Park, CA 94025, USA
 Brian Chase, Josh Einstein, Ed Cullerton, Fermi, Batavia, IL, 60510 | Ramakrishna Bachimanchi, Curt Hovater, JLAB, Newport News, VA 23696, USA
 Larry Doolittle, Gang Huang, Shree Murthy, Carlos Serrano, LBNL, Berkeley, CA 94720, USA

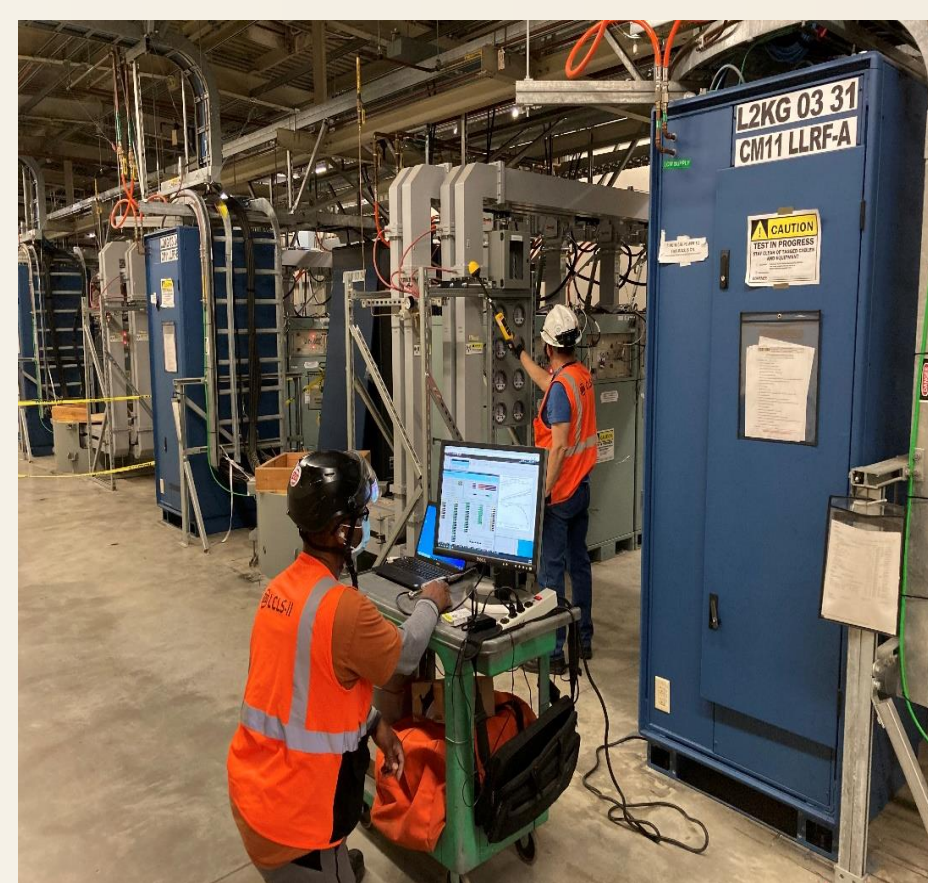
- HPRF test
- LLRF drives SSAs at 400 W to warm CM cavities
- Waveguide non-ionizing radiation (NIR) surveys
- Power measurements are made at the directional couplers
- SSAs are briefly (<200 μs) chirped to 4 kV and the SSA health is characterized

Failure type	Number found
Swapped SSA permit Cables	78 cases
Swapped RF heliax	Many (fixed immediately)
Low RF drive	28 chassis
Failed SSA electronics	18 failed interlock PCB 1 failed Control Unit 2 Failed Amplifier modules
Calibration error > 5%	>50 cases
Poor water flow	often

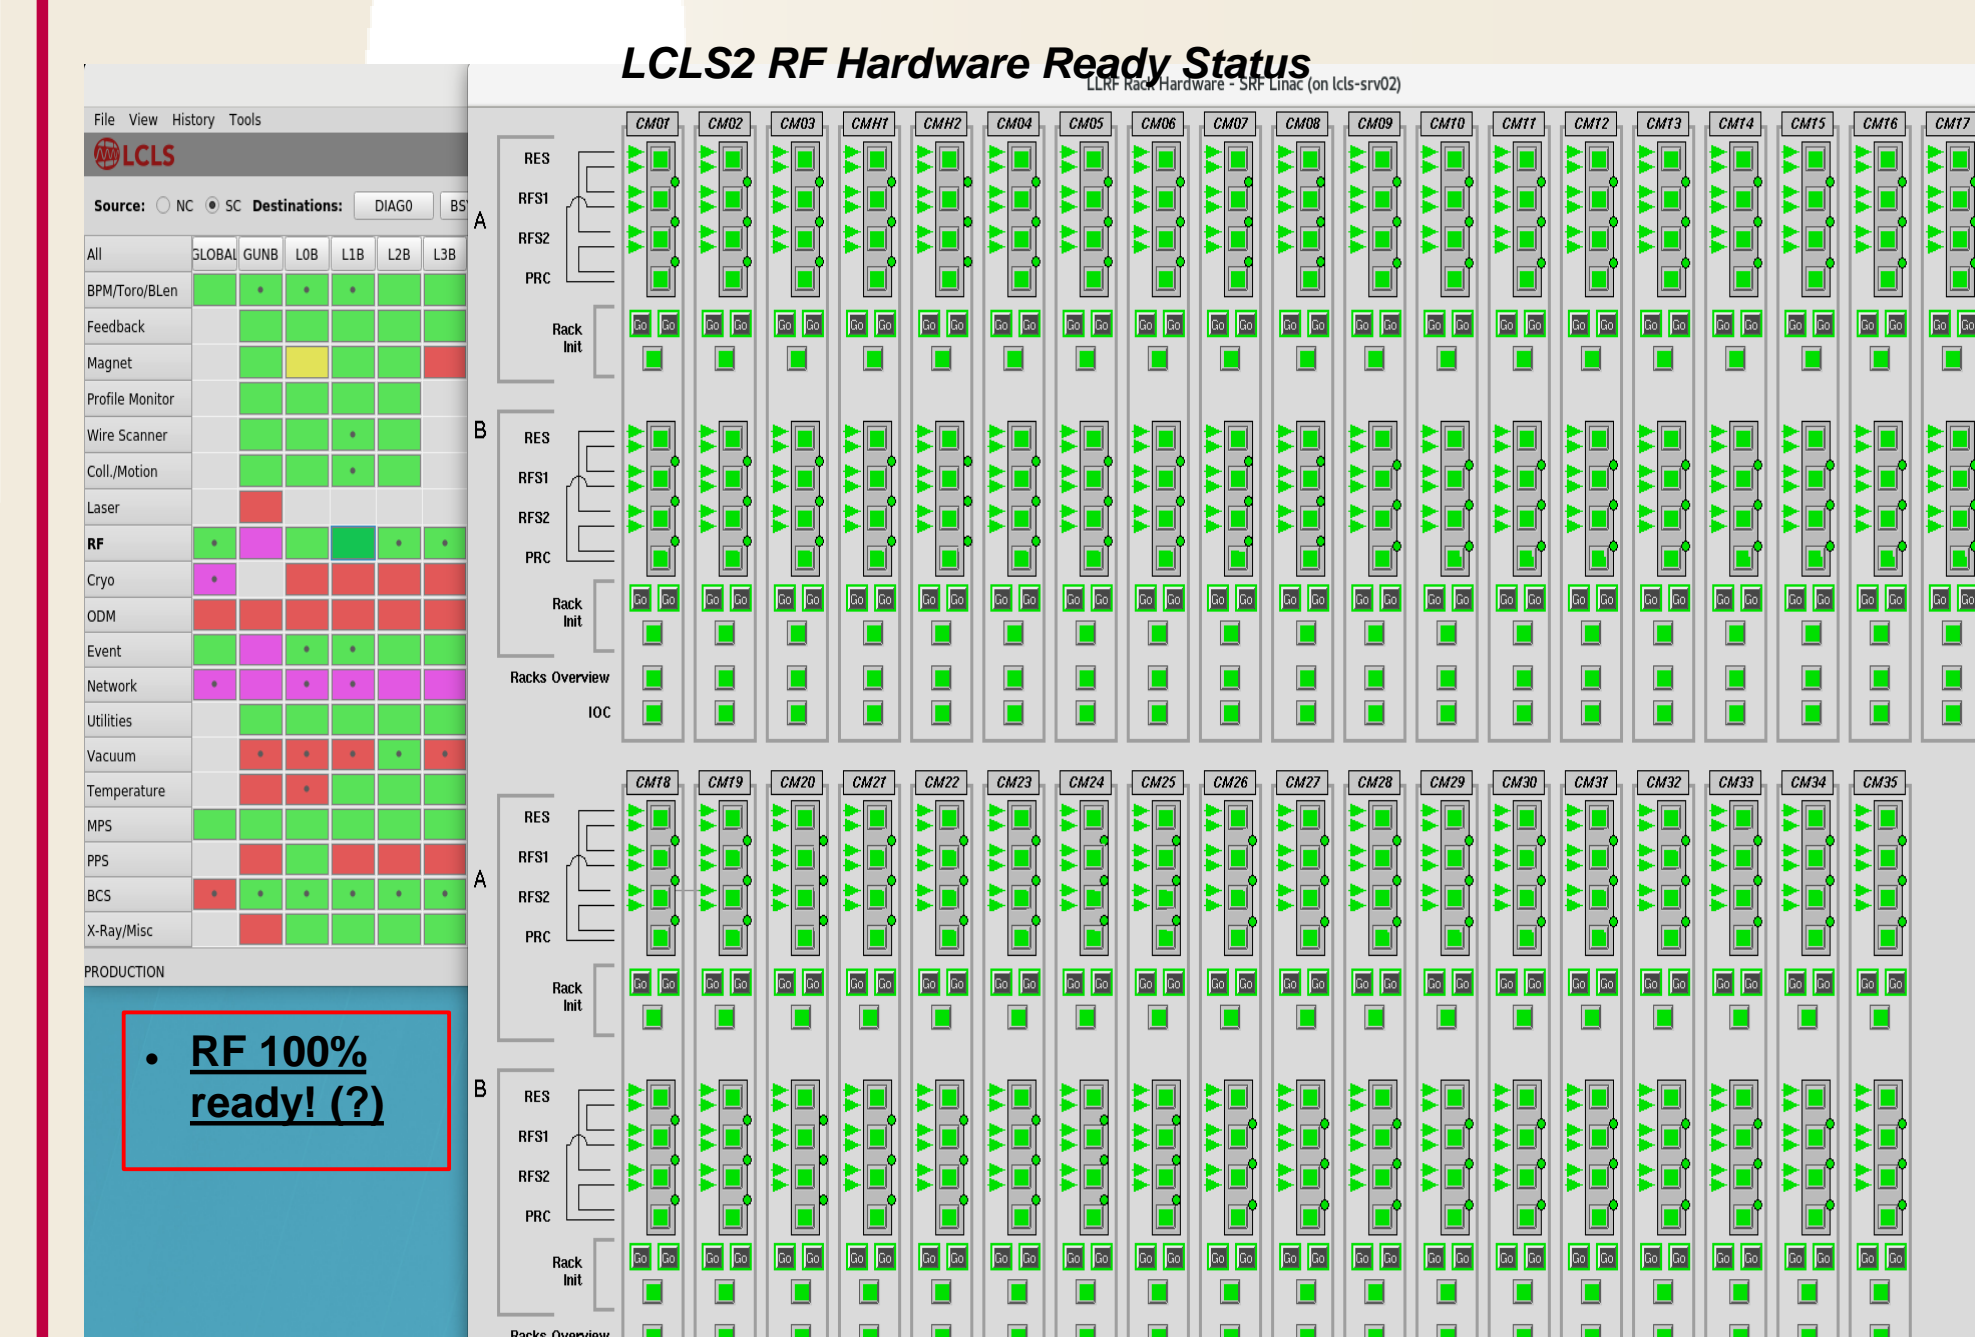
RF 100% ready! (2)

3. LLRF Chassis wire insulation began degrading in more than 50% of LLRF chassis. Suspected counterfeit insulation. All chassis had to be pulled from installation and rewired.

Common problems discovered during hardware checkout	Number found/reason
Heliax swapped	Too many to count
Heliax through the wrong penetration	15 (bad documentation)
Poor multi-pin termination	> 100
Poor heliax termination	Dozens and counting
Piezo tuner disengaged in CM	3 completely (5 single)
Stepper tuner problem in CM	1 motor heats with no tuning
Limit Switches stuck open in CM	1 (suspected)
RTD bad in CM	4
Failed rack checkout – poor fiber connection	Too many to count
Disconnected cable inside chassis	7
Low LO	Failed LO couplers
PRL signal unstable	> 20 and still investigating
Poor LLRF chassis linearity	8 – failing amplifiers
Failed fiber patch panels	5
