MUSE: EQUIPMENT STATUS

PAUL E REIMER

Villigen, Switzerland
5 February 2024

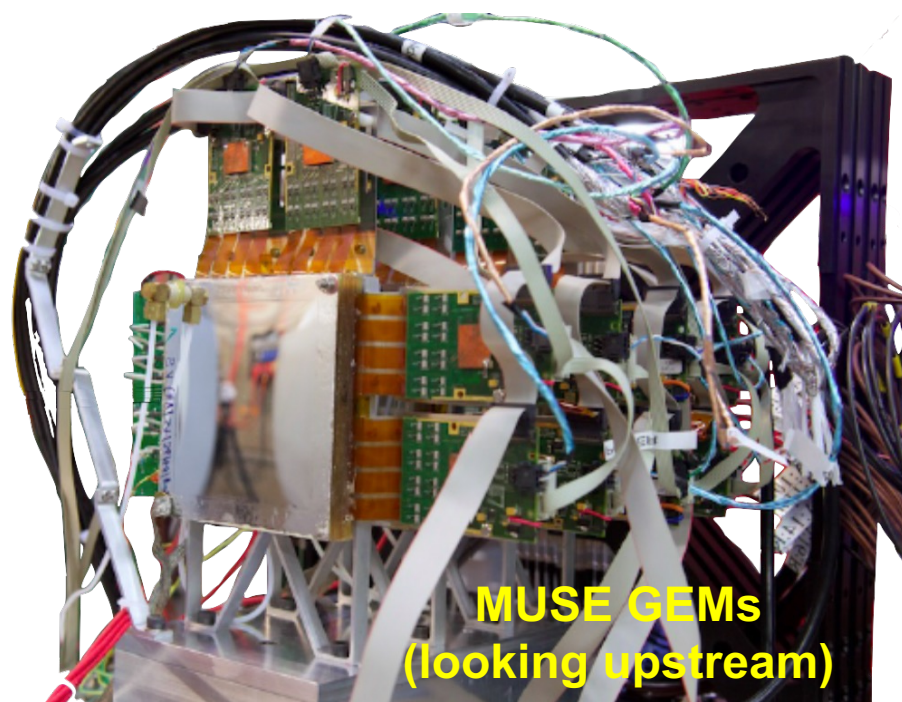
- GEM Readout
 - Front end code improvements
 - 160 μ s 6-frame and less than 100 μ s 3-frame
- Lost 1 GEM readout in Nov/Dec
 - CF card was corrupted
 - Short term—replaced CF card
 - Long term—considering network boot
 - Vulom-4b board issues
 - Purchase of spare Vulom-4b in progress
 - This was possibly caused by an unplanned power outage.

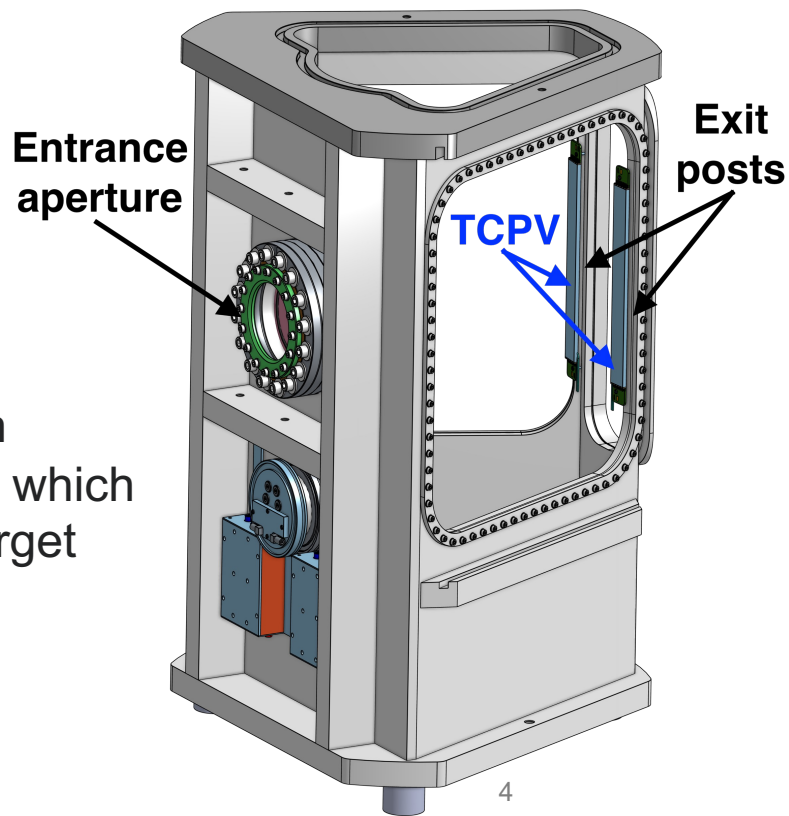
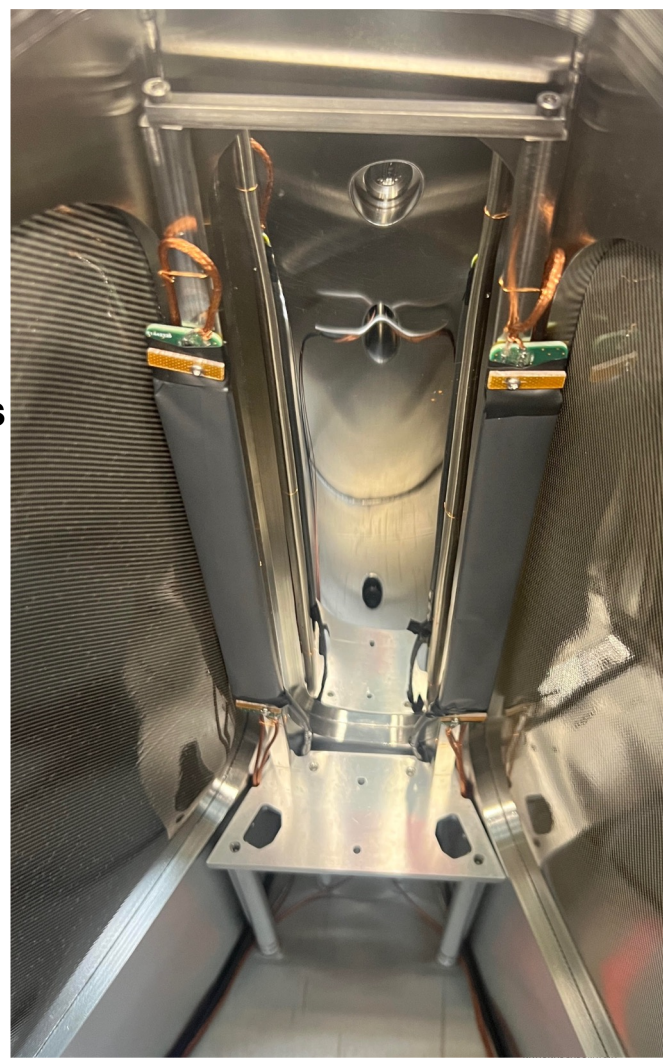
TARGET CHAMBER POST VETO—TCPV

Significant DAQ bandwidth spent in recording particles which scatter from the target posts

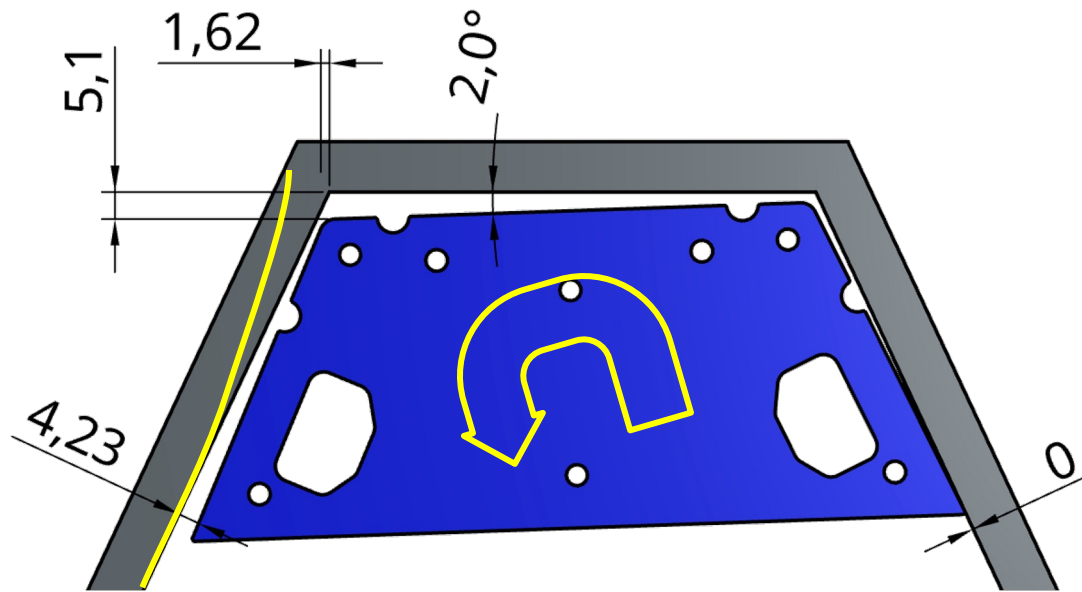
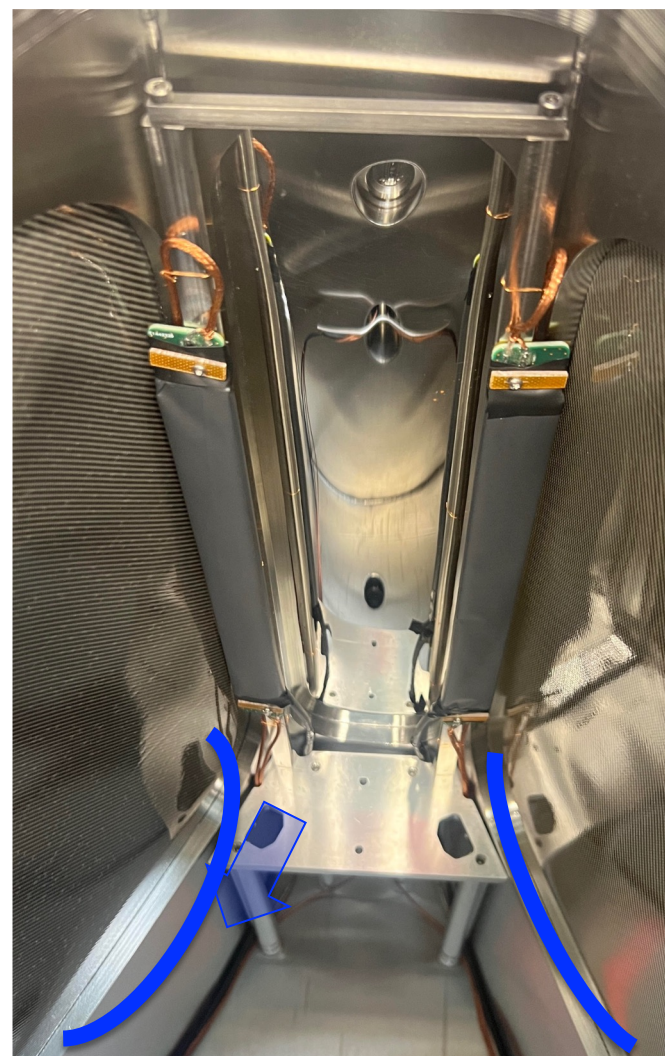
TARGET CHAMBER POST VETO—TCPV

Significant DAQ bandwidth spent in recording particles which scatter from the target posts

- Vacuum chamber pump down caused slight flex in target posts.
- “Chair” slid slightly upstream and rotated
- TCPV damaged
- Received immediate attention from *PSI Detectors, Irradiation and Applied Particle Physics Group* to aid in repair.
- Designed fixed table and better mounting not susceptible to this flex.

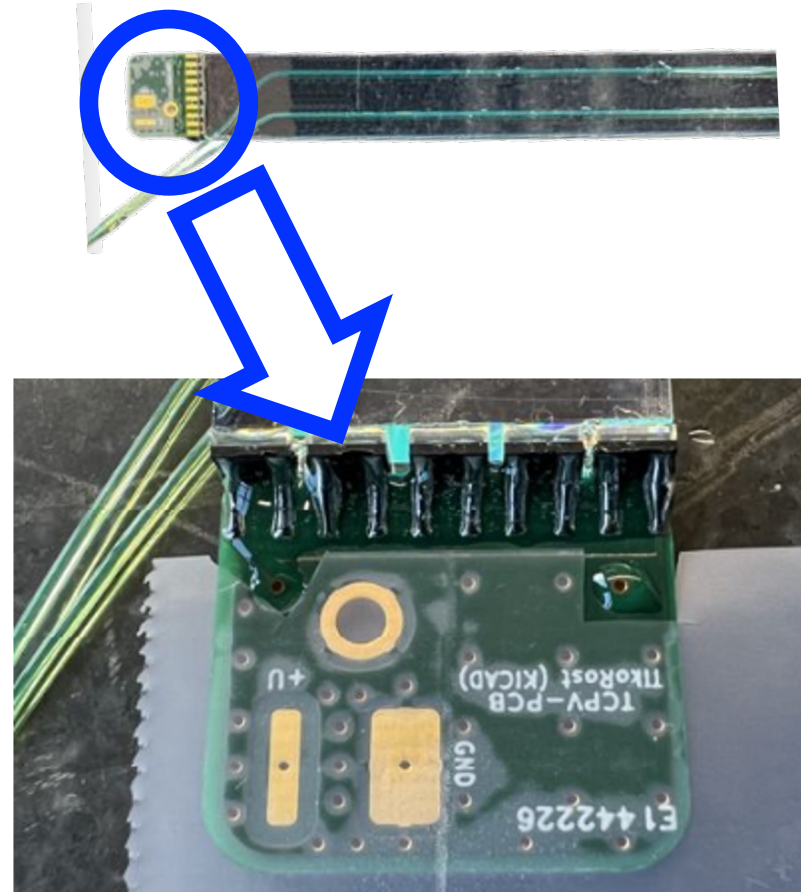
TCPV with WLS lowers background trigger rate, but more improvement possible

- Light collection
- Long decay constant of WLS broadens signal.

Study with no H₂ in the target chamber
